Hydraulic study on scouring downstream of Funagira Dam spillway apron (Japan)

ABSTRACT: Funagira Dam is a concrete gravity dam having a height of 24.50 m and a dam crest length of 220.00 m, and is located approximately 30 km upstream from the mouth of the Tenryu River. The Funagira Dam is owned by the Ministry of Agriculture, Forestry and Fisheries, Shizuoka Prefecture, and Electric Power Development Co., Ltd. (J-POWER), and its objectives include power generation and supply of agricultural water, public water, and industrial water. For energy dissipation, the downstream area of the dam was designed as a hydraulic jump-type dissipater using bed protection blocks. The dam has experienced several large storm events in the 40 years after its completion. The protection blocks were damaged and the scouring downstream of the dam began soon after completion. About 6,300 tetrapods were added stage by stage to the bottom. In recent times (2011), however, flood events have been more intense and of longer duration, with maximum spillway releases of up to approximately 6,396 m³/s. This resulted in increased scouring at the foot of the dam. Emergency measures were taken just downstream of the

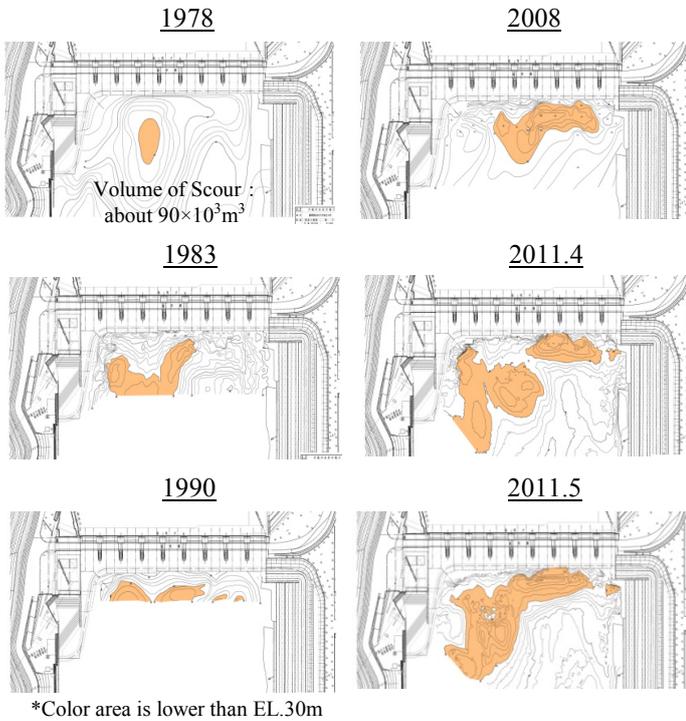
Figure 4. Morphological change in front of Funagira Dam (1978-2011)

The dam has experienced several large storm events during the 40 years after completion. The protection blocks were damaged and the scouring downstream of the dam began soon after completion.

The downstream area of the dam in 2011 was scoured by a volume of approximately 230,000 m³, with a maximum depth of approximately 13 m, for a riverbed height of EL 39.0 m.

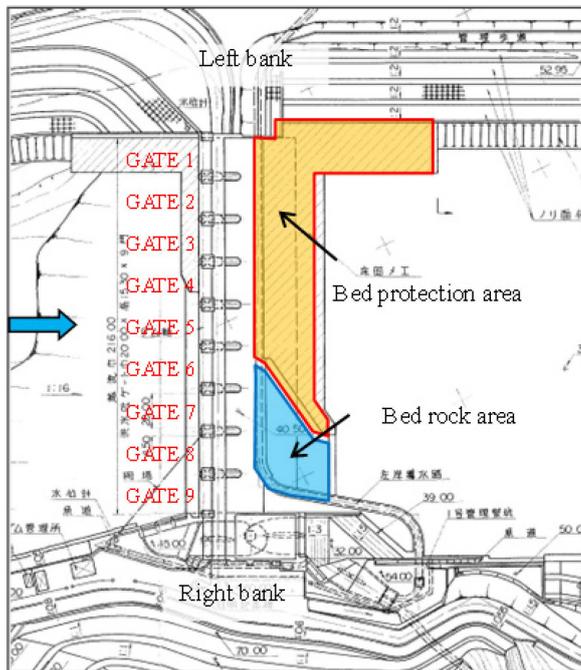
Figure 8. Area of original bed protection measures

As described above, the bed-protection blocks were not evenly placed across the river, but placed along areas where bedrock was not apparent (Figure 8). Therefore, it can be imagined that the bed-protection blocks placed along the edges of the subject area were removed by irregular water flows and unstable hydraulic jump, caused by an uneven riverbed along the boundary between the exposed bedrock and the gravel/bed-protection blocks.

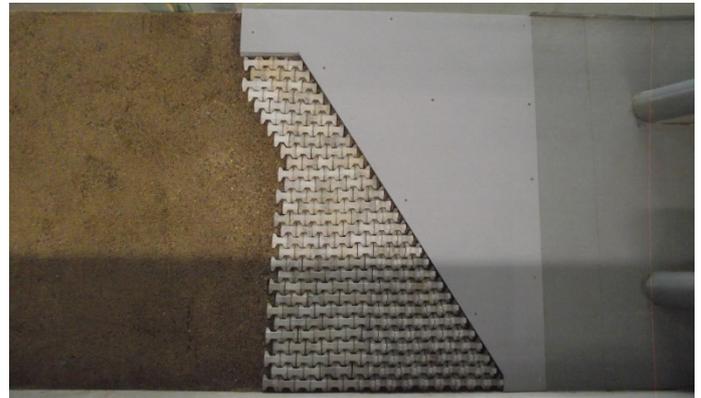
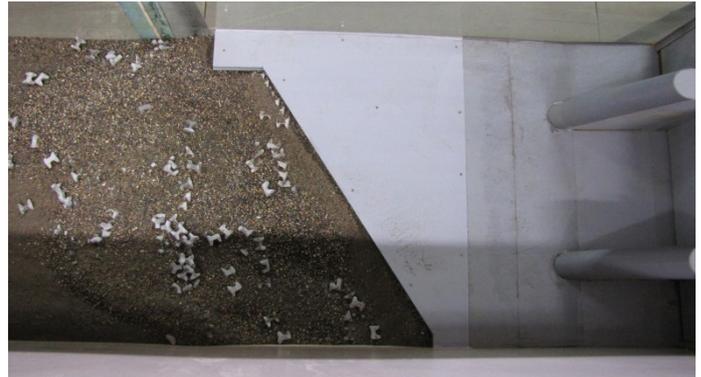
Figure 9. Model test for stability about original bed protection in front of Gate 7

The experiments using the vertical 2-dimensional hydraulic scale model, where a boundary was reproduced between the bedrock and gravel, showed that, even though the bed-protection blocks were stable when they were entirely evenly placed, a large morphological change was observed and the damage to the blocks was expanded in front of Gate 7 (Figure 9).

Accordingly, it can be thought that some bed-protection blocks were removed and the gravel around them was scoured immediately after the dam was completed. This would then reduce the engaging effect of adjacent blocks, and then the blocks were further removed in a wide area, eventually losing the function of protecting the bedrock with the blocks.

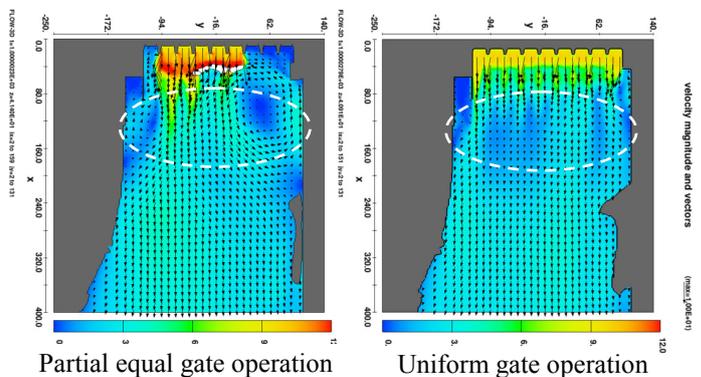
Figure 10. Difference of pyramid and partial equivalent procedures of gate operations until $3,000 \text{ m}^3/\text{s}$

In the flood events experienced after the dam was completed, several floods were discharged from the gates in a pyramid style (consecutive gate openings) during 1978 and 1982. After two large floods, we changed the gate operation in a partially equivalent procedure in 1983 (Figure 10). Even in the case of following this equivalent procedure, the rates of water discharged on both left and right sides differed, still generating a plane horizontal swirl flow in an area near both the left and right banks downstream of the gates from which no water was discharged (dead water region).

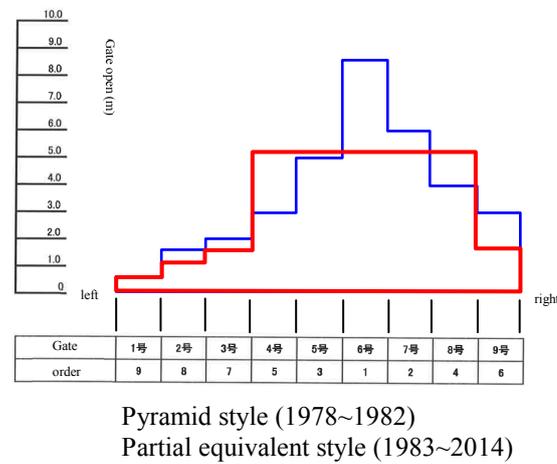
Figure 11. Comparison of flow condition with gate operations

Downstream of Funagira Dam, in particular, the horizontal swirl flow around the left bank was larger than around the right bank. Figure 11 shows the flow conditions downstream of Funagira Dam computed by a 3-dimensional free surface mathematical model. The partially equivalent procedure generates a huge horizontal swirl flow around the left bank of the dam.

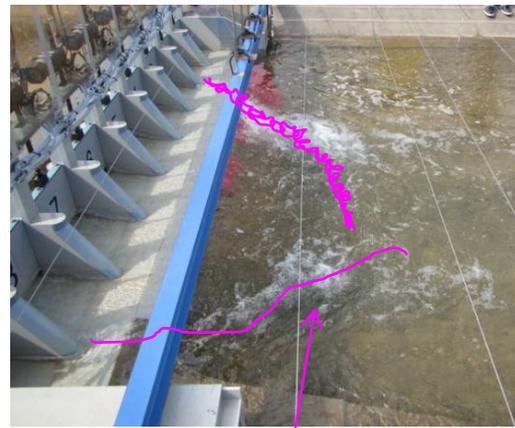
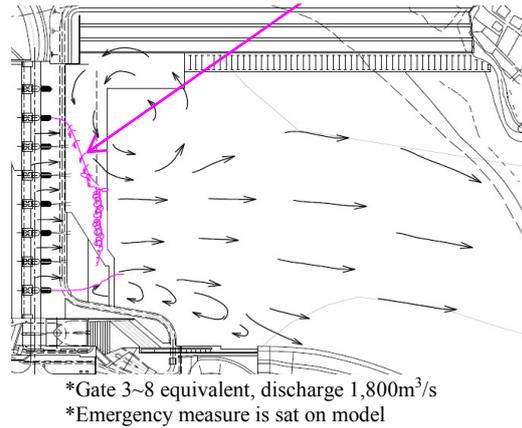
Figure 12. Flow regime of partial equivalent gate style

The experiments using the 3-dimensional model showed that the horizontal swirl flow proceeded upstream towards the left bank, changed direction at the lower edge of the apron, and then flowed parallel to the dam axis (Figure 12). The water flowing parallel to the dam axis formed a diagonally downward flow when joining the flow of water discharged from the gates, creating a critical flow for the protection blocks and scouring on the riverbed unlike a normal hydraulic jump.

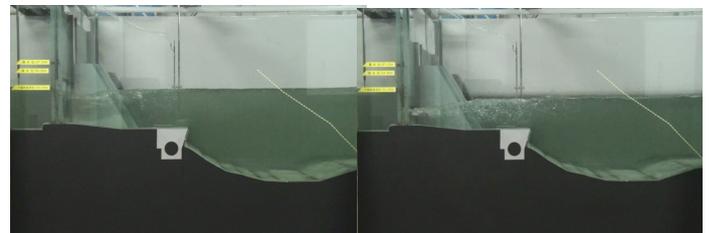
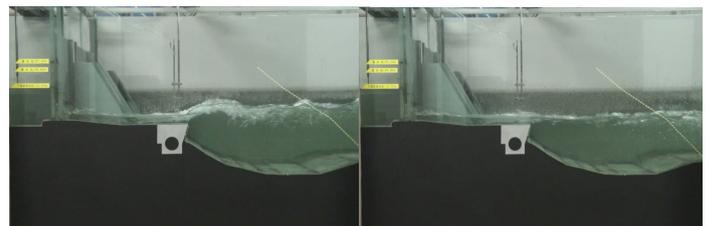
Figure 13. Types of hydraulic jump in front of Gate 7 following different downstream water levels

For a constant discharge rate, different types of hydraulic jump are formed as (1) an underwater flow, (2) a submerged flow, (3) a free flow, and (4) a drop flow (overflow), according to the downstream water level. The riverbed was mostly scoured in the presence of an underwater flow type (Figure 13).

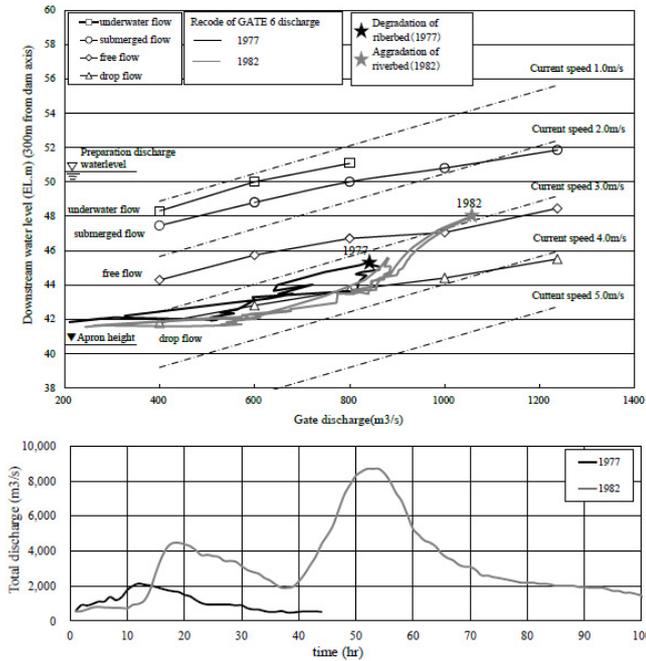
Figure 14. Types of hydraulic jump following the downstream water level and for different Gate 6 discharge rates

Figure 14 summarizes the different types of hydraulic jump as a function of the downstream water level and as a function of the Gate 6 discharge rate. It shows that the lower the downstream water level, the more different types of hydraulic jump are appearing. Also, drop flow appears in the case of the lowest downstream water level.

The flood of 2,134 m³/s in 1978 and the largest flood of 8,700 m³/s in 1982 generated similar types of hydraulic jump until 800 m³/s discharge of Gate 6 in the figure. It means that the downstream water level is low at the beginning of discharge with any class of flood discharge, and that it facilitates scouring of the riverbed at the initial discharge operation. It is the reason that Funagira Dam was seriously scoured during the small flood in 1978.

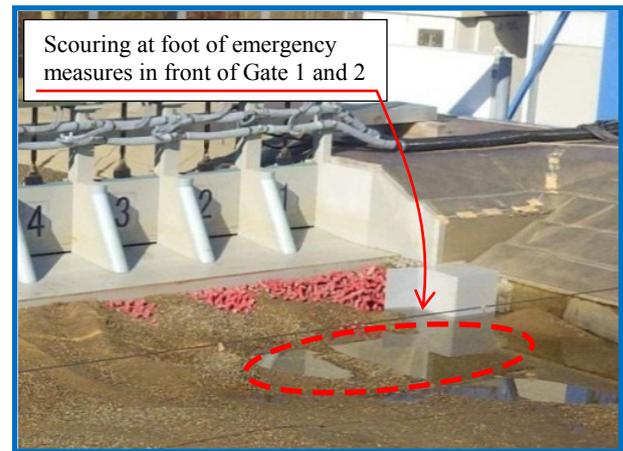
Figure 15. Stability of emergency measure in 2013 after design discharge of 11,130 m³/s with equivalent procedure of gate operation

full-gate equivalent procedure, sand was built up and kept relatively stable with a discharge in a range from approximately 7,200 cm to 8,000 cm. However, when the discharge exceeded 8,000 m³/s, that is, the water flowed freely, sand was scoured downstream of Gates 1 to 4 and of Gate 9. Particularly, the left and right banks were largely scoured (downstream of Gates 1, 2, and 9) (Figure 15).

In the present situation with emergency measures, the left and right banks can be scoured when water is discharged, even in a full-gate equivalent procedure, at a rate of a minimum of 8,000 cm. So we have determined that some permanent mitigation measures (hereinafter referred to as “long-term measures”) must be implemented as quickly as possible to obtain sound protection.

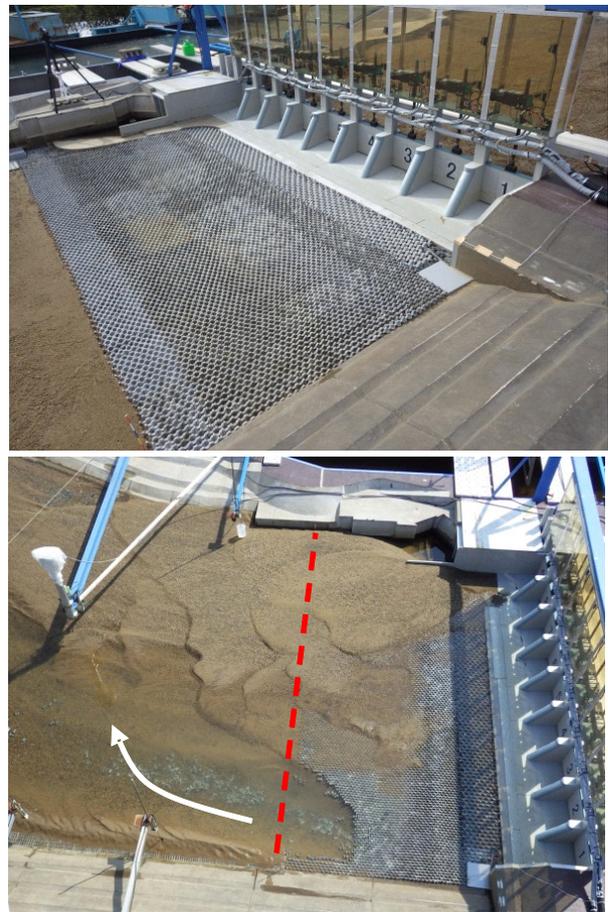
Figure 17. Stability of recovery plan after design flood

According to the results of the experiments, both riverbed plans reduced scouring potential during extreme flooding. The measures led to stable results, meaning that they were safe against scouring immediately downstream of the dam. During free flow discharge, the water flow was biased toward the left bank by the sedimentation on the right bank, resulting in local scouring along the left bank. Therefore, although the blocks placed along the left bank downstream of the dam were partially removed, it was considered that the impact was local and did not expand further (Figure 17 and Figure 18).

In the experiments with a design flood, sand was deposited along the right bank. Both mitigation plans showed some morphological changes in the consolidation blocks placed along the left bank. The riverbed maintenance plan showed a larger degree of morphological change, lowering the height of the riverbed around the river wall block foundation. Therefore, it was determined that the riverbed maintenance plan was not capable of preserving the structural integrity of the river wall.

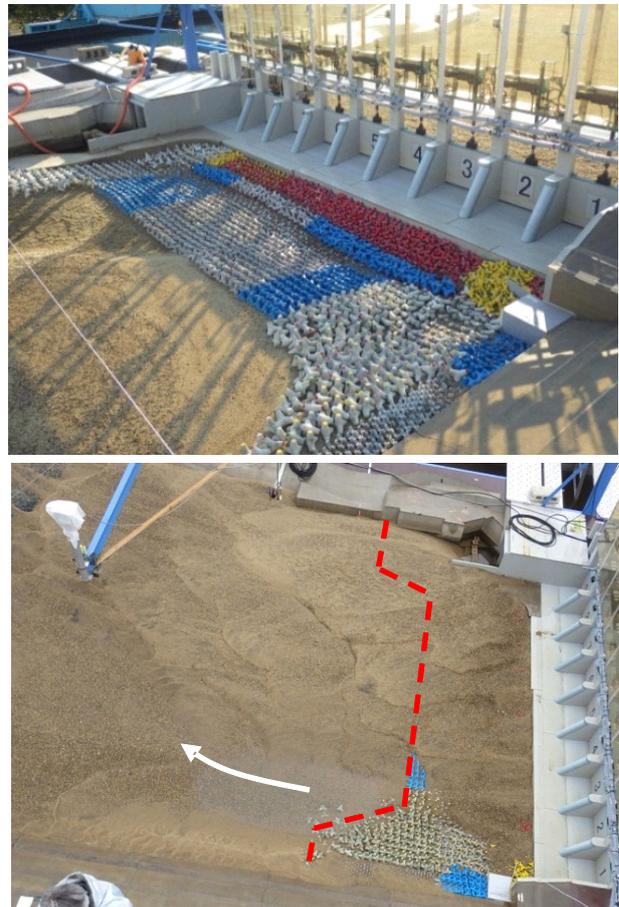
Figure 18. Stability of maintenance plan after design flood

Even though the riverbed maintenance plan showed a superior effect in reducing the amount of water discharged from the gates, this plan also showed instability in hydraulic jump positions due to sand deposits along the right bank, lowering this discharge reduction along with the hydraulic jump positions shifted upstream and downstream, and causing the water flow to accelerate at a high velocity.

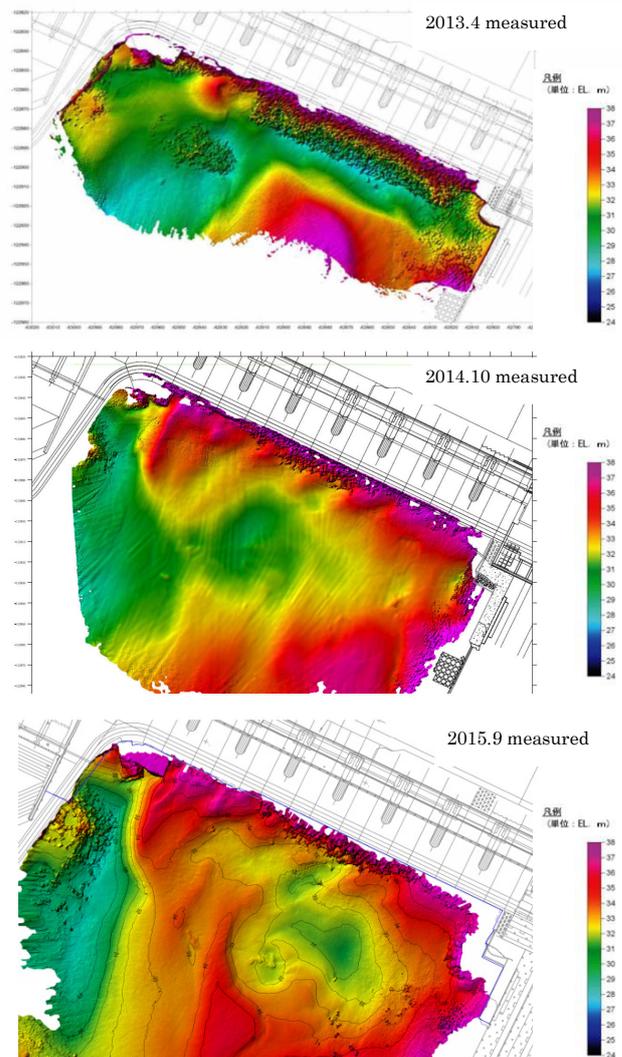
Figure 20. Field observation of morphological changes, measurement with multi-beam sonar

For the riverbed maintenance plan, there is an essential issue: reduction of the structural integrity of the river wall. The issue arises if the height of the riverbed around the river wall foundation cannot be stabilized by the consolidation blocks placed along the left bank, due to sediment deposits on the right bank, lowering the amount of water flowing along the right bank, and thus resulting in faster flow velocities. Then, field observations of morphological changes will be important. Figure 20 shows the morphological change of the riverbed in front of Funagira Dam.
