Investigation into the multiple recent sinkholes in Pokhara, Nepal

R. Kuwano, T. Kiyota, R. M. Pokhrel & T. Katagiri
Institute of Industrial Science, The University of Tokyo, Japan

ABSTRACT: Since November 2013, numerous sinkholes have been forming in the Armala area of Pokhara Valley, Central Nepal, posing serious threat to local residents. In order to provide countermeasures for reducing sinkhole risk, detailed investigations into the cause and the formation mechanism of the sinkholes are crucial. Preliminary surveys were conducted in June 2014 and November 2014. Comparison of photos, taken in the two surveys, clearly indicates not only the formation of new sinkholes, but also the re-activation of filled sinkholes. By means of dynamic cone penetration tests and surface wave investigations, qualitative characterization of the soil profile was attained, and shallow weak soil layers which are believed to be the location for future sinkholes could be identified. On the basis of the preliminary field investigation, possible sinkhole formation mechanisms are considered. A risk of sinkhole does not seem to disappear as white turbid water continuously springs. It indicates that the int

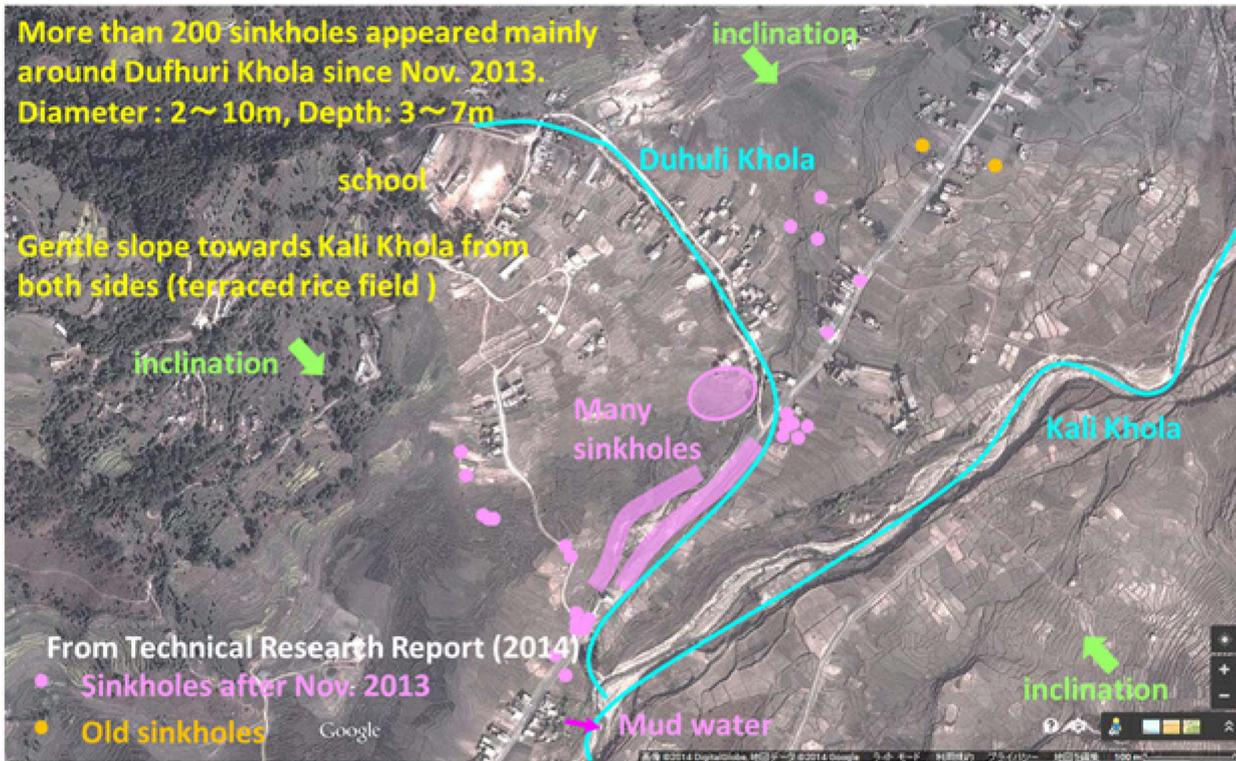
Figure 1. Outline of the sinkhole area

Figure 1 shows the aerial photo of the sinkhole area. There is a big river called Kali Khola running through the area. A relatively small river, named Duhuli Khola, flows into Kali Khola. Many sinkholes occurred along Duhuli Khola as indicated in Figure 1.

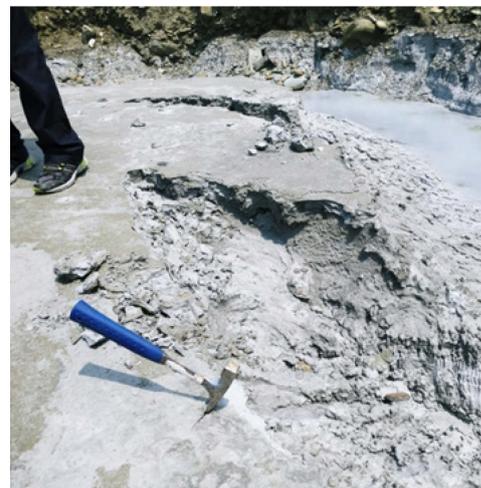
Figure 2. White silty clay deposit

Field investigations were carried out in June and November in 2014, and July, August and December in 2015. In June 2014, we found that all the sinkholes had been completely backfilled except for two. At the bottom of these unfilled sinkholes, soft white clayey silt sediment was found as shown in Figure 2. The white deposit seemed to be brought by water

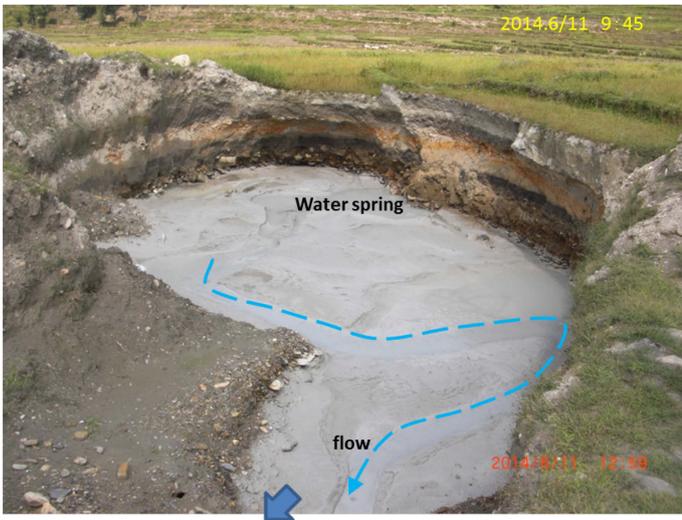
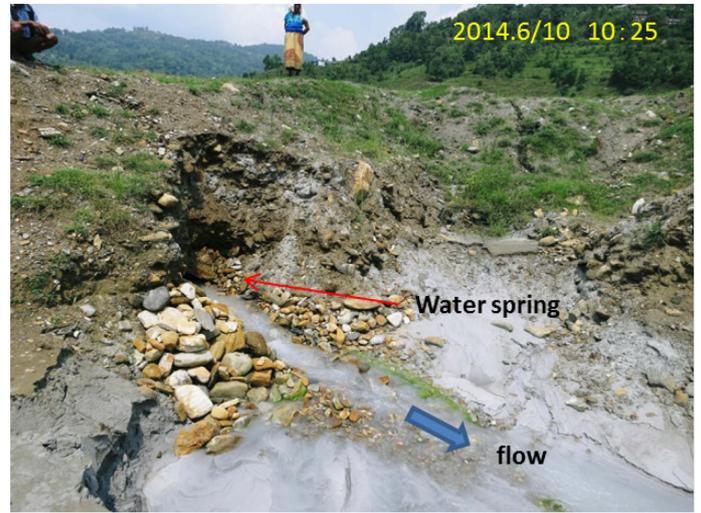
Figure 3. White turbid water spring at the sinkholes
Filled sinkhole (June 2014)

springing at the bottom or the side of the sinkhole as shown in Figure 3. Sprung water was white turbid, indicating that the subsurface internal erosion continued.

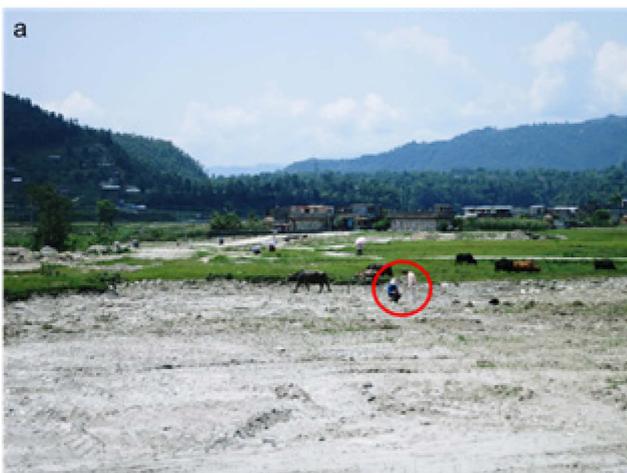
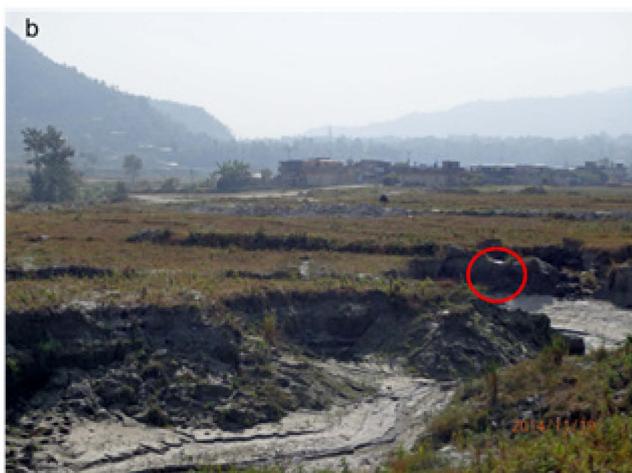
Figure 4. re-occurrence of backfilled sinkholes

In November 2014, we observed a lot of sinkholes, including newly formed ones and reactivation of sinkholes for backfilled ones. Figure 4 compares photos of the same location taken in June and November 2014. The process of sinkhole formation seems to be still continuing. Especially after the rainy season, many new or reactivated sinkholes appear. Figure 5 presents an aerial photo of south west parts of the area taken in December 2015. Most of the sinkholes observed in Figure 5 are reactivated ones and they are in lines, implying that the subsurface water pathway may be developed and cause the internal erosion.

Sinkhole appeared again (Nov. 2014)

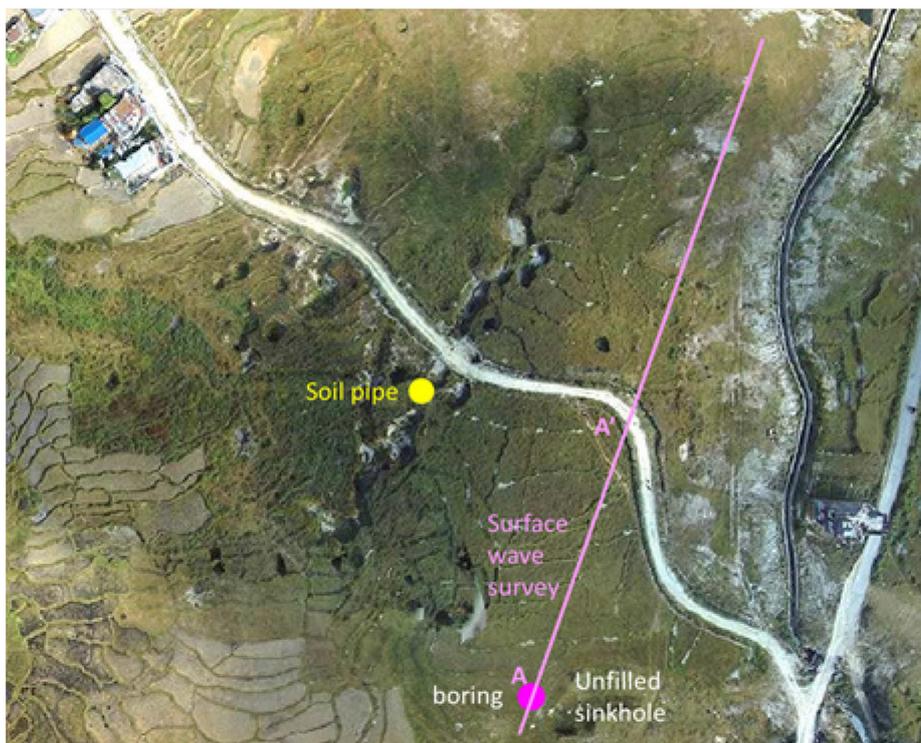
Figure 5. Aerial photo of the area taken in December 2015

Boring survey was conducted in August 2015, beside one of the unfilled sinkhole, indicated in Figure 5. As shown in Figure 6, a thick white silty clay layer was found below GL-4m and a cavity of 2.5m high was discovered at GL-7.5 to 10m. The white silty clay seems to be very stiff. The SPT values of the layer were over 50.

The sign of subsurface water pathway was found in the bottom of one of sinkholes, as shown in Figure 8. The soil pipe developed in a white silty clay layer at GL-6.0m. White turbid water stayed around the pipe. A lot of reactivated sinkholes existed at the location of soil pipe as shown in Figure 5.

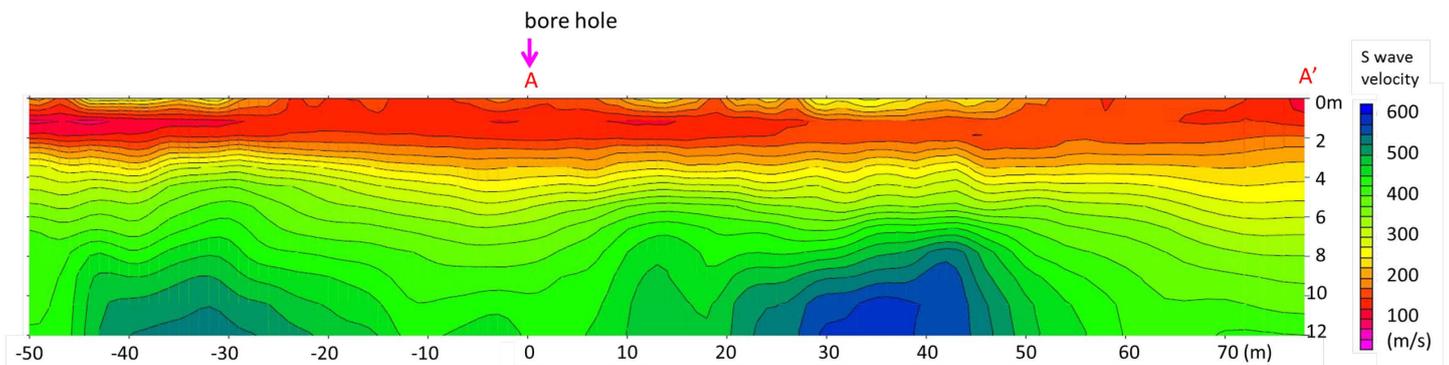
Figure 7. S wave velocity profile obtained from the surface wave survey for line A-A'

A part of the results of surface wave test along the line A are shown in Figure 7. The line A is passing on the borehole as indicated in Figure 5. Figure 7 presents S wave velocity profile for line A-A'. Although it was confirmed that the 2.5m high subsurface cavity exist at the borehole point, it was not clearly identified in the profile of S wave velocities obtained from surface wave survey. A low velocity section observed at -40 m and 40-50 m from the borehole point may indicate potential cavities or loosening in the ground.

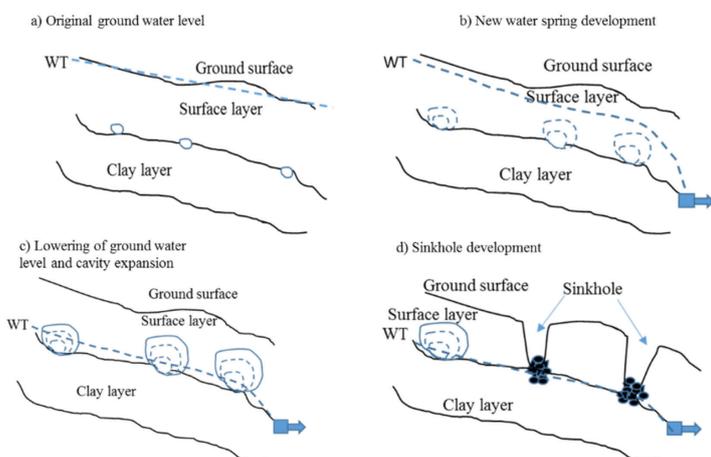
Figure 9. Mechanism of subsurface development (Pokhrel et al. 2015)

The groundwater flow is the triggering factor involved in the generation of sinkholes. In fact, it is assumed that in this area, there has been an active erosion process, where water gradually dissolved soluble soil, creating cavities beneath the ground surface. Pokhrel et al. (2015) assumed that the erosion process occurred at the boundary between surface layer and white silty clay due to the change of underwater condition, as demonstrated in Figure 9. In the investigation in 2015, the results almost support the hypothesis proposed by them but it was confirmed that the erosion took place within the white silty clay layer, not at the boundary.
