Riprap design for wind-wave attack

Retrospective model tests of the measured damage to
riprap panels on the offshore bank in the Wash

Report No. IT 213
December 1981
Crown Copyright

Hydraulics Research Station
Wallingford
Oxon OX10 8BA
Telephone 0491 35381

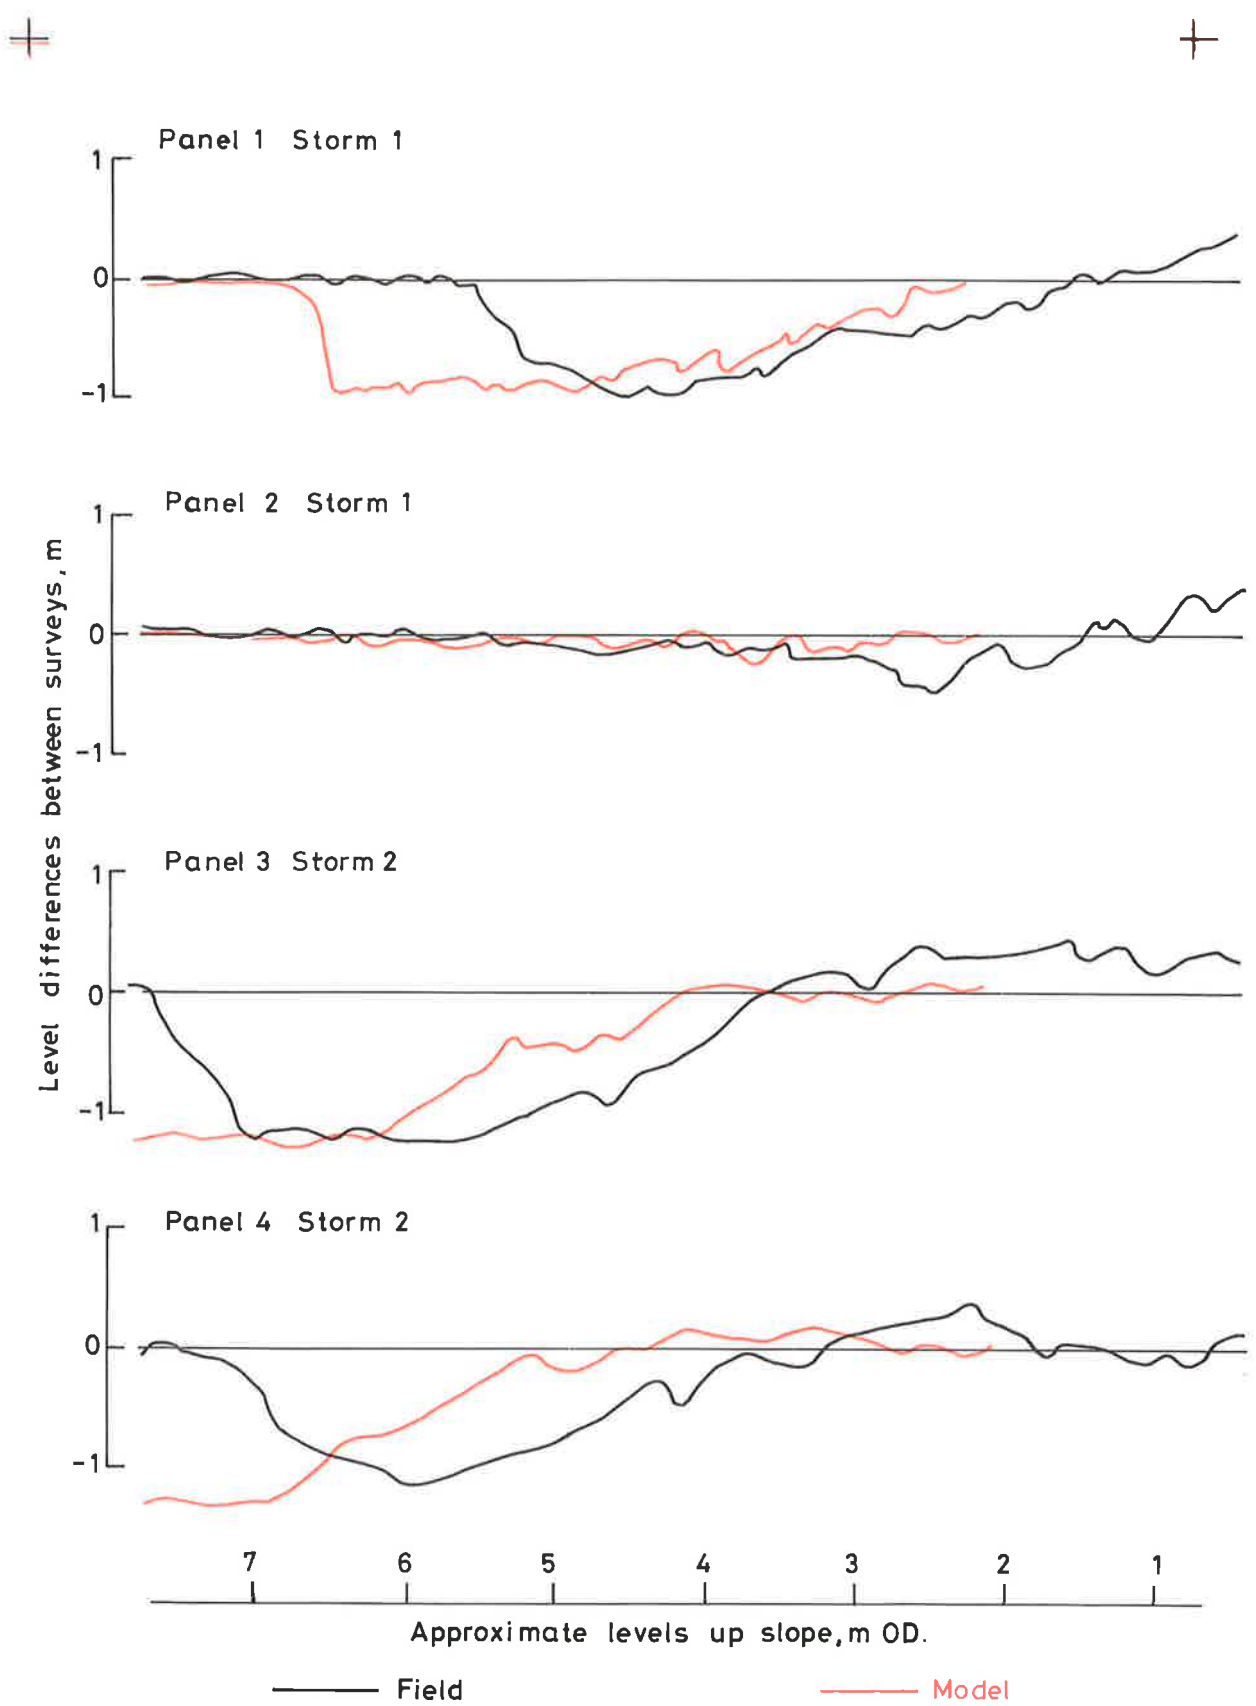
Extent of damage 3.7.2 A comparison of level differences between surveys for corresponding events for the field measurements and for the model test run 2 is shown in figure 9. The comparison for panels 1 and 2 is based on surveys taken before and after storm 1 for both the field and model measurements. For panels 3 and 4 the field differences are based upon surveys after storm 1 and storm 2 whereas the model differences are based on the initial survey and that taken after storm 2. The level differences for panels 1, 3 and 4 show the erosion hole to be higher up the slope on the model than on the field. Indeed the upper part of the riprap panels was completely eroded on the model whereas on the field some material remained at the top of the riprap slope.

Comparison of level differences between surveys field and model

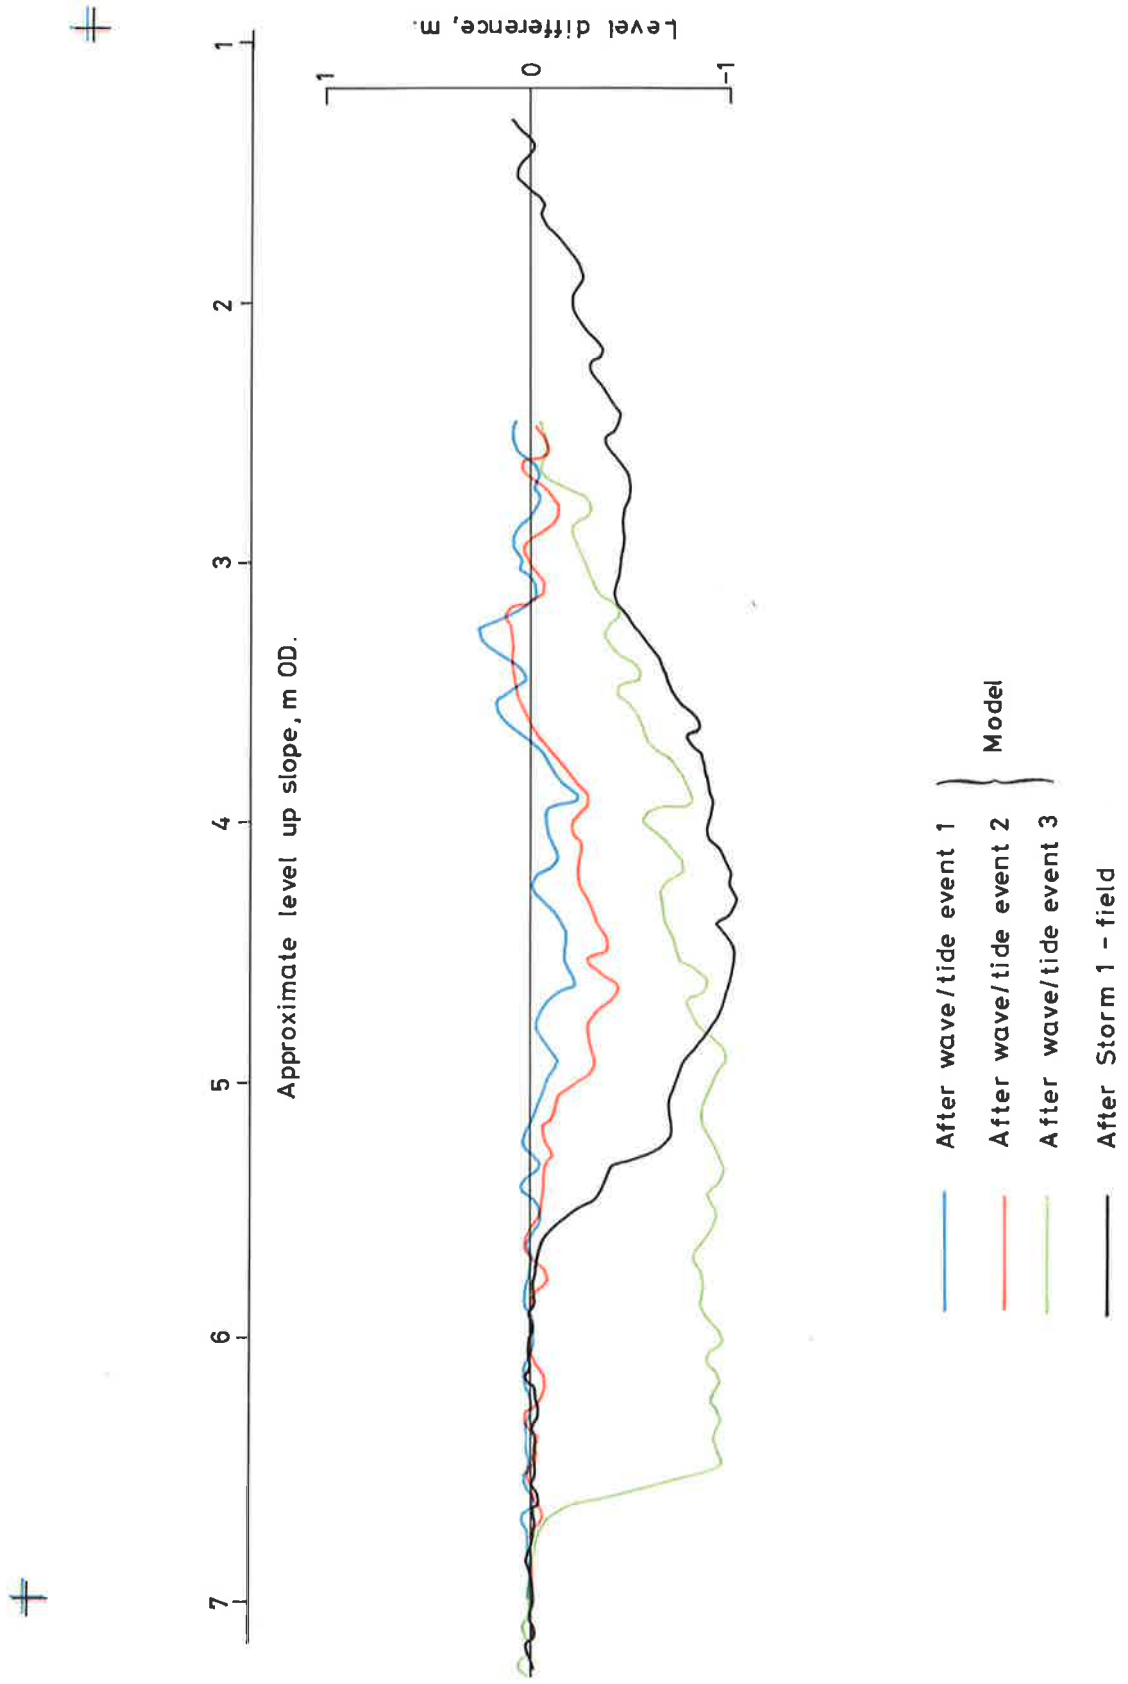
Fig 10

Level differences after each wave/tide event for storm 1 on panel 1

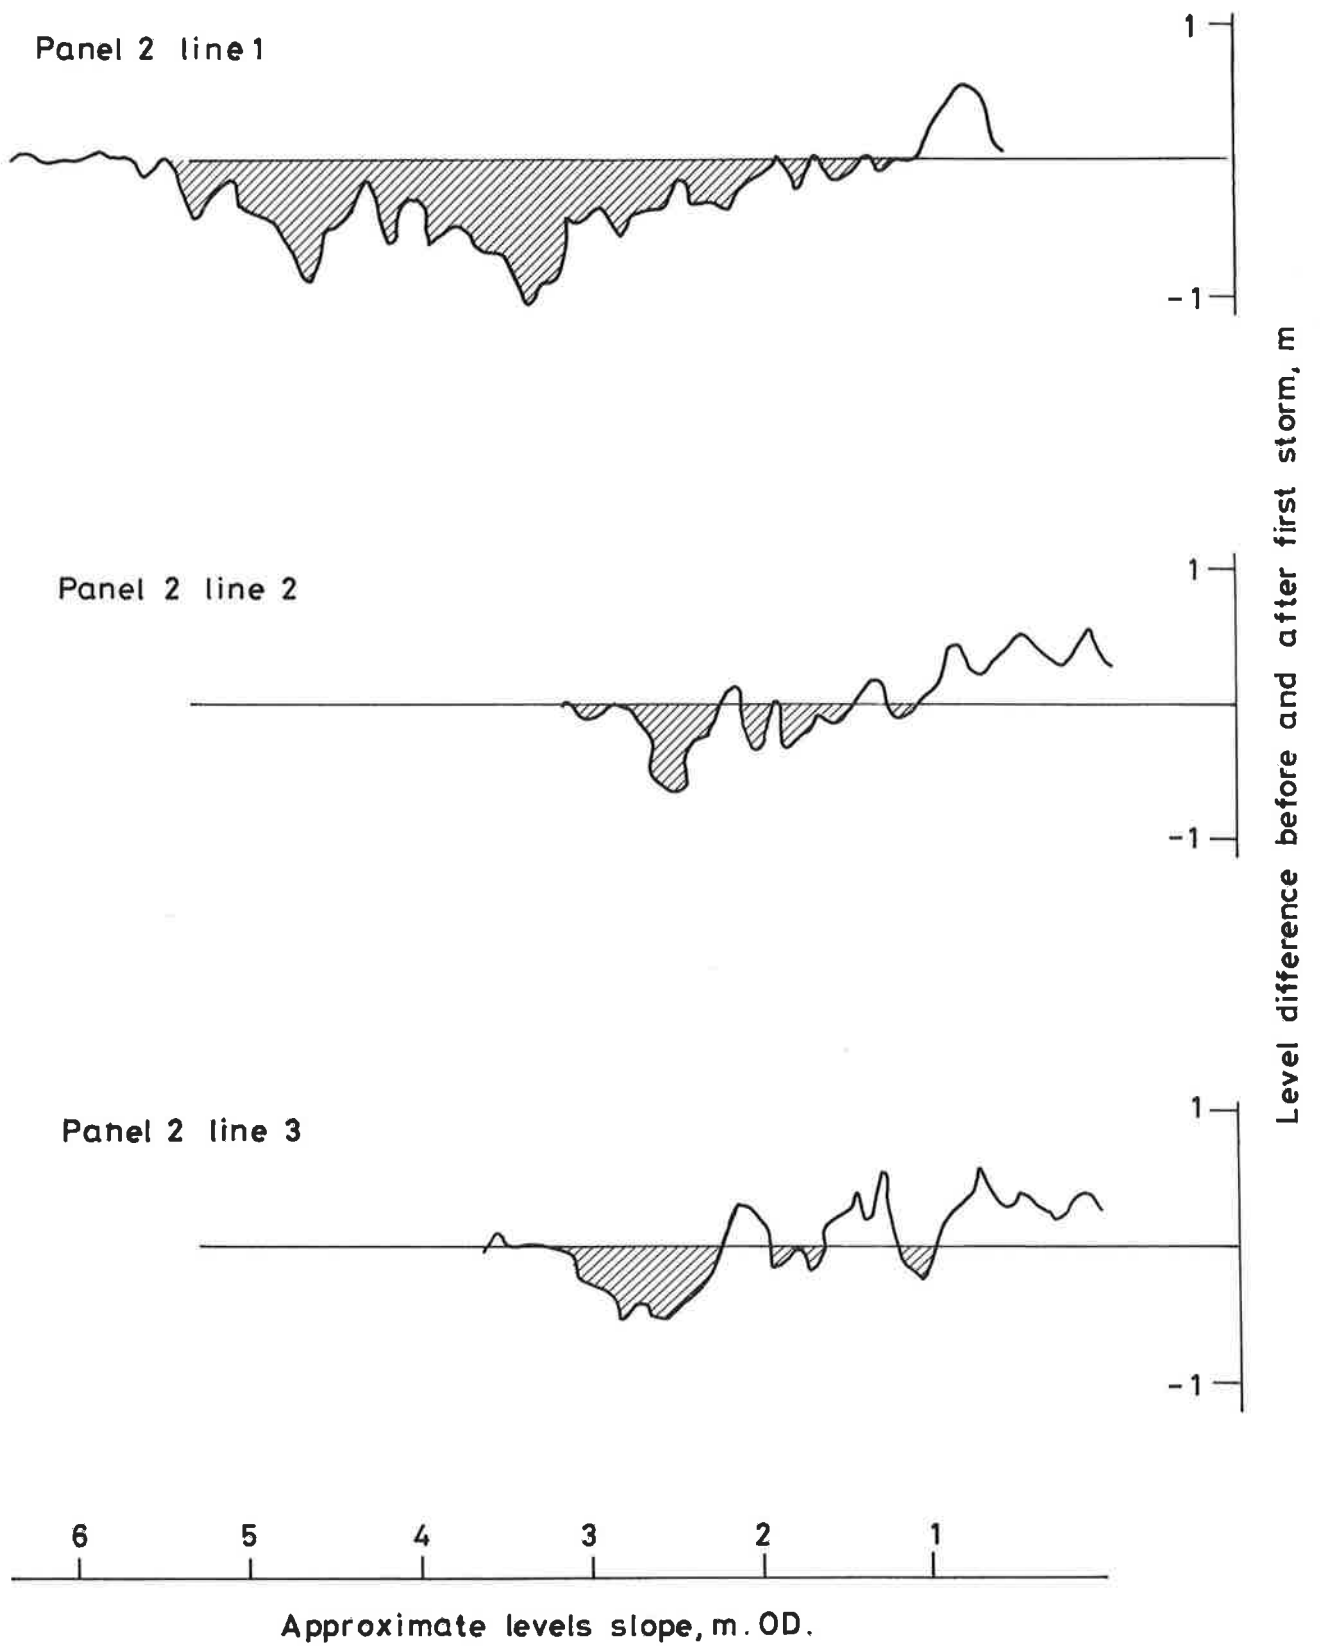
Panel 2 3.8.2 The field measured levels of survey lines 1-3 of panel 2 prior to and after storm 1 are shown on figure 11. They show substantial damage along the line adjacent to panel 1, consistent with the removal of the panel 1. The lines 2 and 3 show only limited damage towards the lower part of the slope suggesting that the sideways undermining of panel 2 was limited.

Panels 3 and 4 3.8.3 In both cases the damage on the model after storm 2 was less than on the field and was also higher up the slope, table 3 and figure 11. Undermining of both panels on the model began at the top of the slope and worked downslope with a considerable proportion of the undermined material being washed diagonally downslope onto the lower parts of panels 1 and 2; an action that was enhanced by the smooth exposed model underslope. The material deposited on panels 1 and 2 hindered further erosion of these panels and also impeded further undermining of panels 3 and 4. In addition the cross slope movement of the smaller material from panels 1 and 2 onto panels 3 and 4, due to the angled wave attack, hindered the surface erosion of panels 3 and 4. Prior to the deposition of material on panel 4 there was little evidence of surface erosion from this panel as Plates 14 show. In test run 1 where little undermining of panel 4 occurred there was similarly little surface erosion. Again it is thought that modelling the underslope conditions together with extending the tests to lower tidal levels would have ensured that the undermining action would have progressed at a lower level into panels 3 and 4 leaving some of the upper slope intact.

Field sections on panel 2

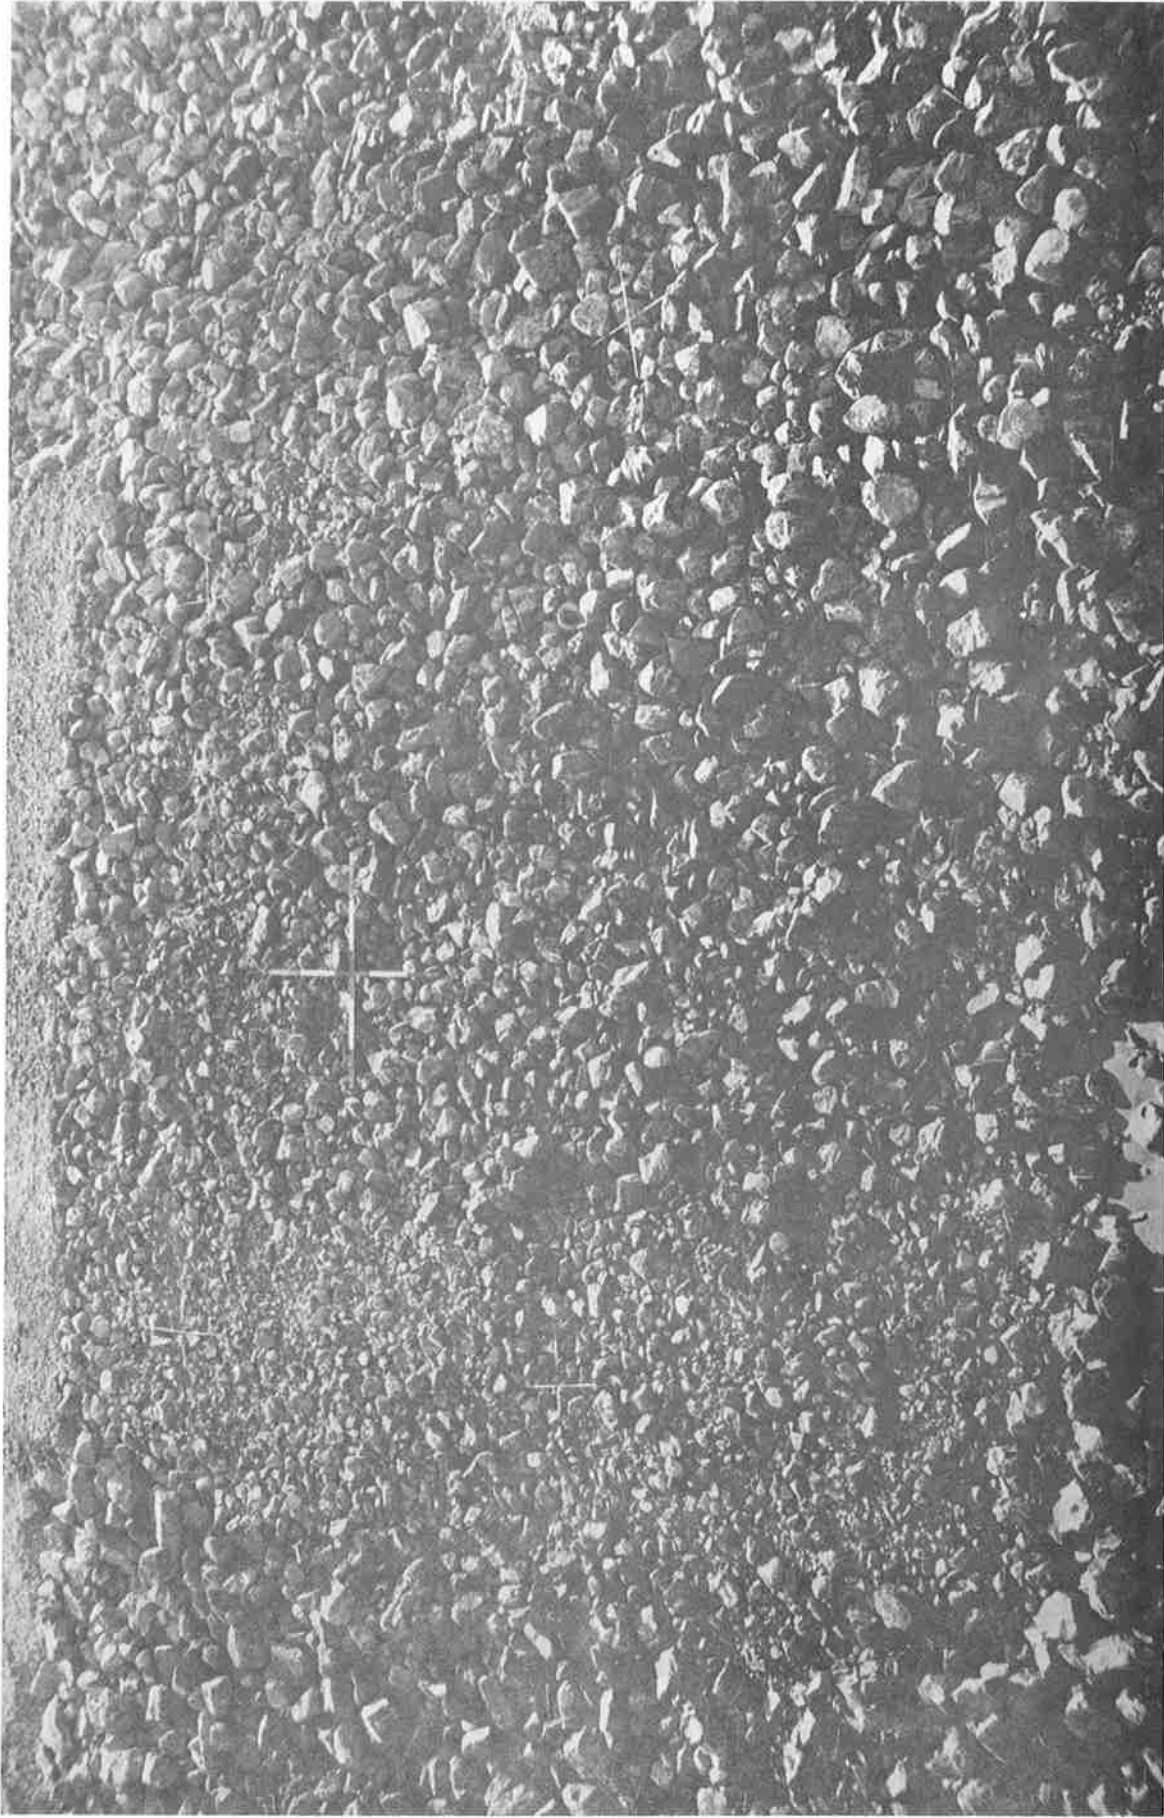
The model riprap was laid in such a way as to simulate some of the field procedures and a comparison of plates 1 and 2 indicates the degree of similarity produced for test run 1. Panels 2-4 show a reasonable similarity but panel 1 appears to lack sufficient fine material. The grading curve on figure 4 shows the tail of the curve at the ¼" size with 7% less than this size. For test run 1 the grading was terminated at the ¼" cut but for test run 2 an extra cut down to ⅛" was added and the improvement in appearance can be seen by comparing plates 1 and 3.

Plate 1 Field riprap panels 1-4

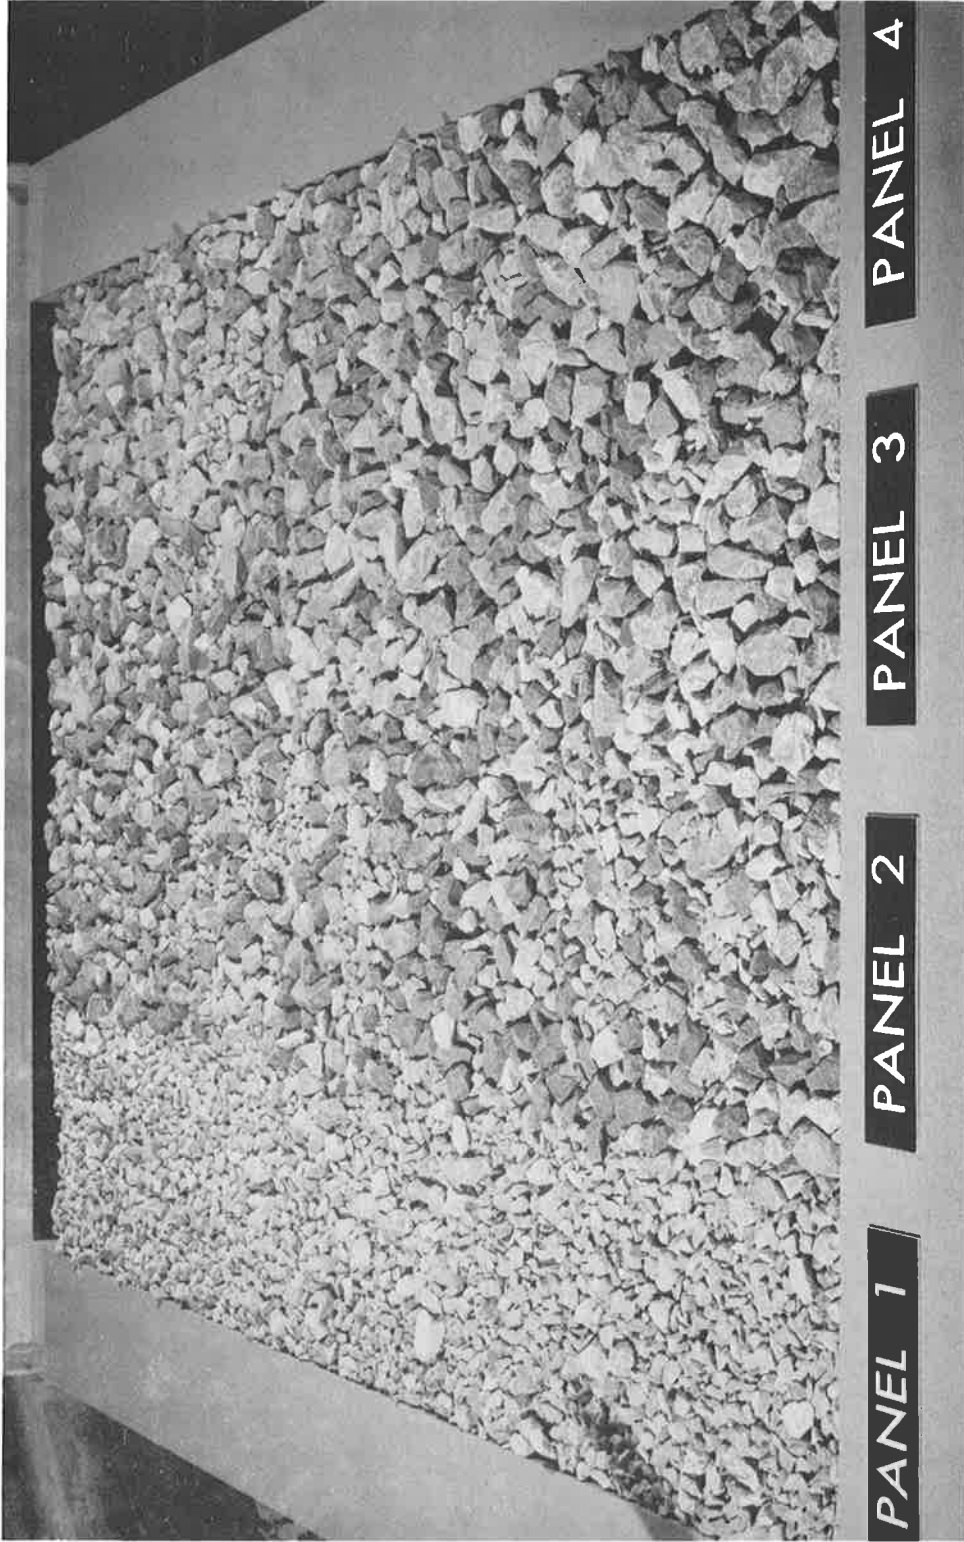
Plate 2 Model riprap panels 1-4 — test run 1

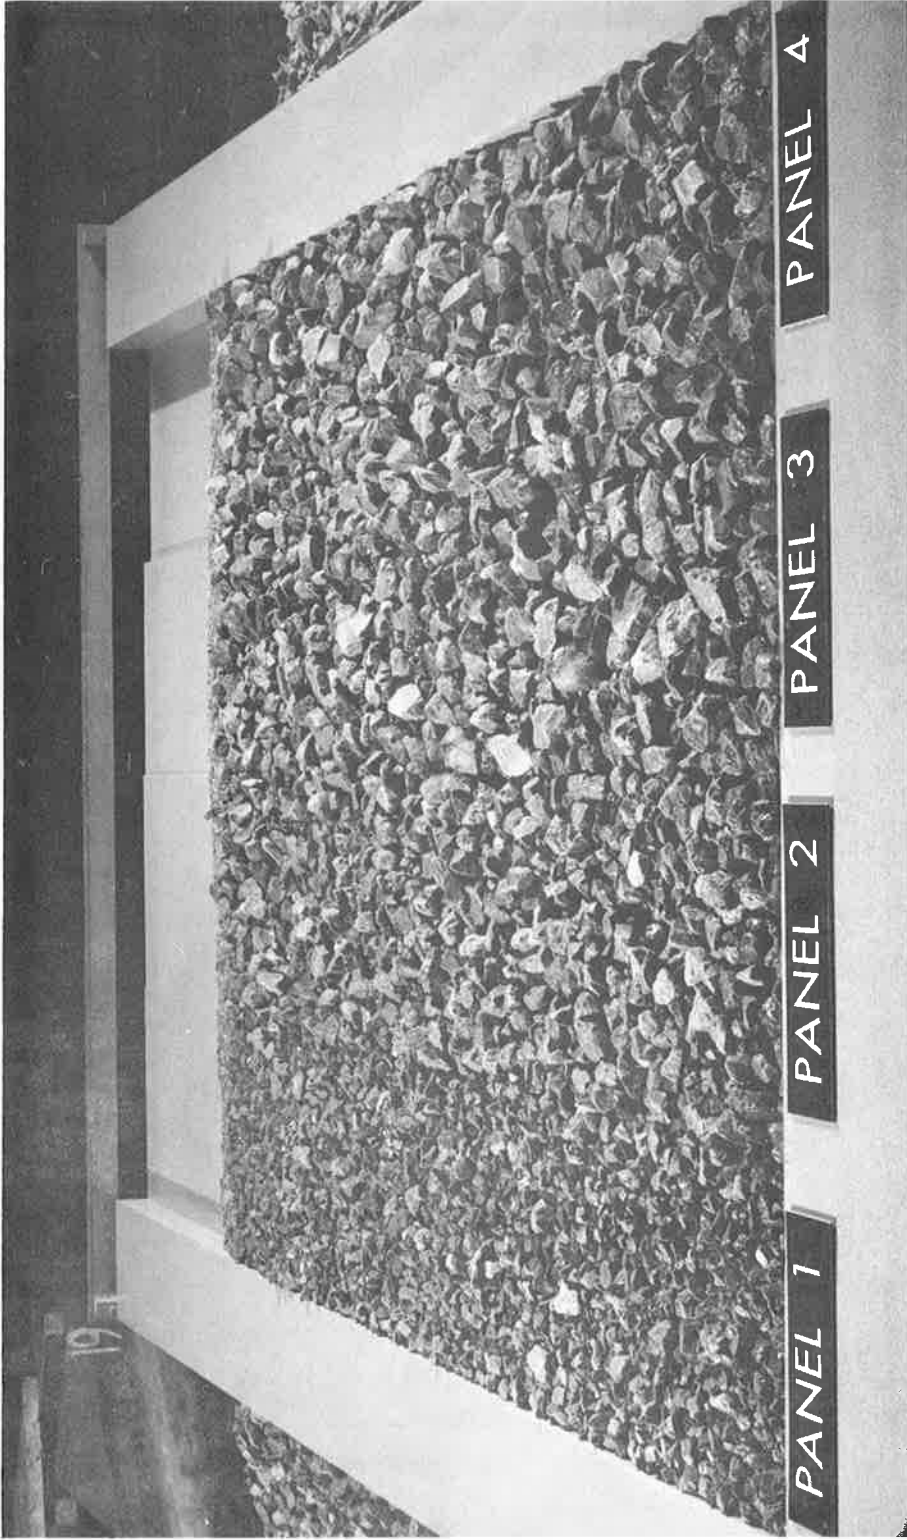
Plate 3 Model riprap panels 1-4 — test run 2

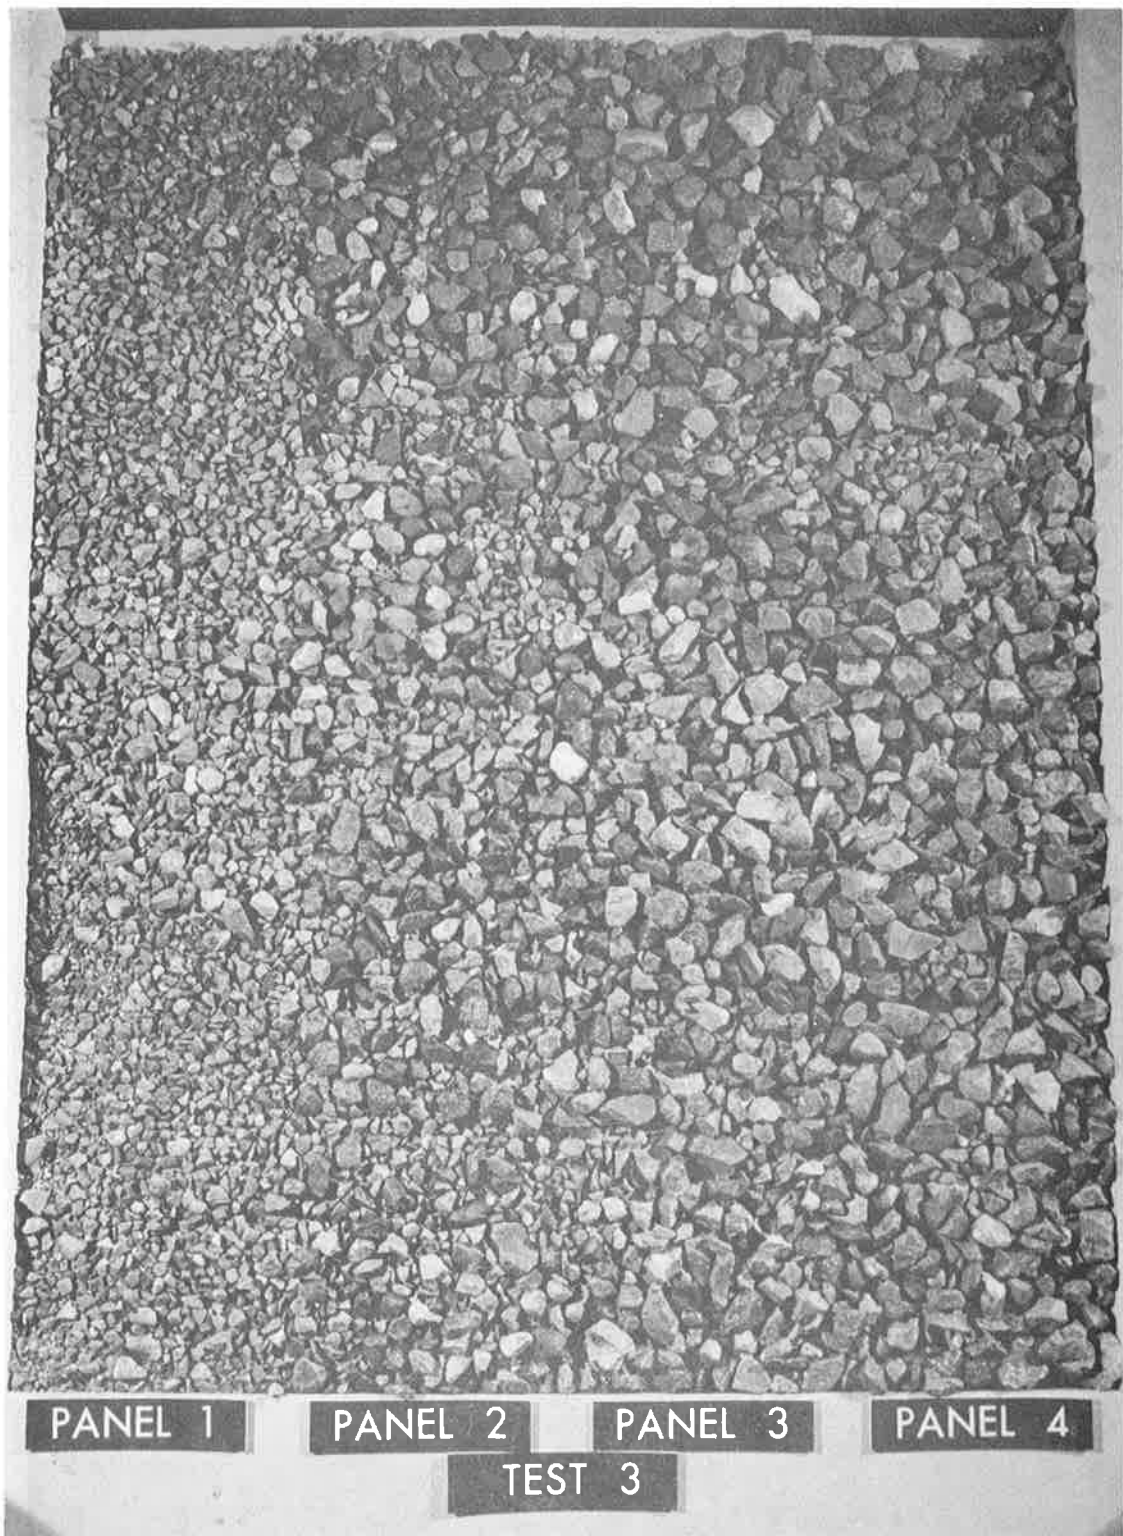
Plate 5 Riprap after storm 1 — test run 1

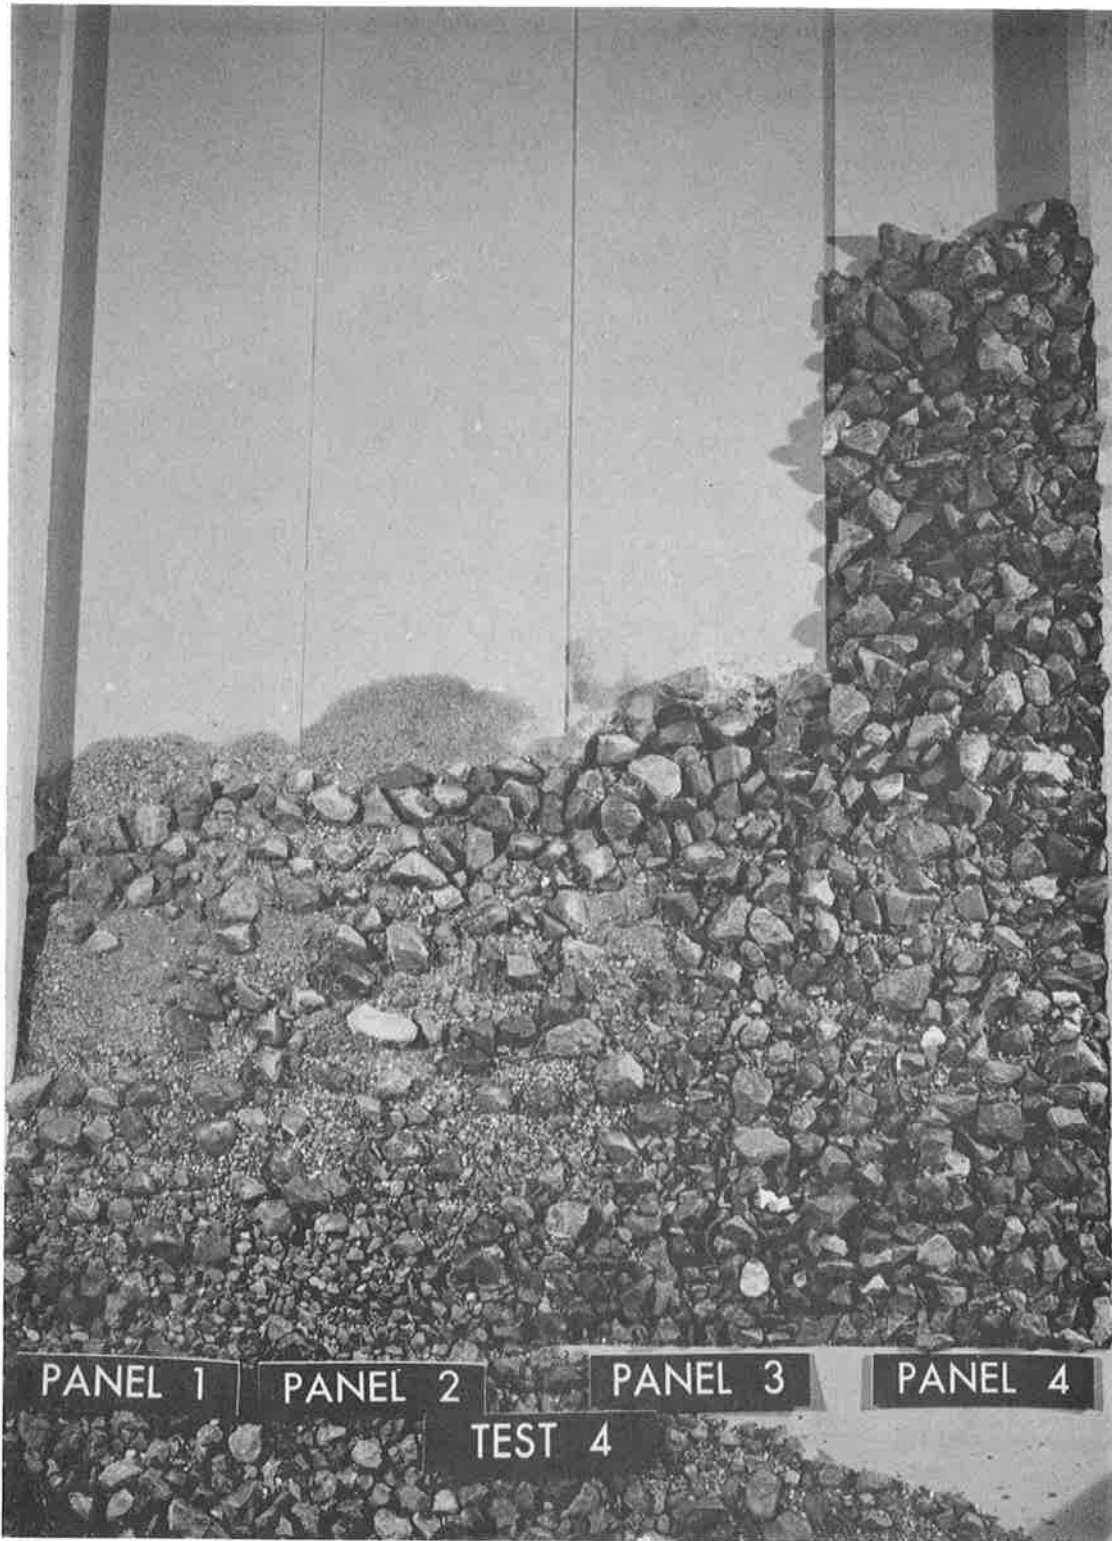
In test run 1 the damage to panel 1 by storm 1 only reached down to the filter layer, which although partially exposed was not washed out. After storm 2 the damage to panels 1-3 was similar to that for test run 2. Panel 4 was only marginally damaged as a result of the riprap becoming wedged against the large step in the support structure floor, (plate 6). There was little surface erosion from panel 4.

Plate 6 Riprap after storm 2 — test run 1

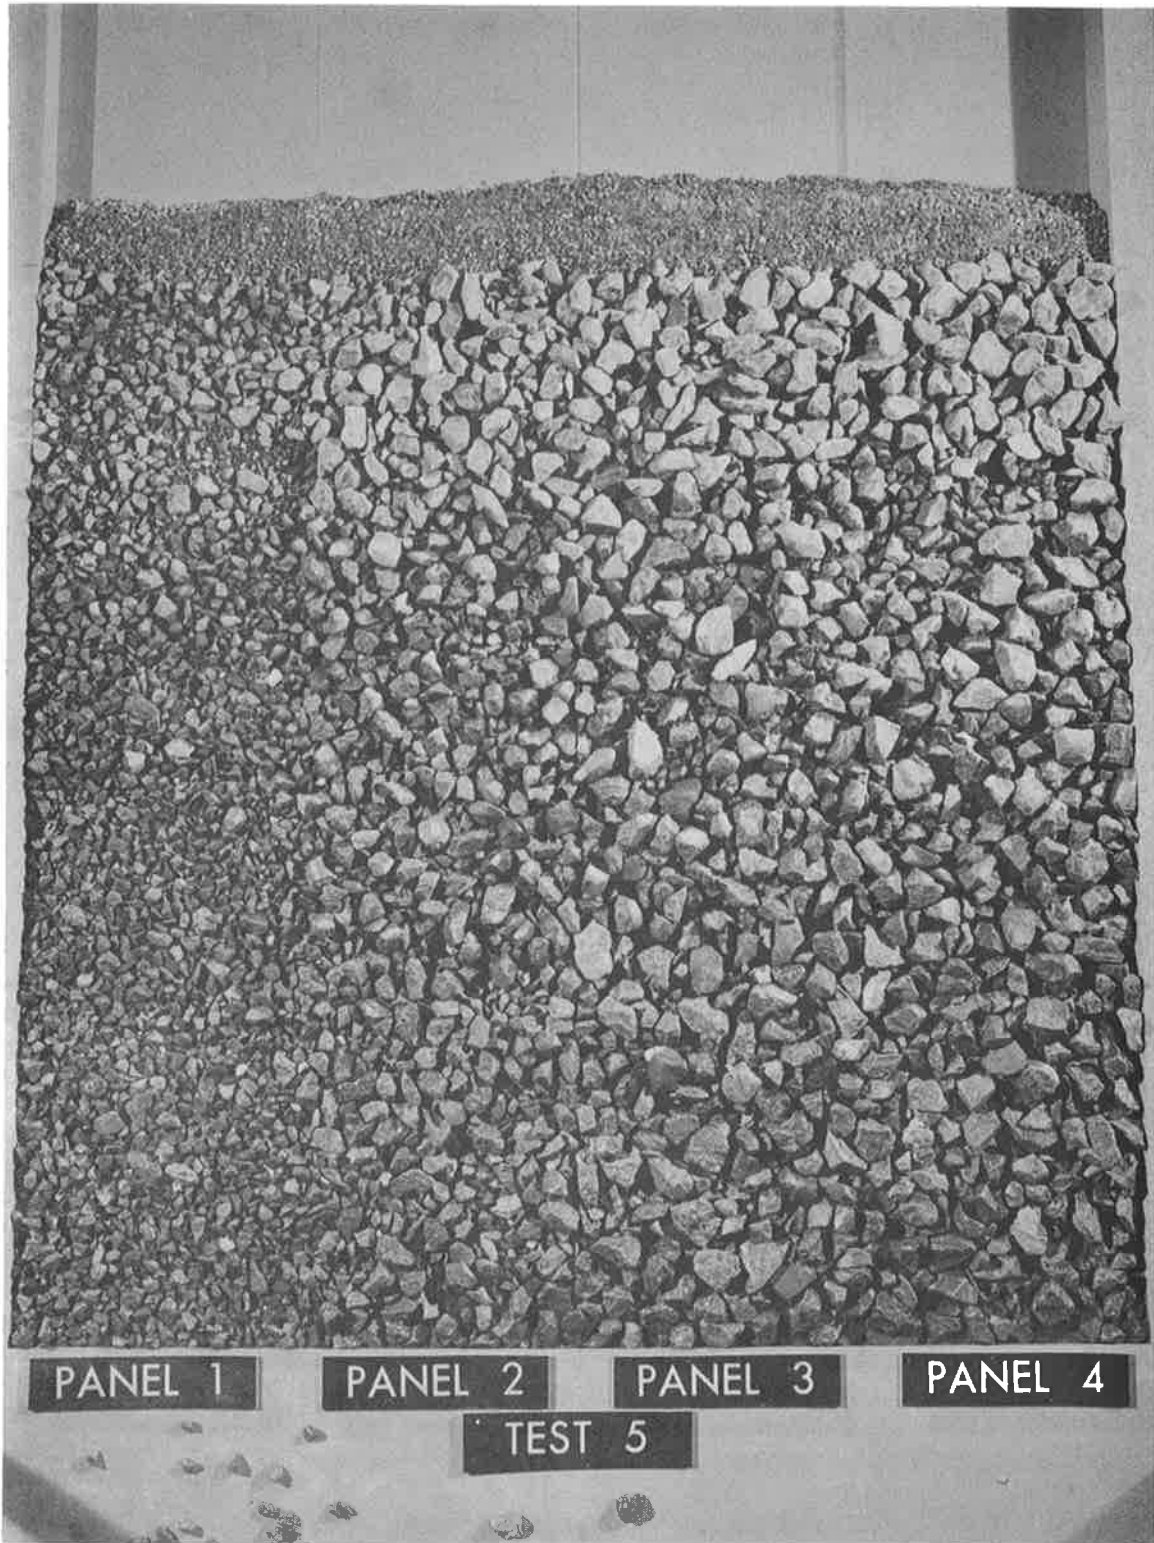
Plate 8 Riprap after wave/tide event 1, storm 1 — test run 2

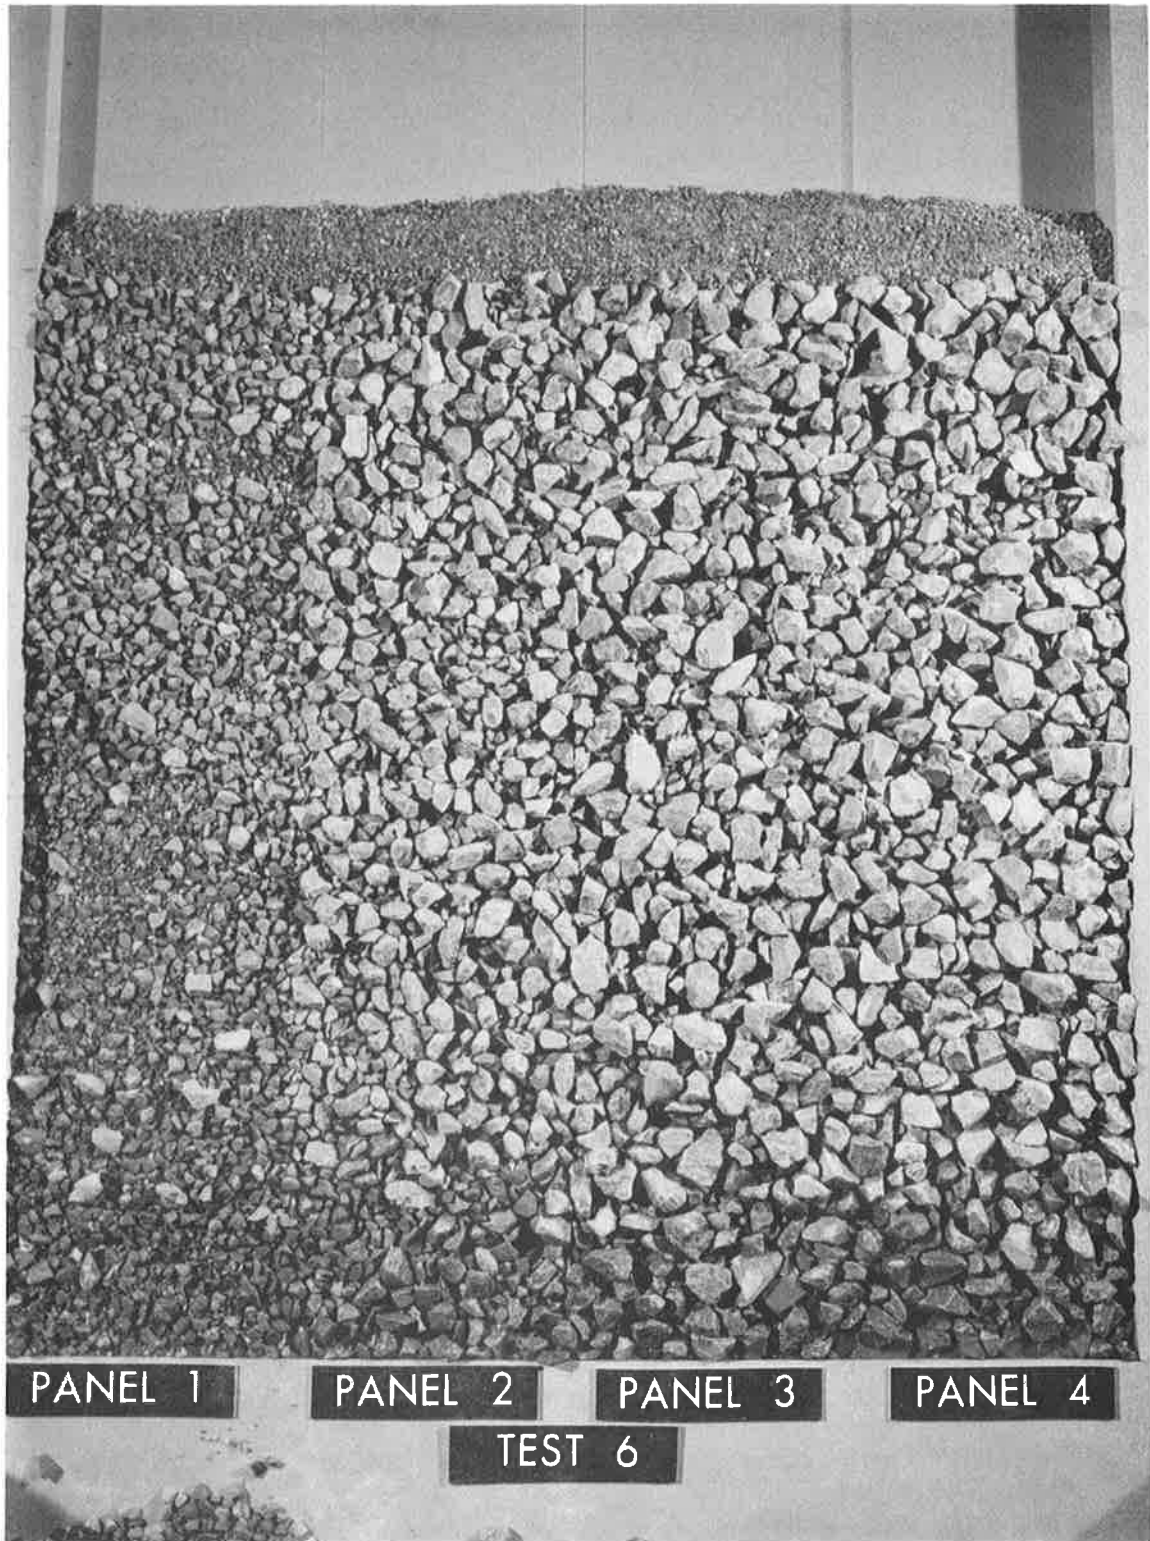
Plate 9 Riprap after wave/tide event 2, storm 1 — test run 2

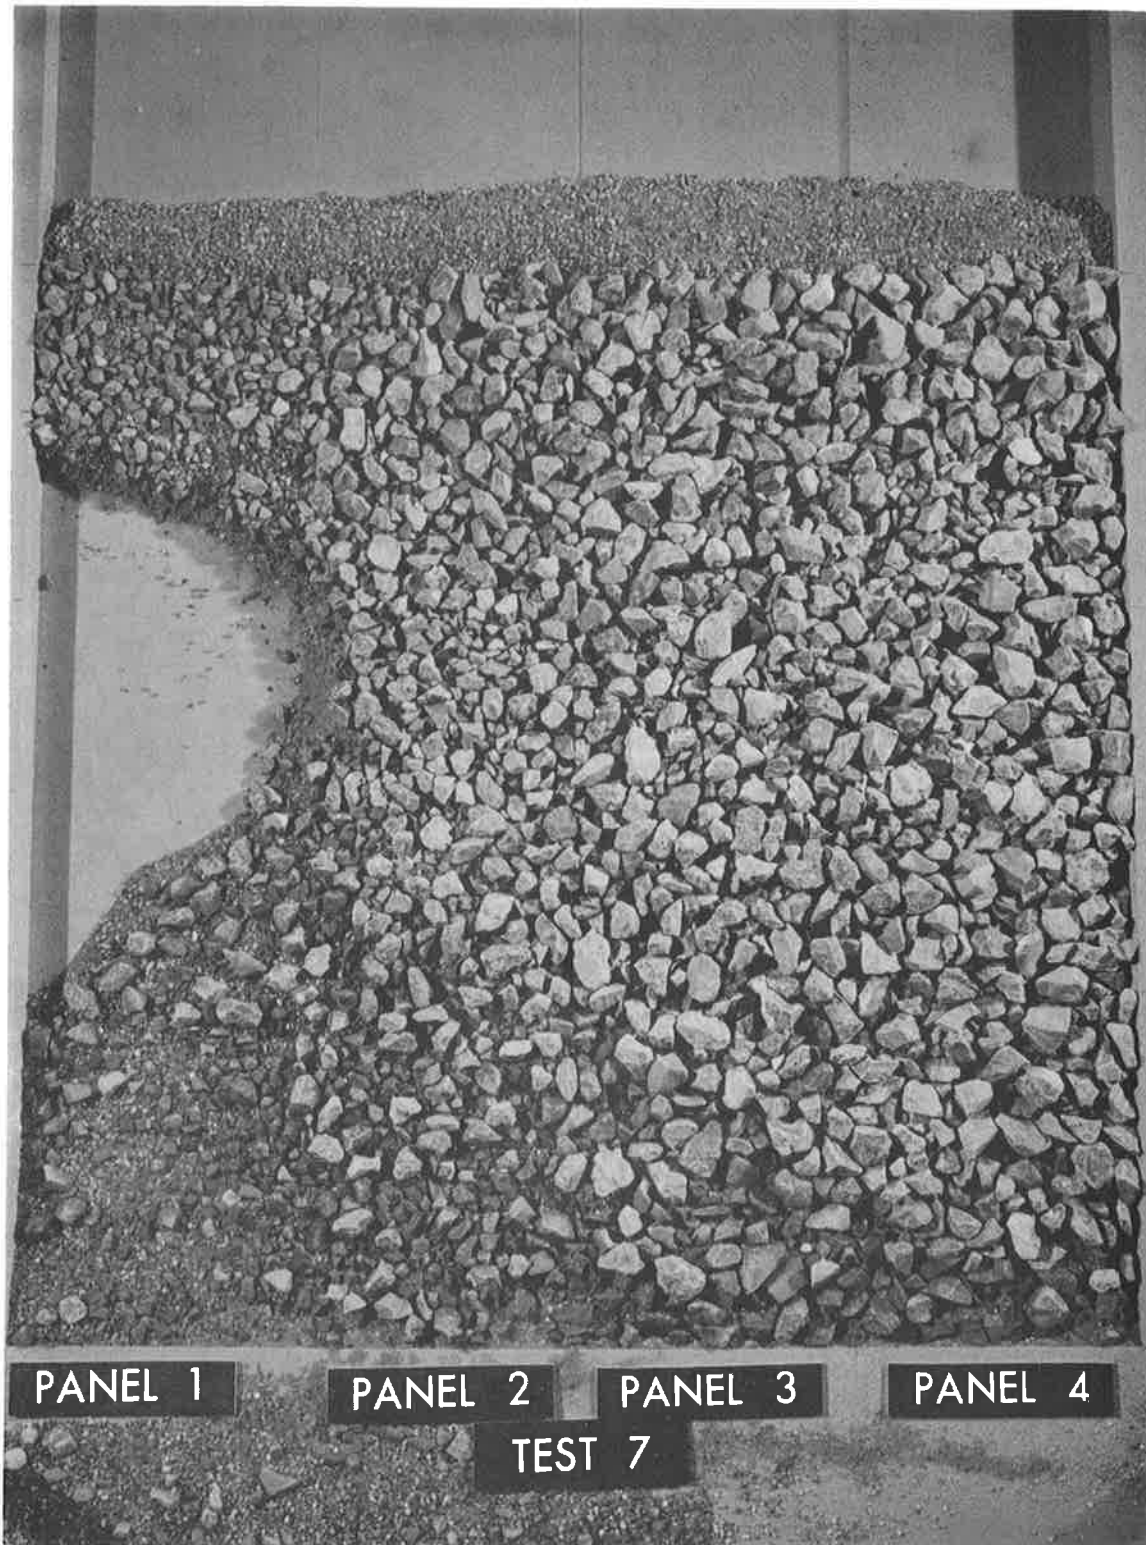
Plate 10 Riprap after storm 1 — test run 2

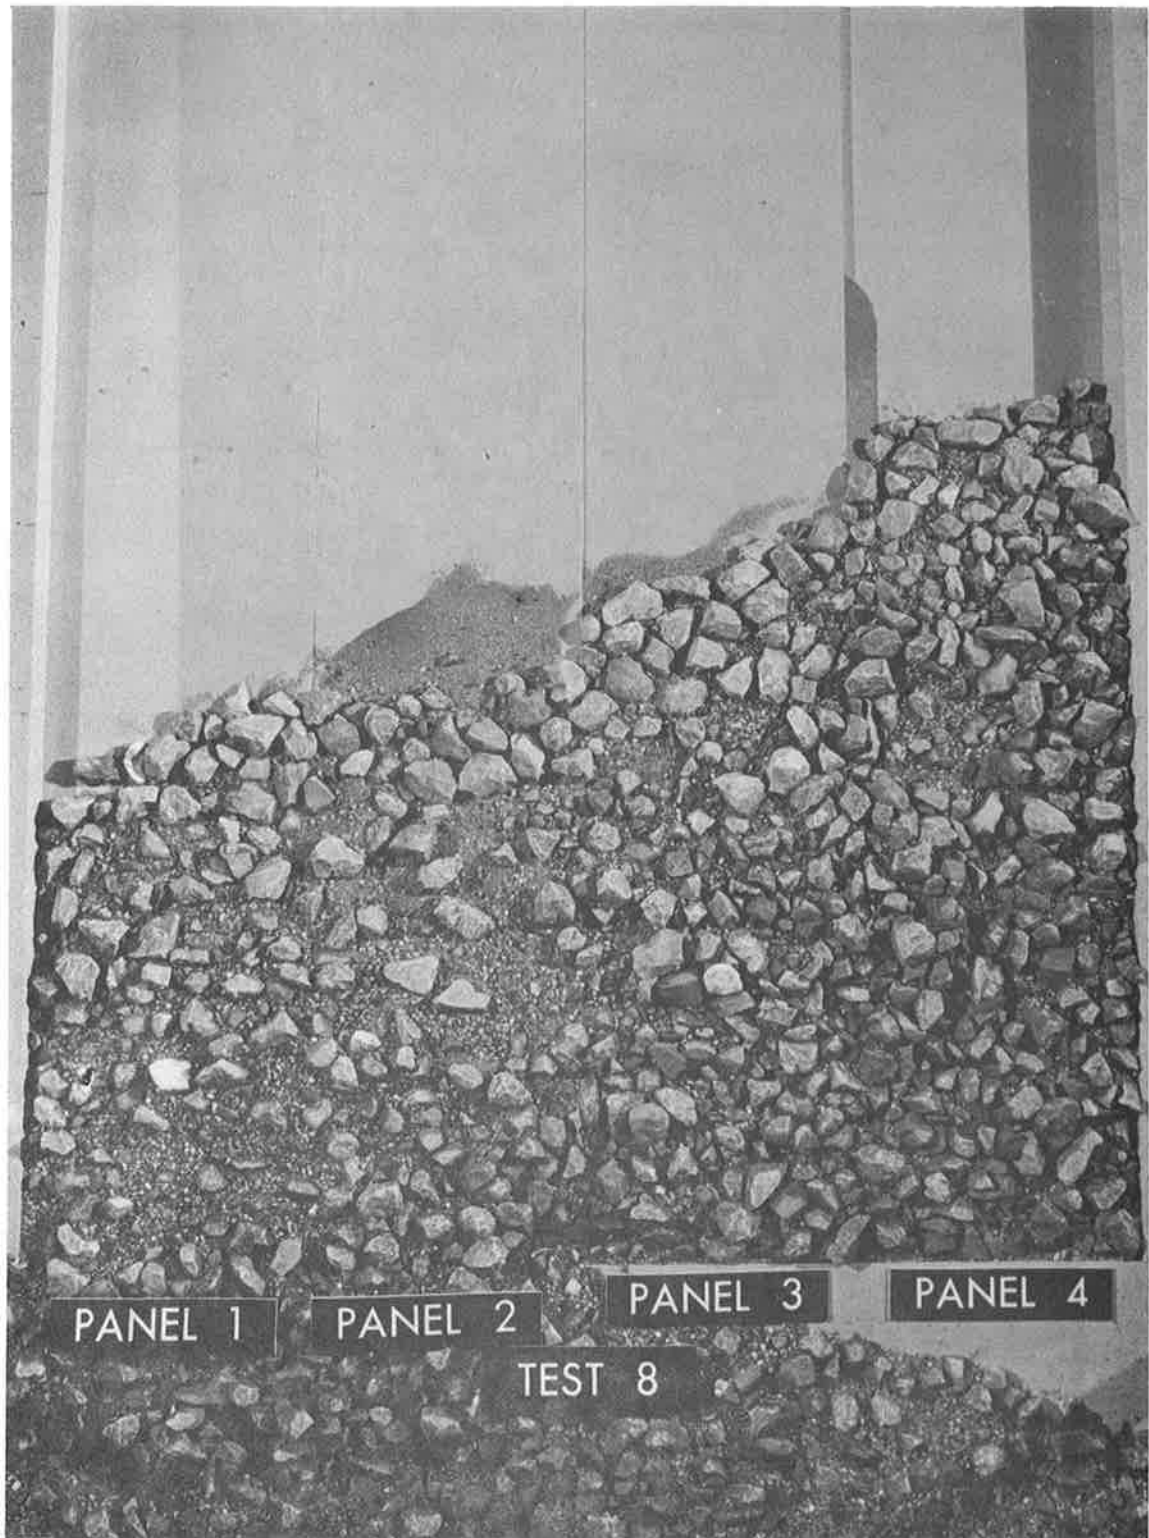
Plate 11 Riprap after storm 2 — test run 2
