Riprap design for wind-wave attack

Retrospective model tests of the measured damage to
riprap panels on the offshore bank in the Wash

Report No. IT 213
December 1981
Crown Copyright

Hydraulics Research Station
Wallingford
Oxon OX10 8BA
Telephone 0491 35381

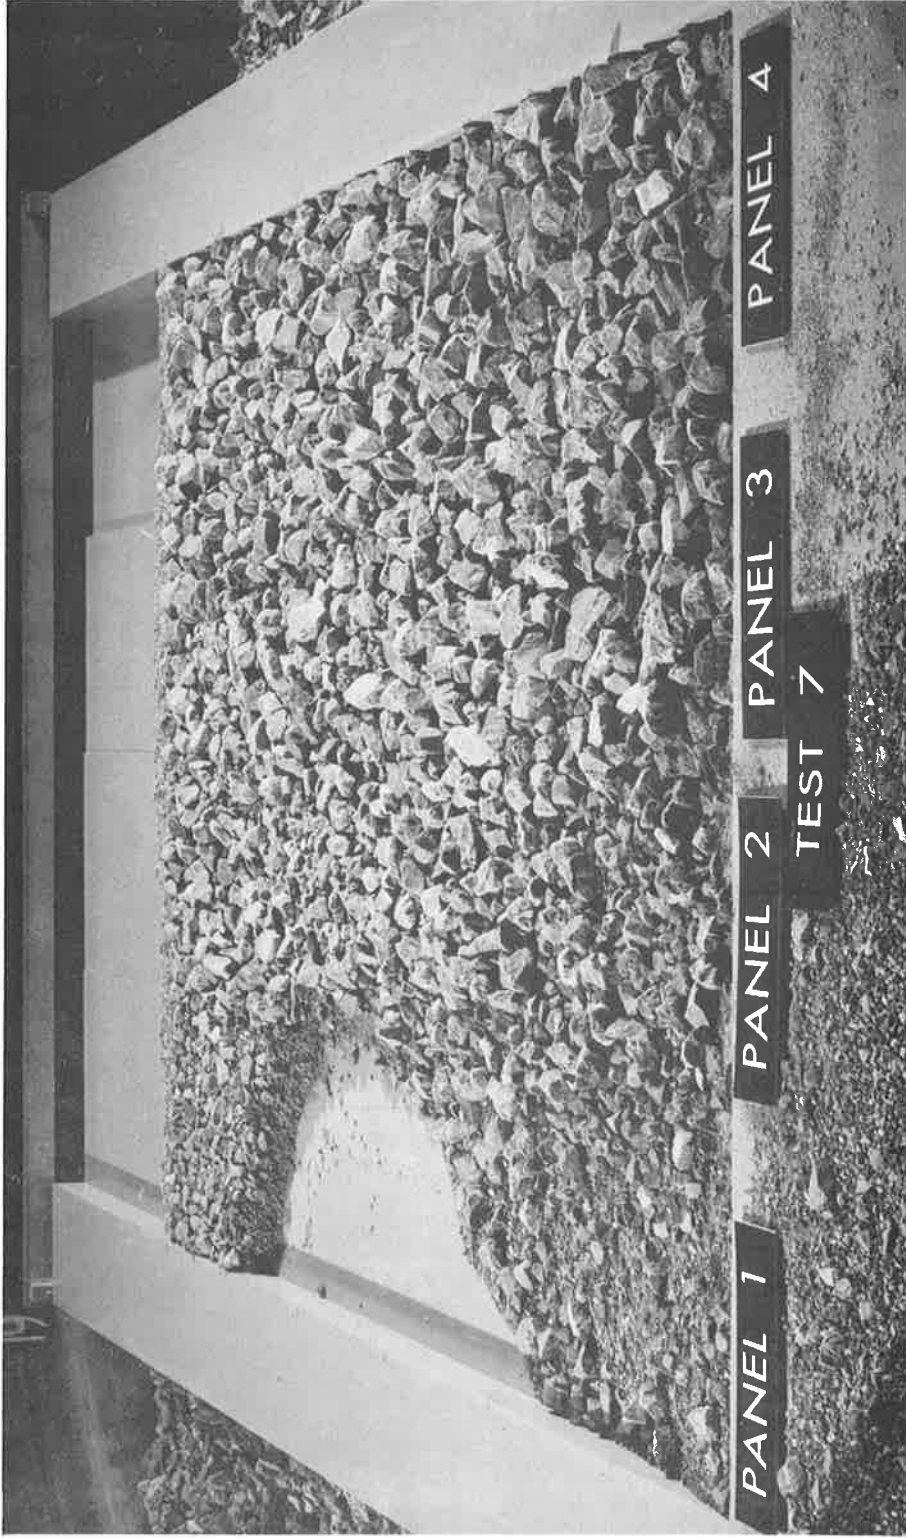
Plate 12 Riprap panels 1-4 after storm 1 — test run 2

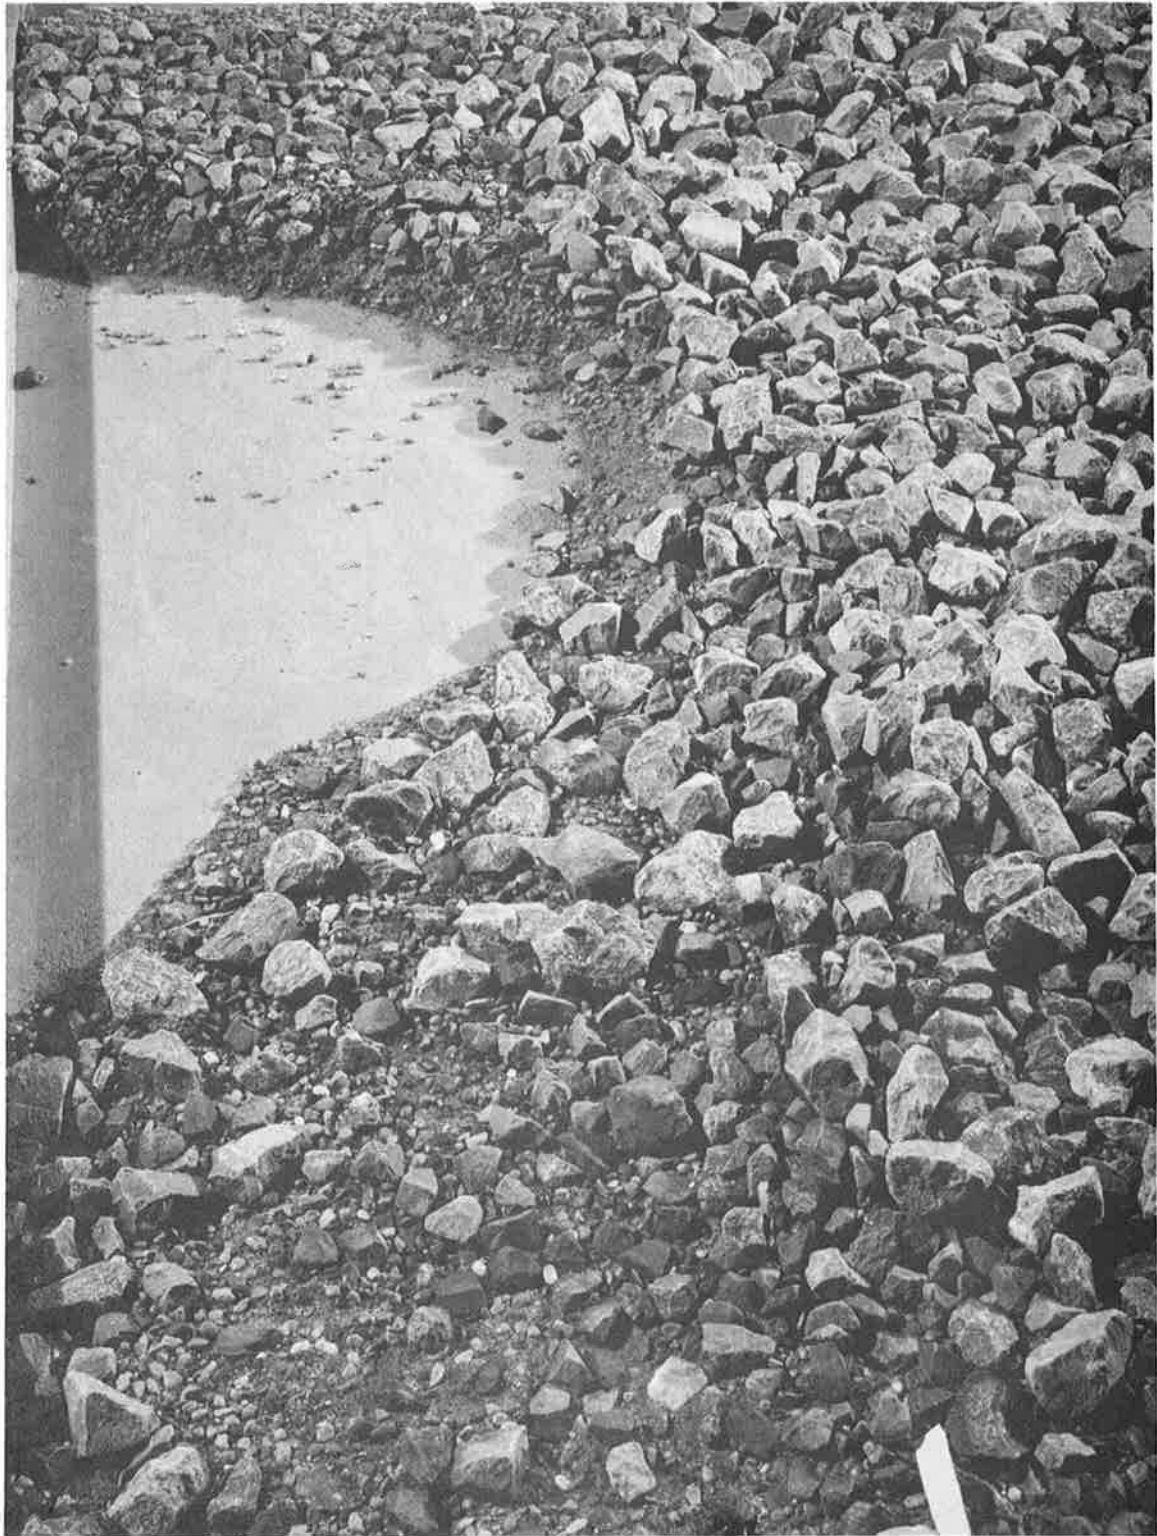
Plate 13 Riprap panel 1 after storm 1 — test run 2

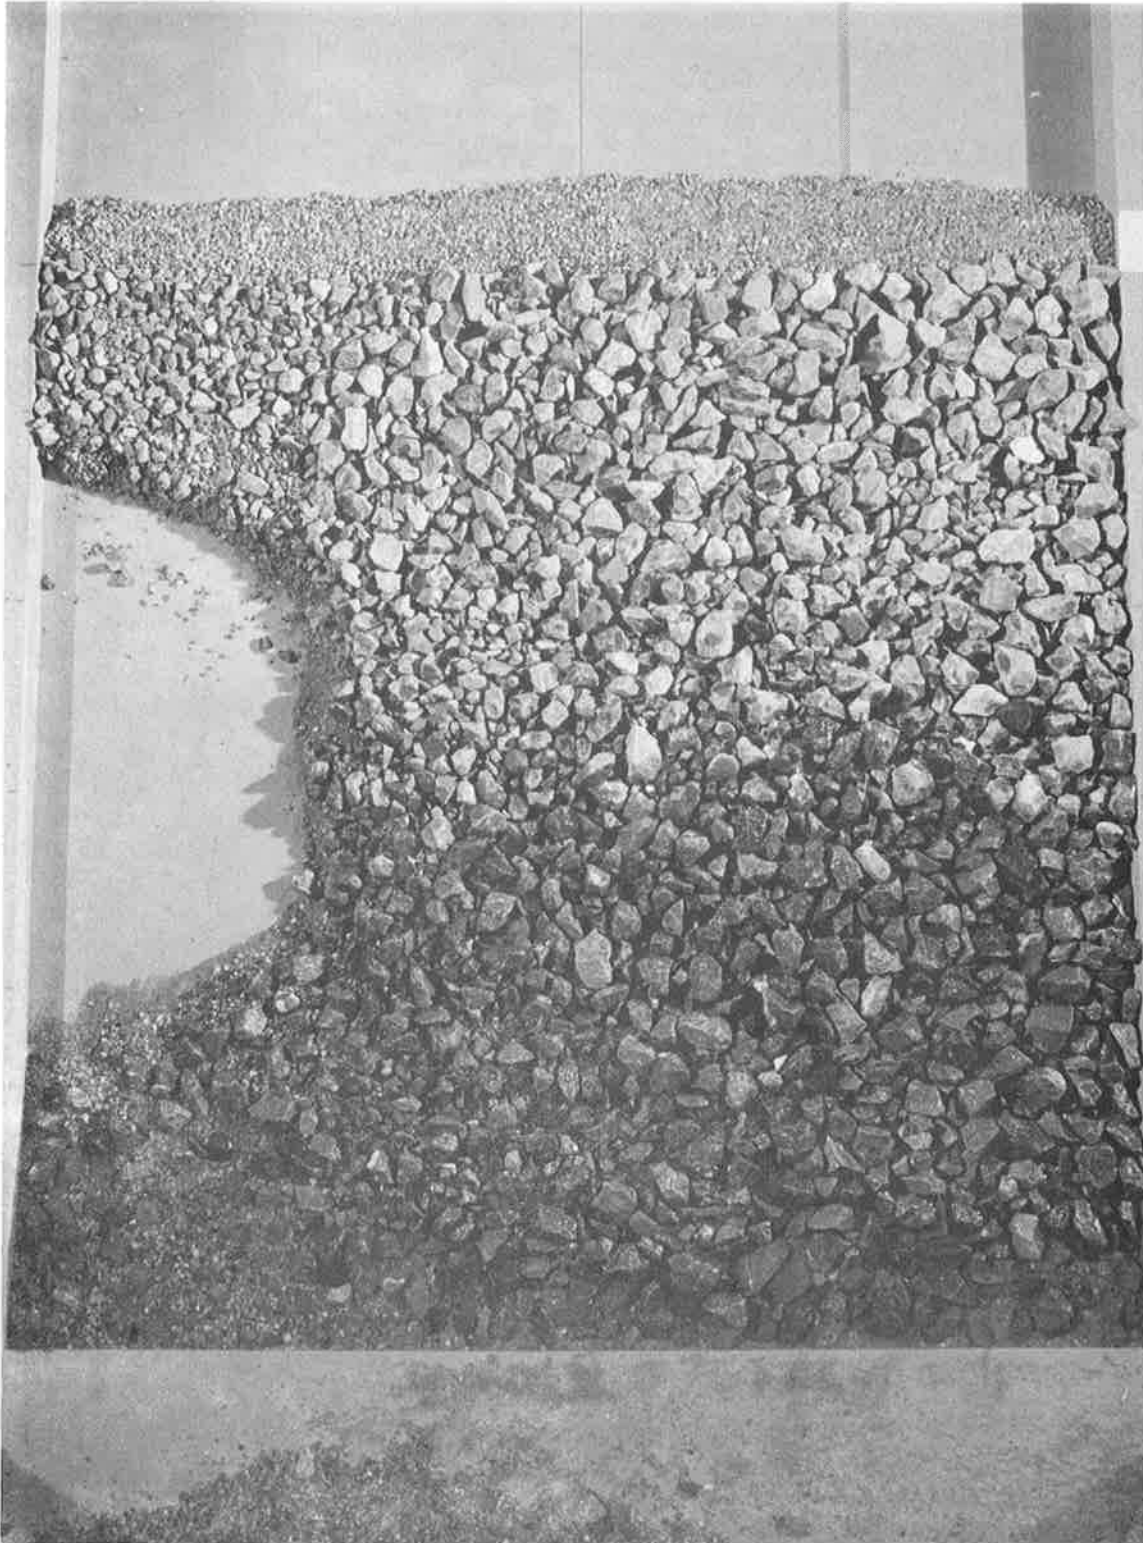
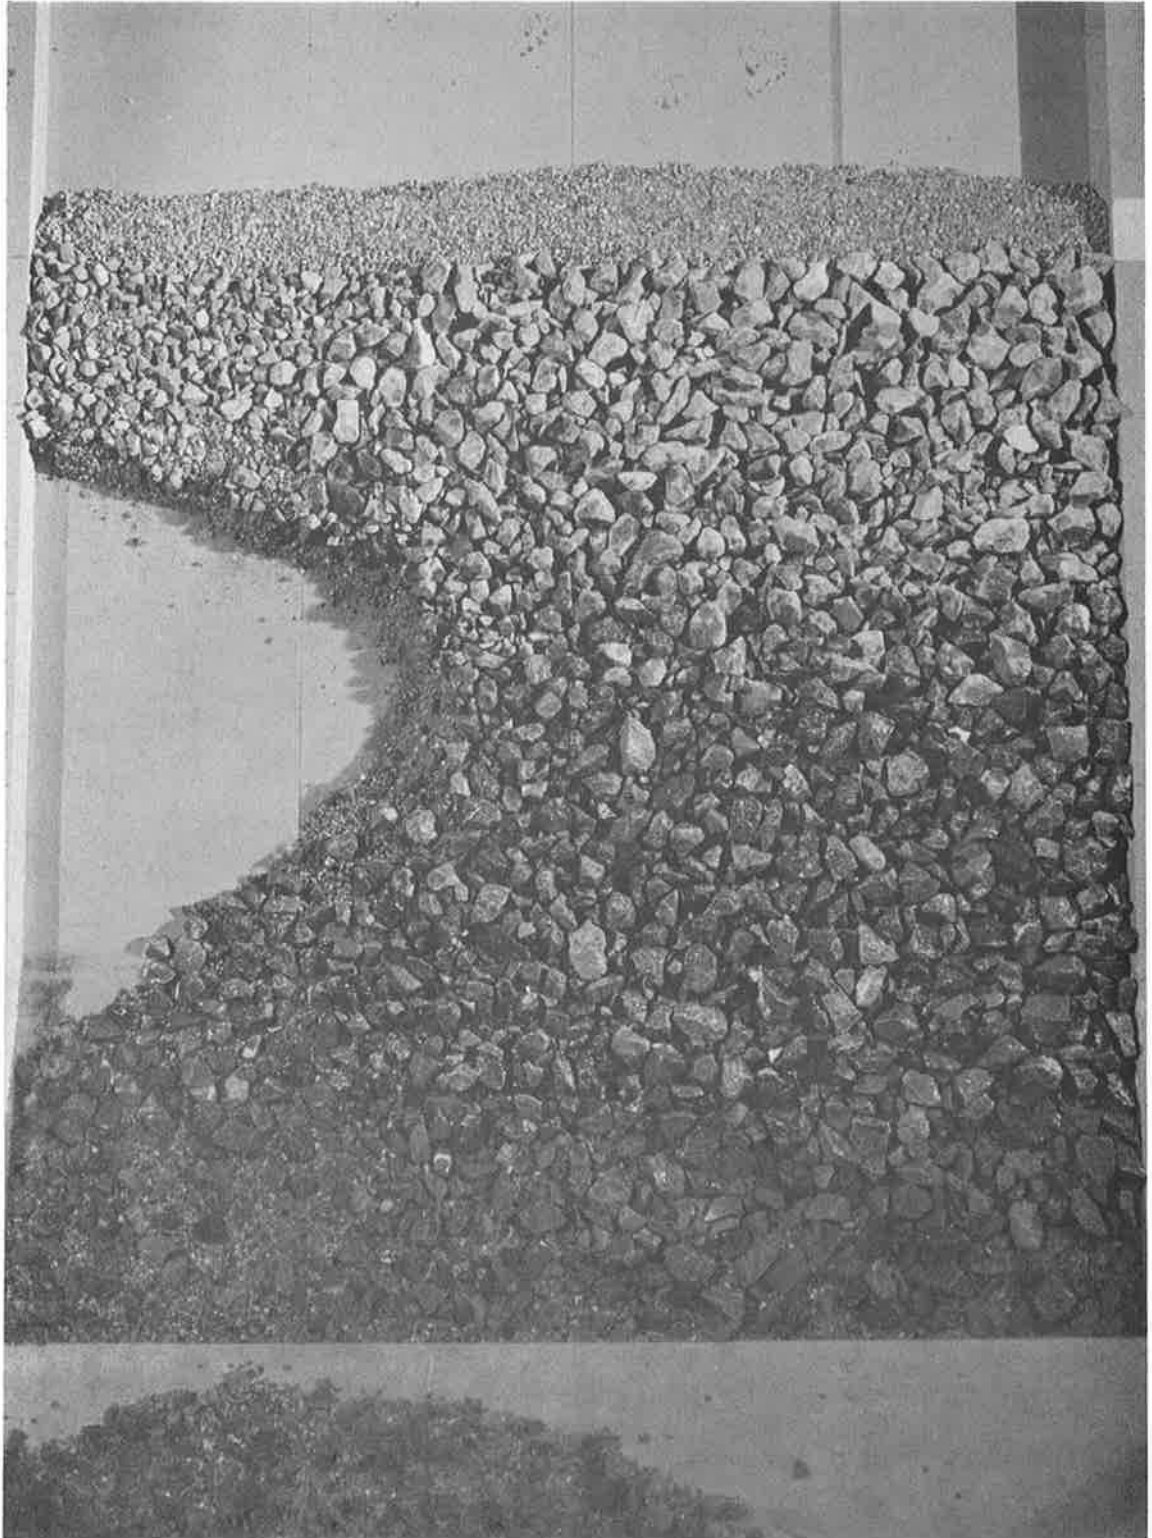
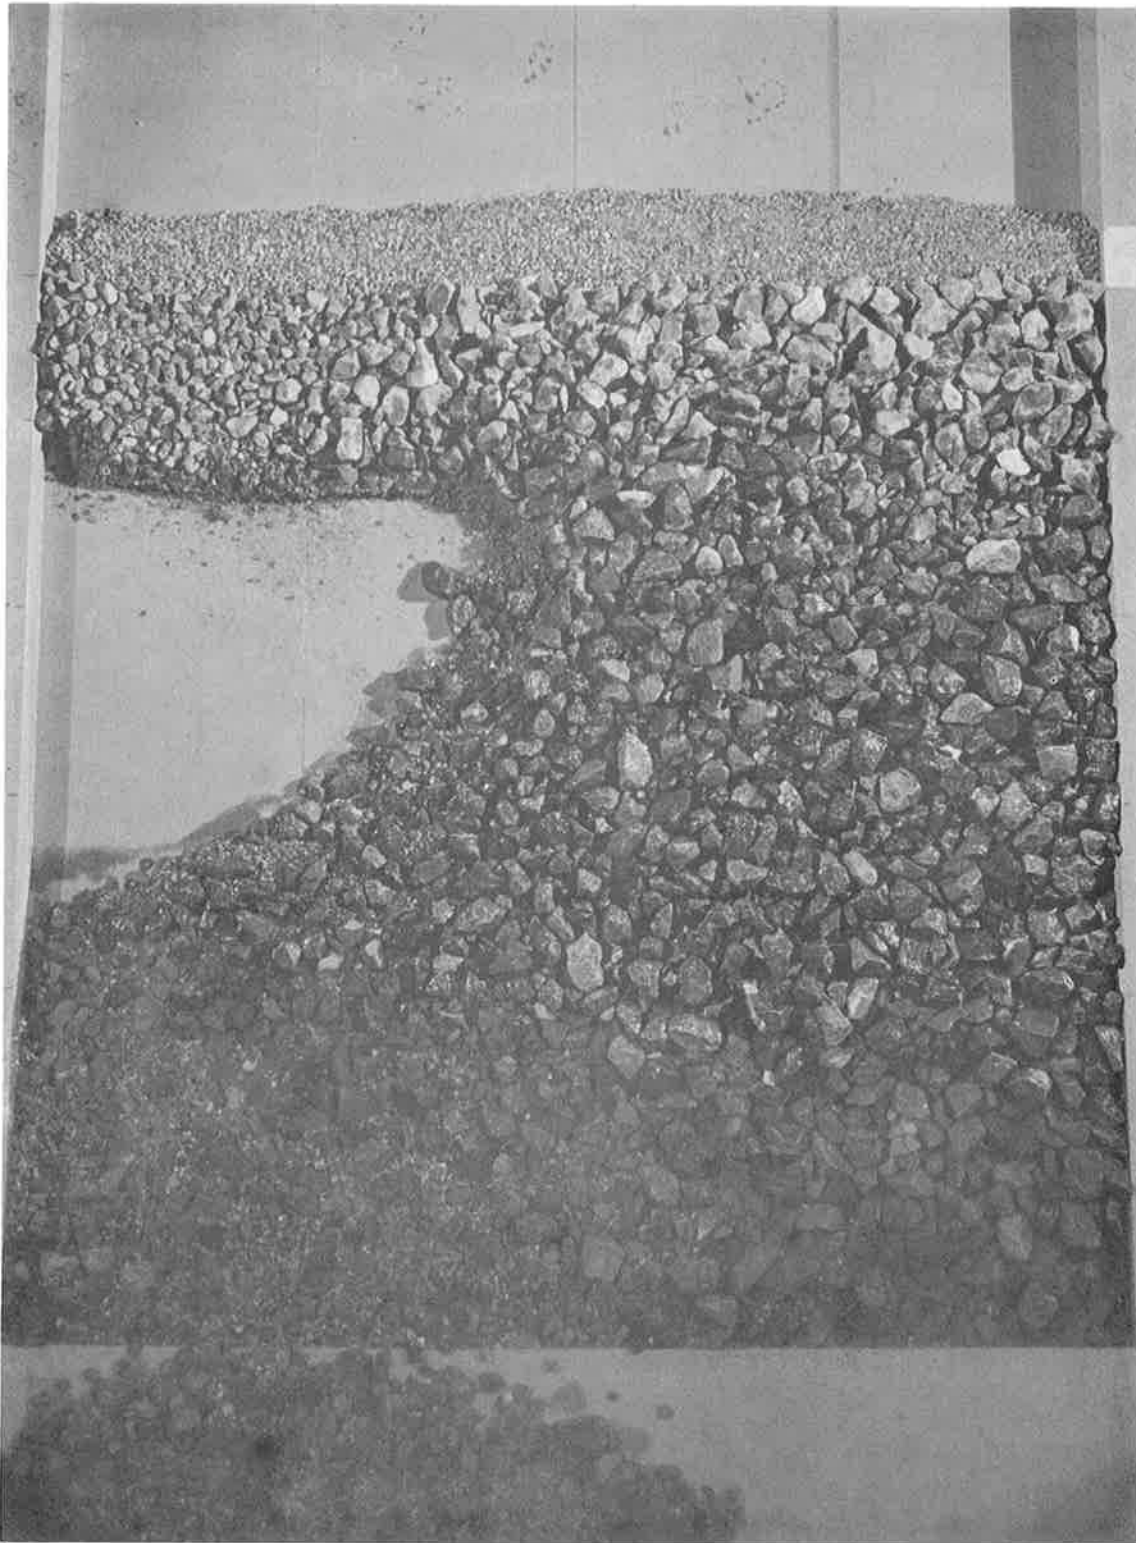
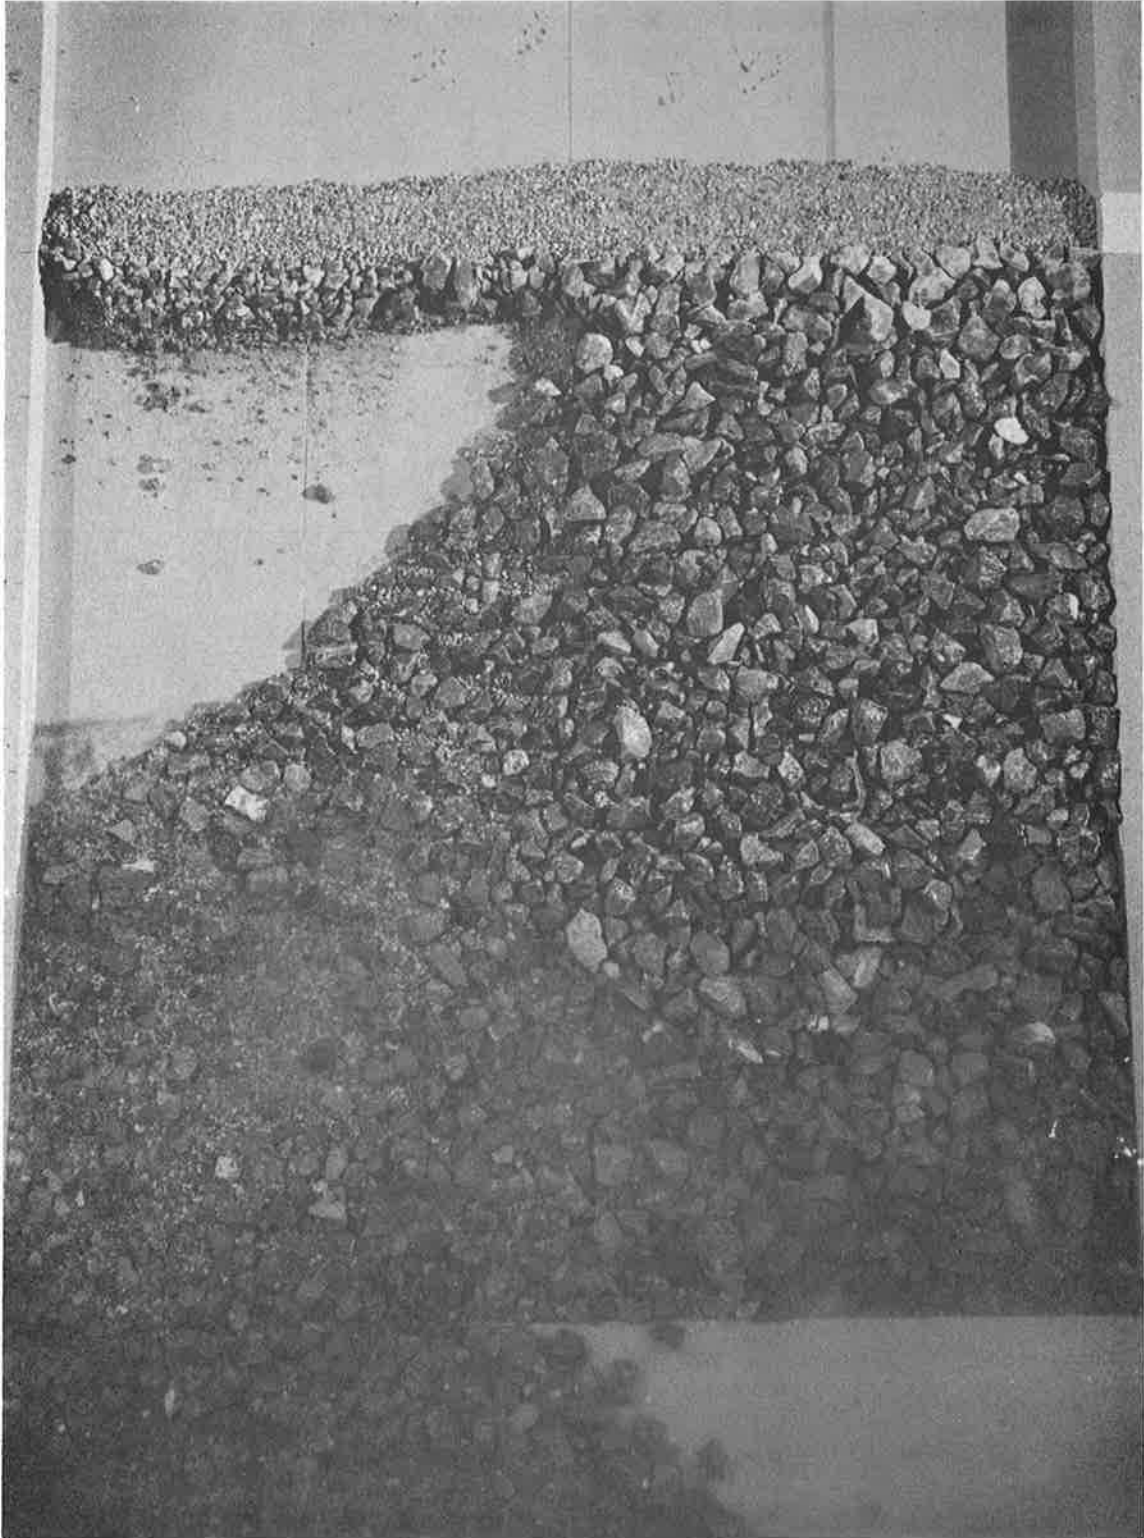
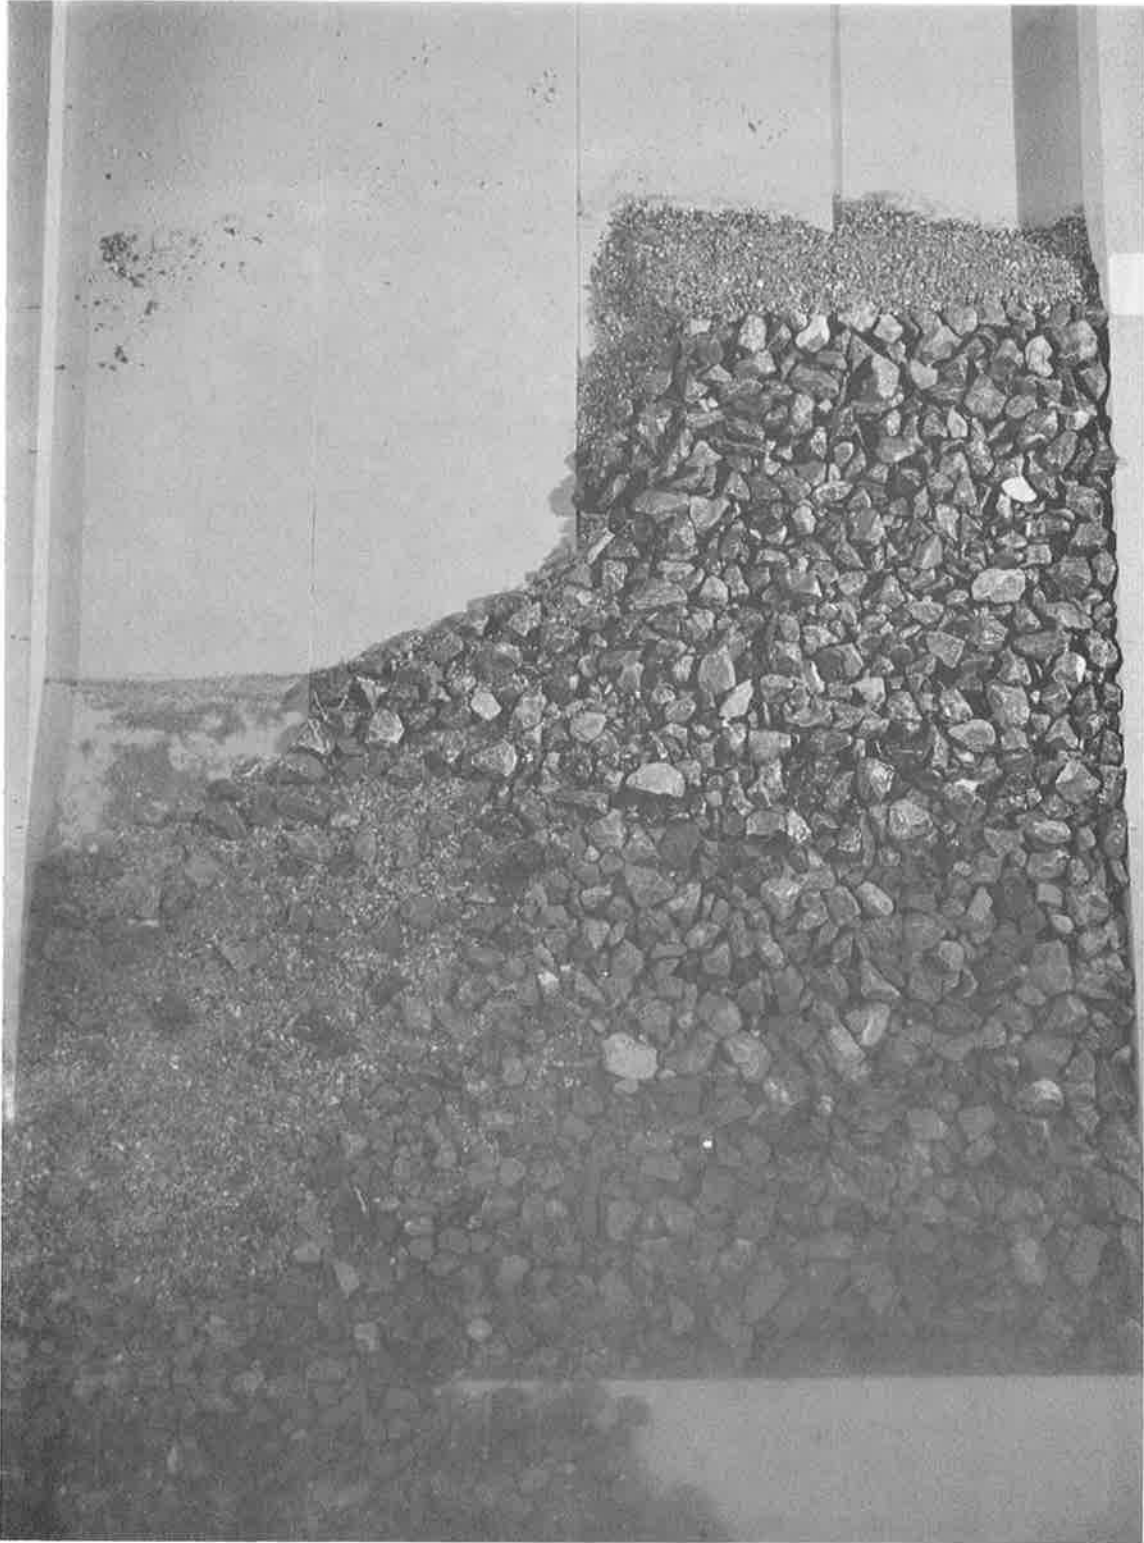
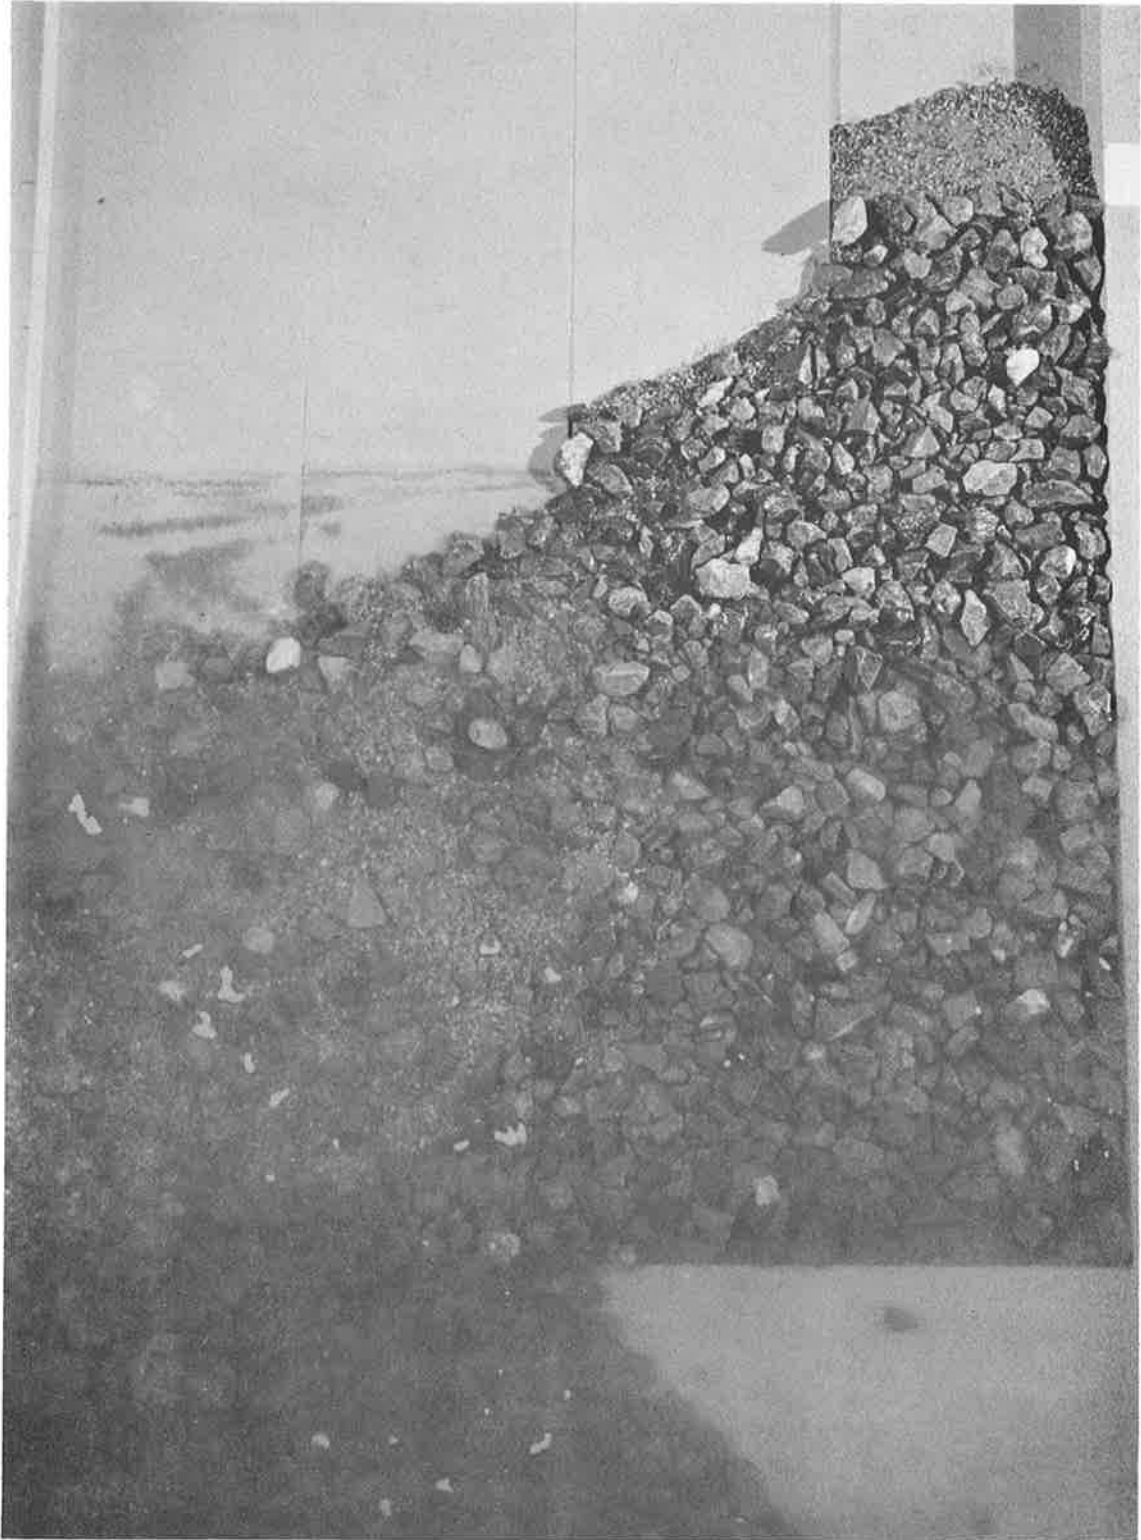
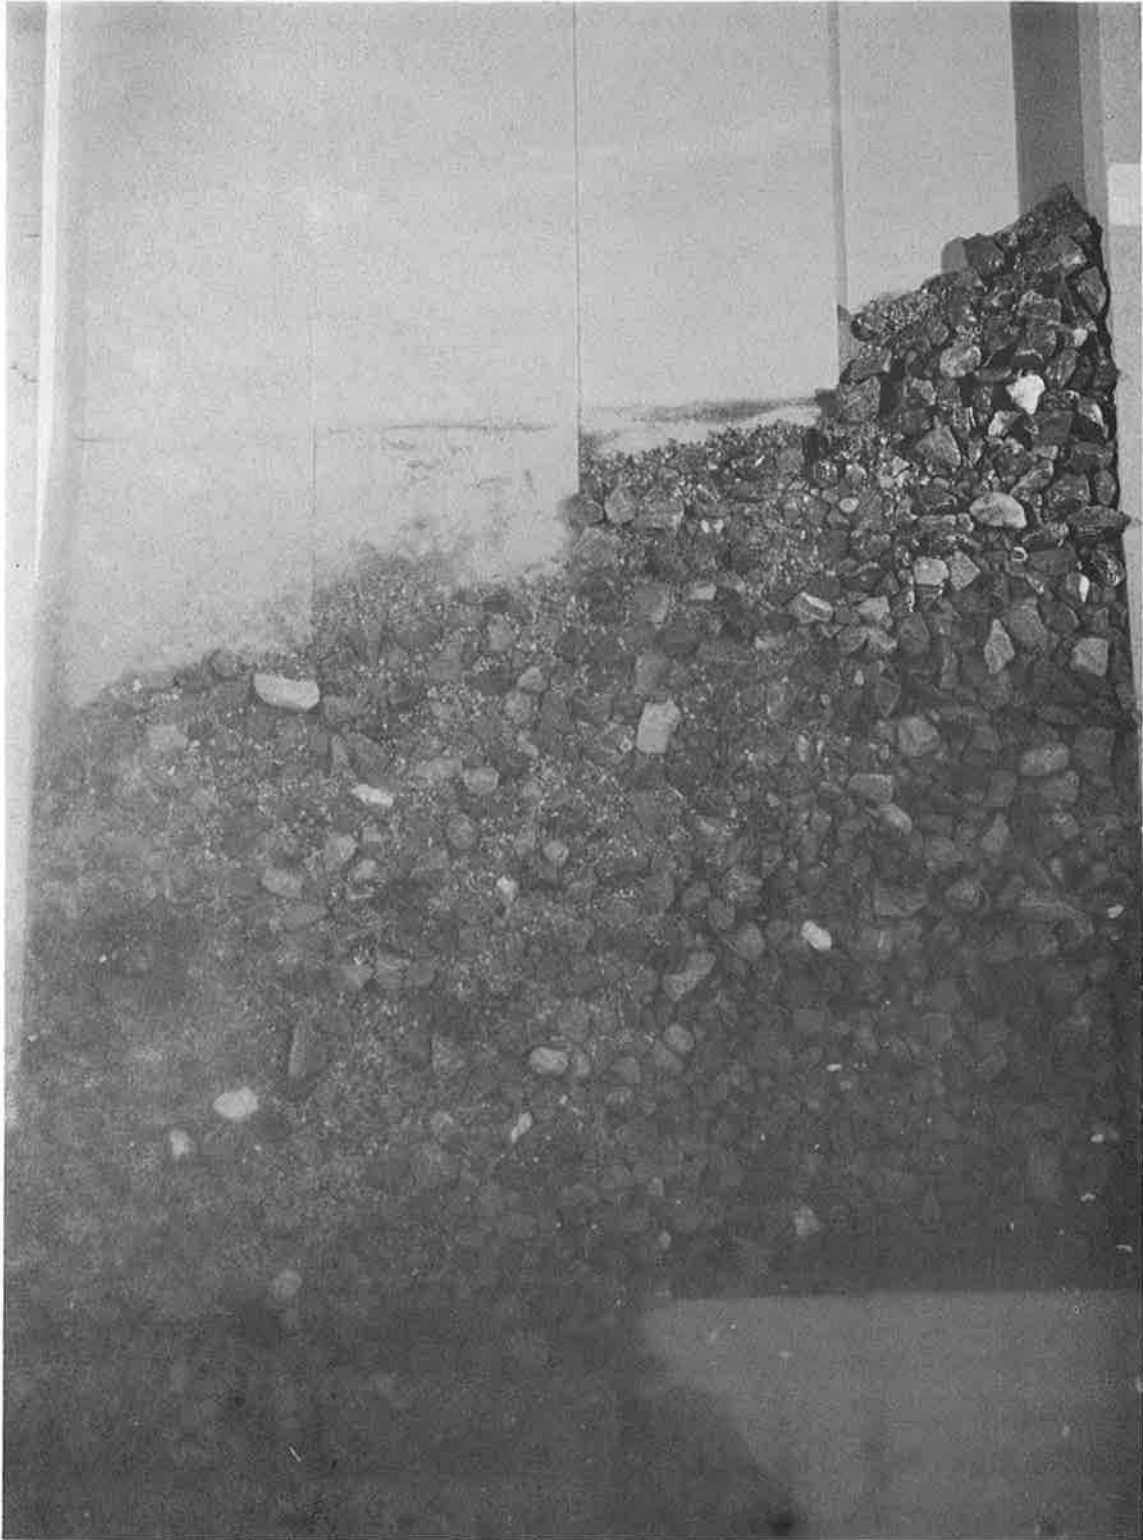
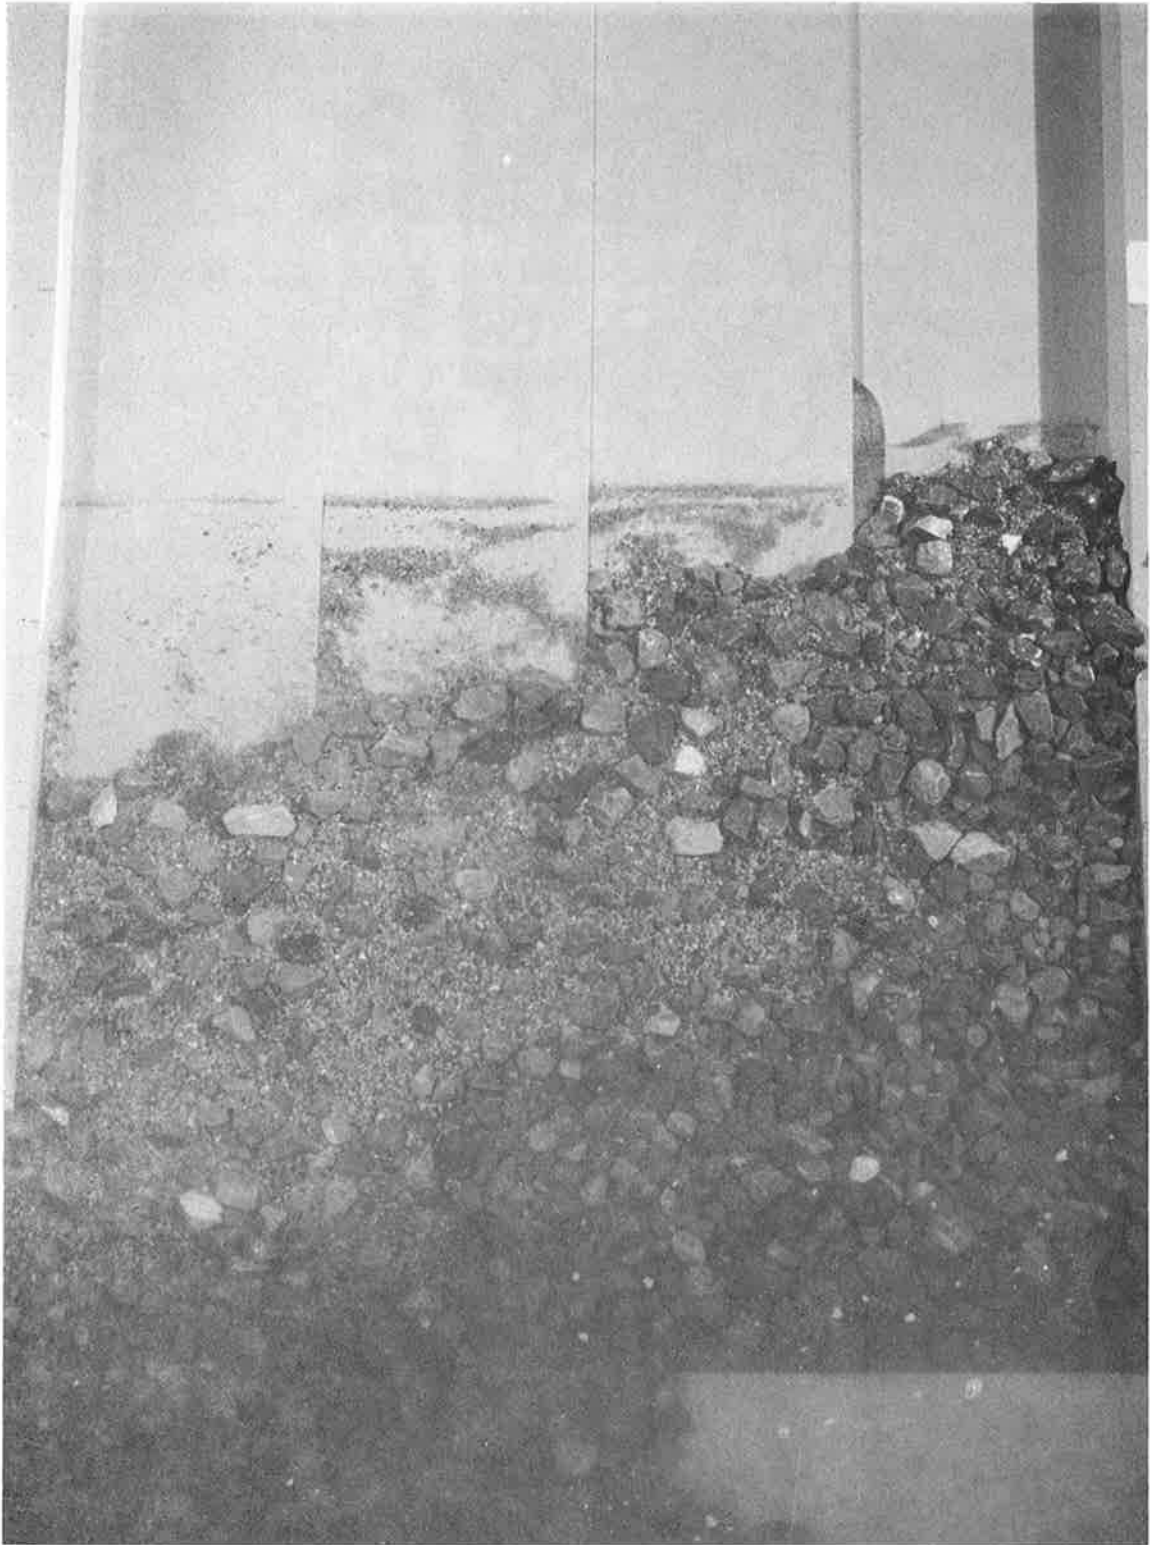
Plate 14 Progress of damage during storm 2 — test run 2

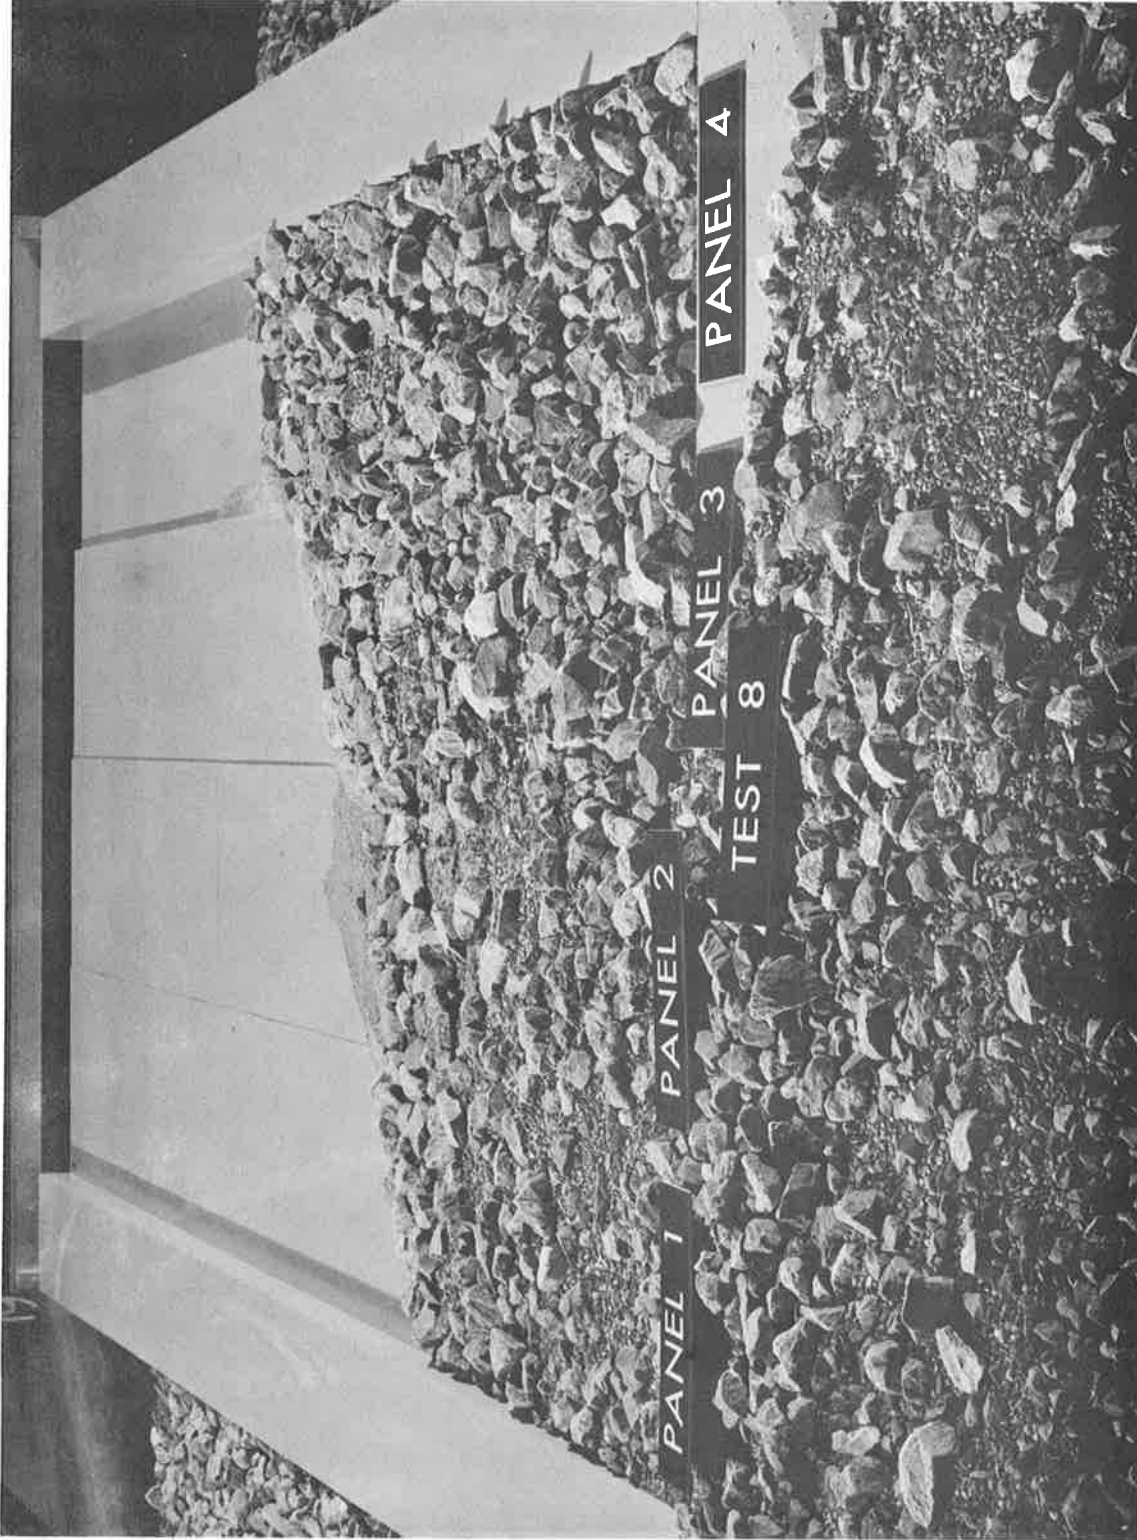
Plate 15 Riprap after storm 2 — test run 2
