A Review of Novel Shore Protection Methods

Vol 3 - Gabions

Report No SR 5  
November 1984

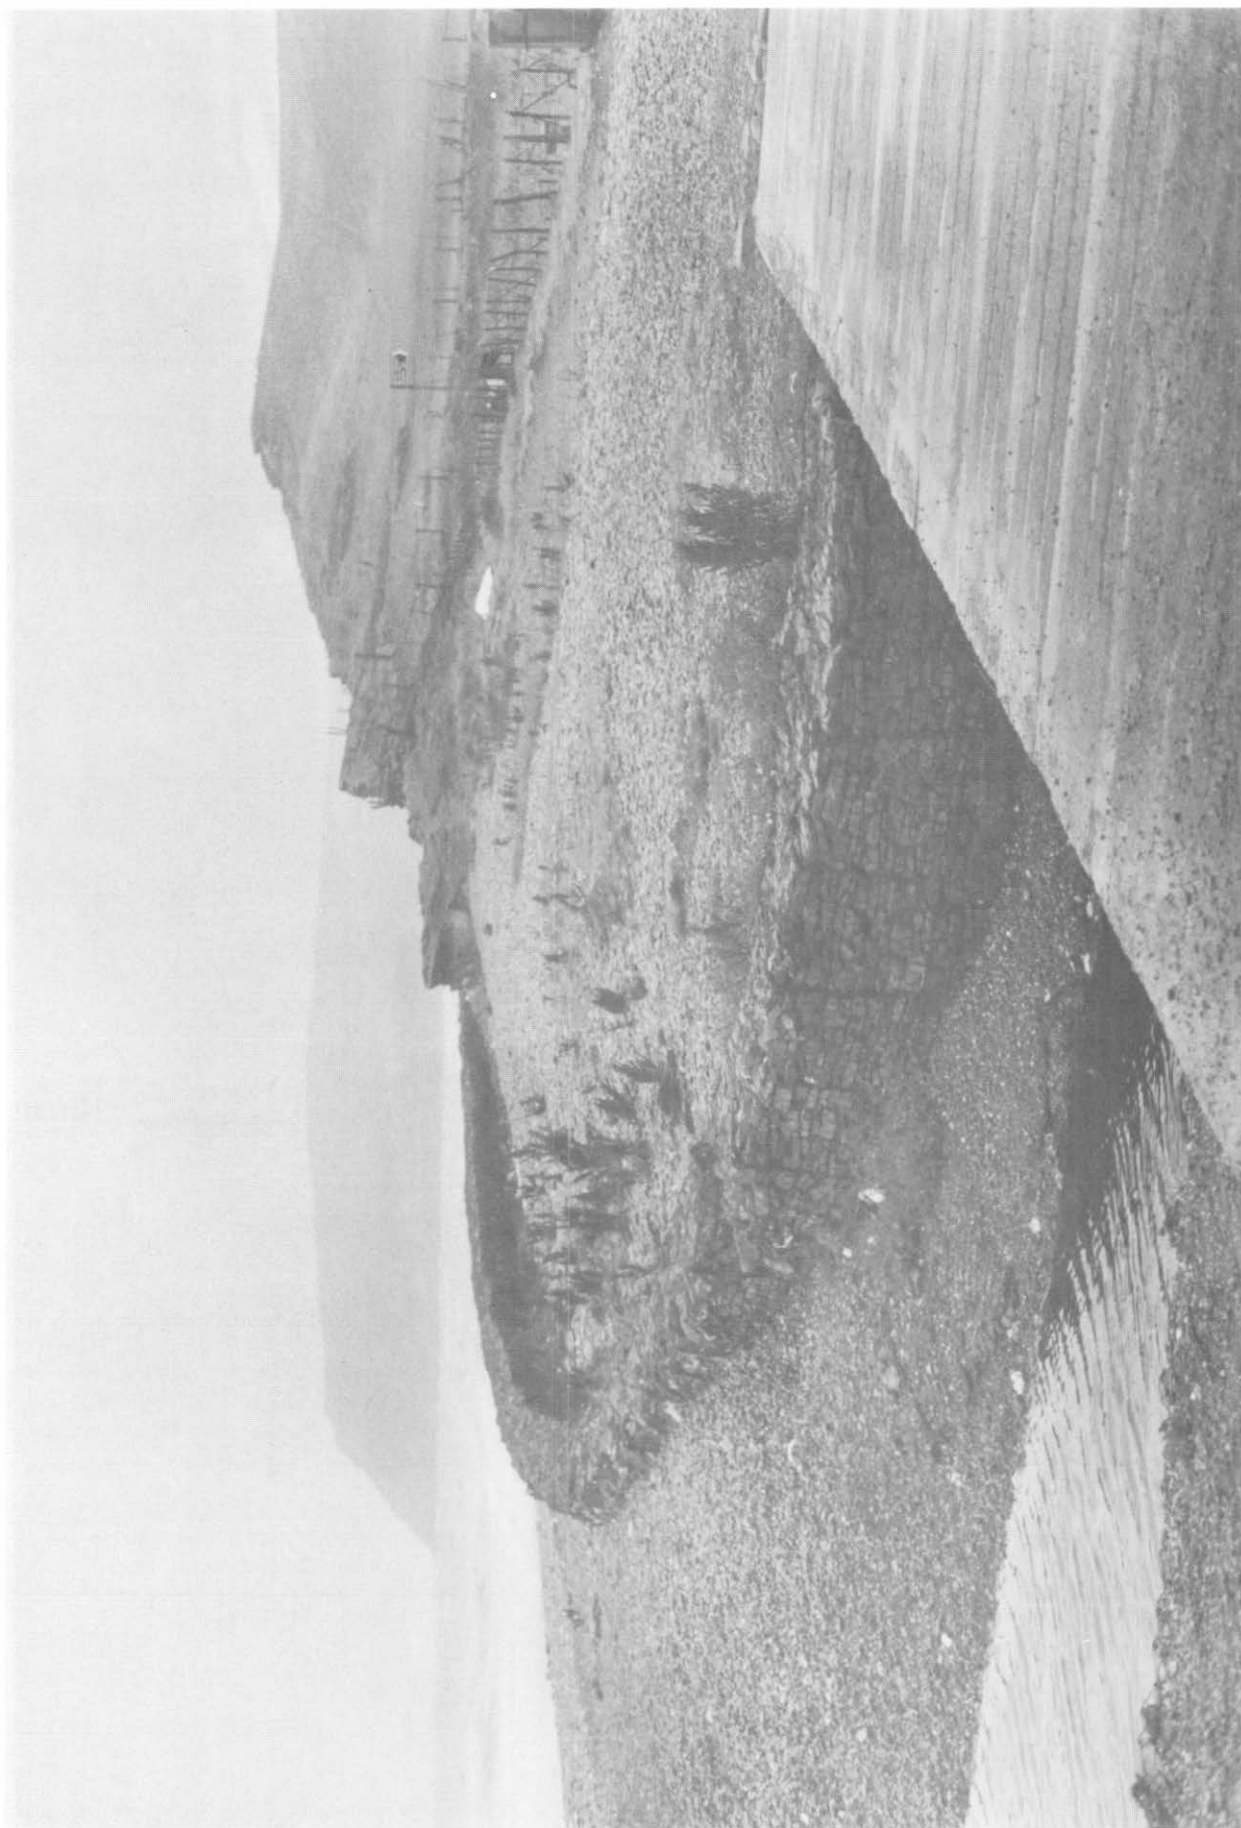
Gabions are most often used on sand beaches but can also be used on shingle beaches providing they are only subjected to occasional wave action. If they are placed within the intertidal zone, movement of the shingle, pebbles etc can rapidly abrade the surface of the basket wire and thus enhance corrosion by exposing the metal to the salt water environment. In other words abrasion is not good for PVC or galvanised coating, nor is it good for already rusted surfaces which are themselves protected to some degree by oxidation. Having said that, there are a number of sites on the North-west coast of England where they are being used, seemingly successfully, on stoney and shingle beaches (see Plate 1) although with a limited life expectancy. In

**Plate 1** "Maccaferri" type gabion sea wall on shingle beach at St Bees Bay

these areas regular maintenance is needed to prevent the gabions from deteriorating.

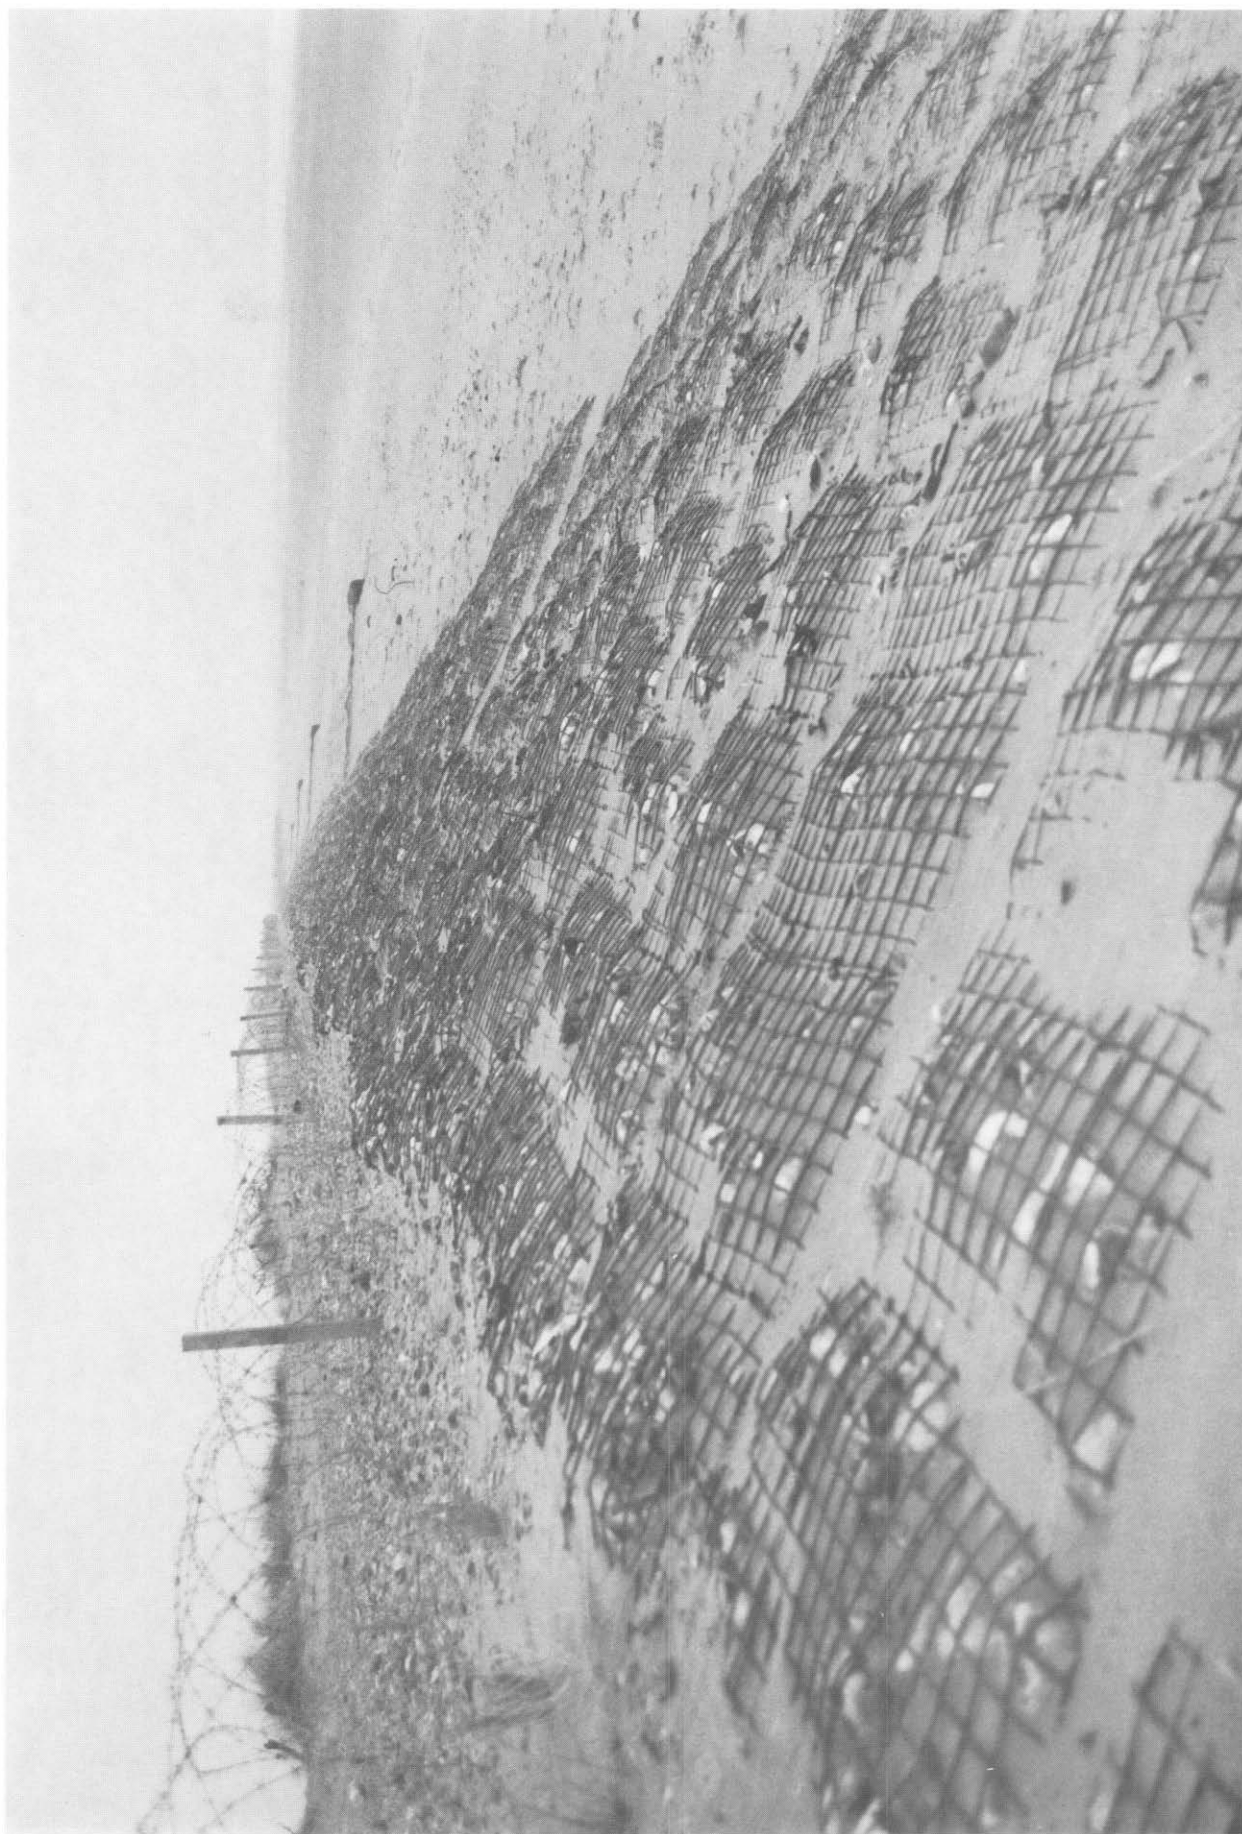
The third type of gabion in use today is constructed in heavy duty polyethylene mesh. This material is very flexible and non-corrodible but whether it will withstand abrasion, long term creep and vandalism (or even general wear and tear) has yet to be proven. In a coastal environment one can only consider using these on the backshore to stabilise sand dunes, earth banks, etc., (see Plate 6).

**Plate 6** "Netlon" type revetment at Brancaster with stub groynes

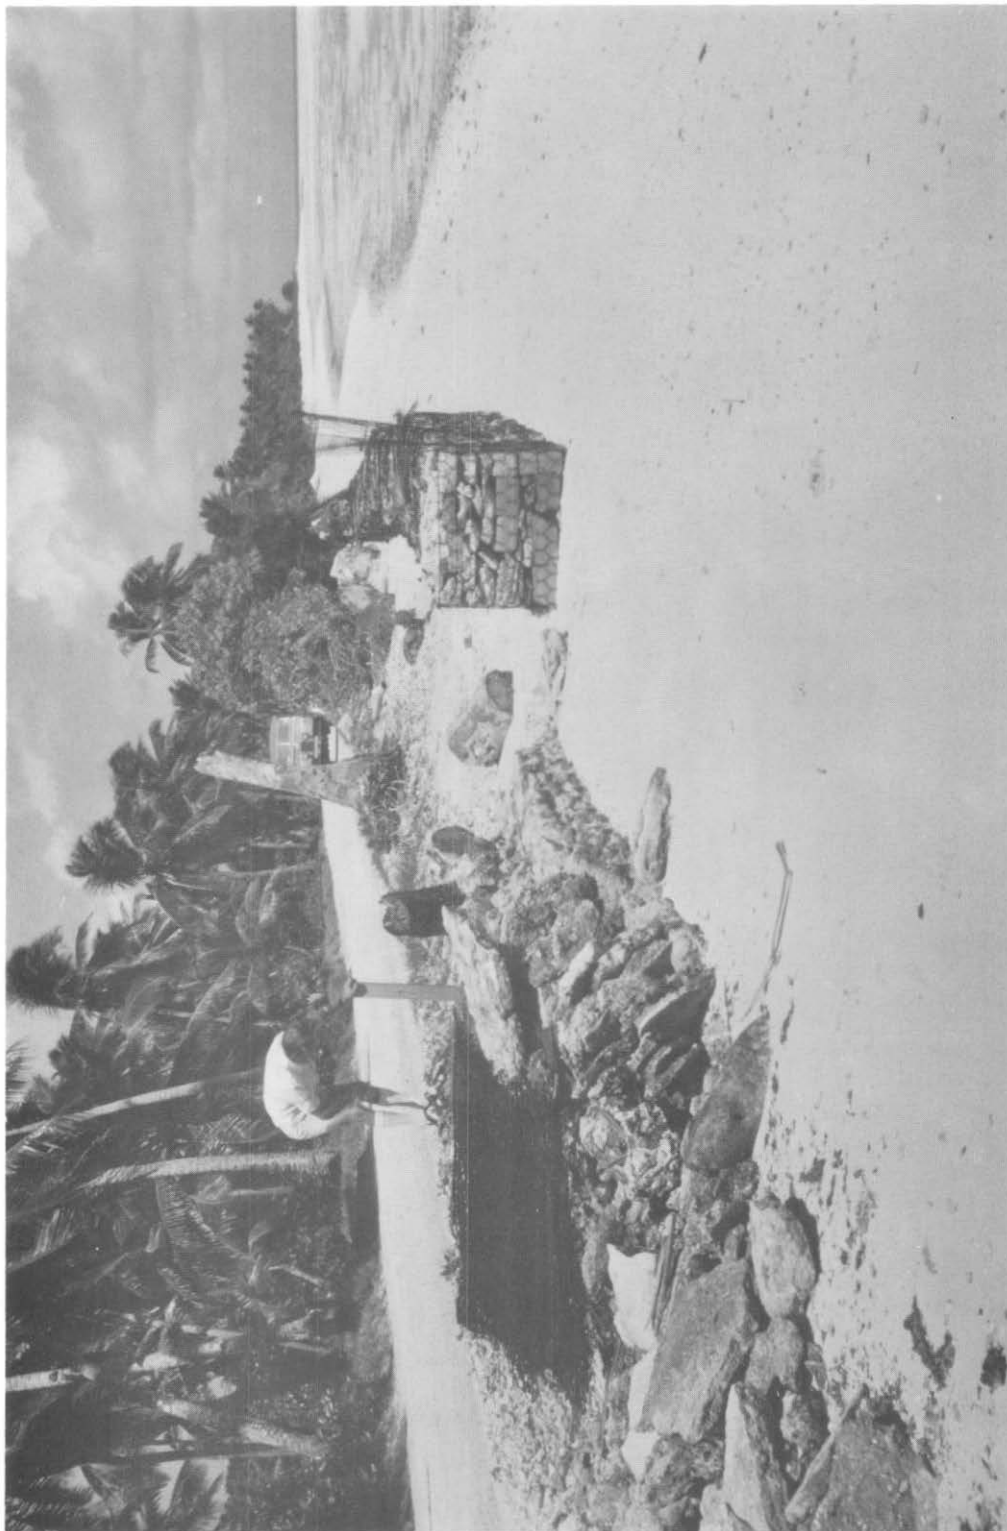
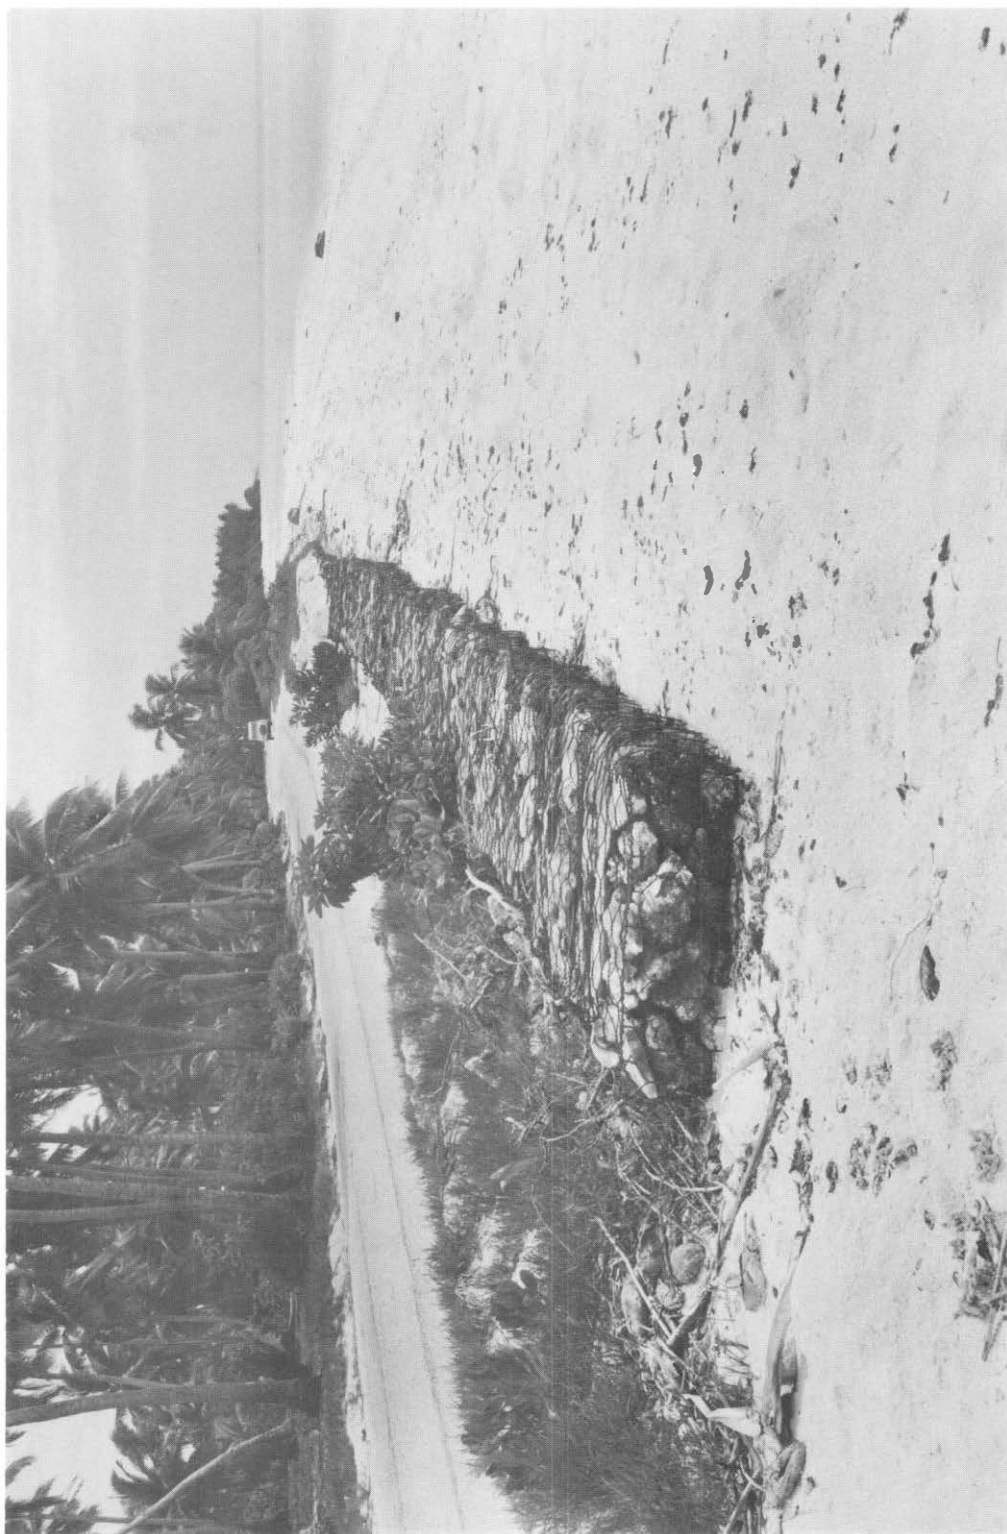
Plates 7 and 8 show plastic covered Maccaferri gabions at Ambo on Tarawa in Kiribati (formerly the Gilbert Islands) (Ref 7). They have been placed on the lagoon side of a causeway to protect the road from erosion. When constructed in July 1975 they were filled with coral boulders and adjacent gabions wired together for extra strength. Although they are sheltered somewhat from heavy seas by an offshore reef, they are nevertheless exposed to direct wave action and their life under these conditions is likely to be limited. Coral has sharp edges which will eventually cut through the plastic covering and thus enhance the corrosion process.

**Plate 7** "Maccaferri" type gabion being installed - Ambo, Gilbert Islands, 1975

Plate 8 Beach build up at Ambo, Gilbert Islands, 1978.

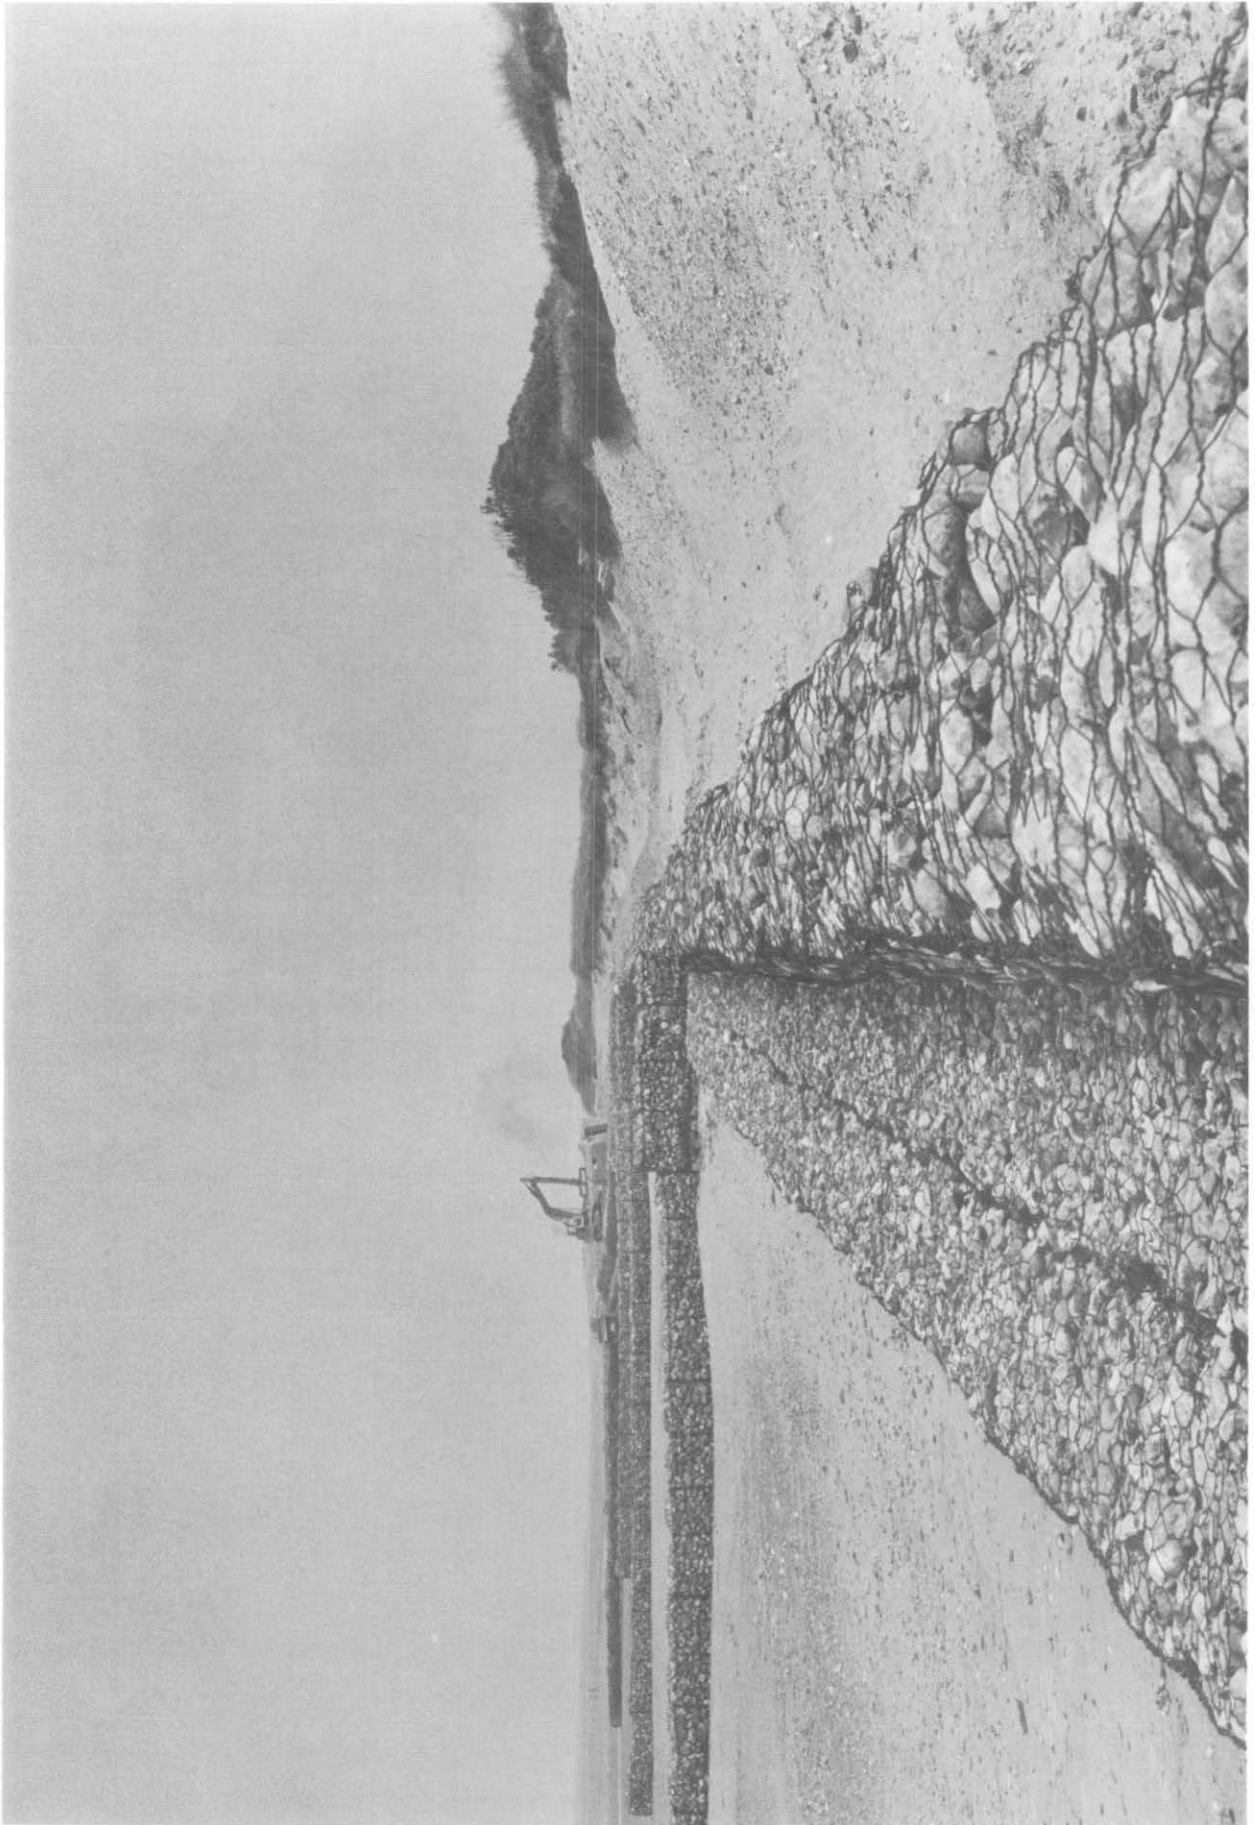
The gabions have proved effective, with only minor damage occurring after the surge of 1978. They have recently been extended by 380m toward Old Hunstanton (see summary sheet and Plates 9 and 10). To further stabilise the sand dunes to the rear of the structure, marram grass was planted on the sand backfill. A filter cloth was also used to retain backfill from leaching through the gabions. The good performance of this system stands in contrast to gabions installed on a nearby beach, where they were abraded rapidly by shingle and lasted only a few years.

**Plate 9** "Maccaferri" type sea wall at Old Hunstanton

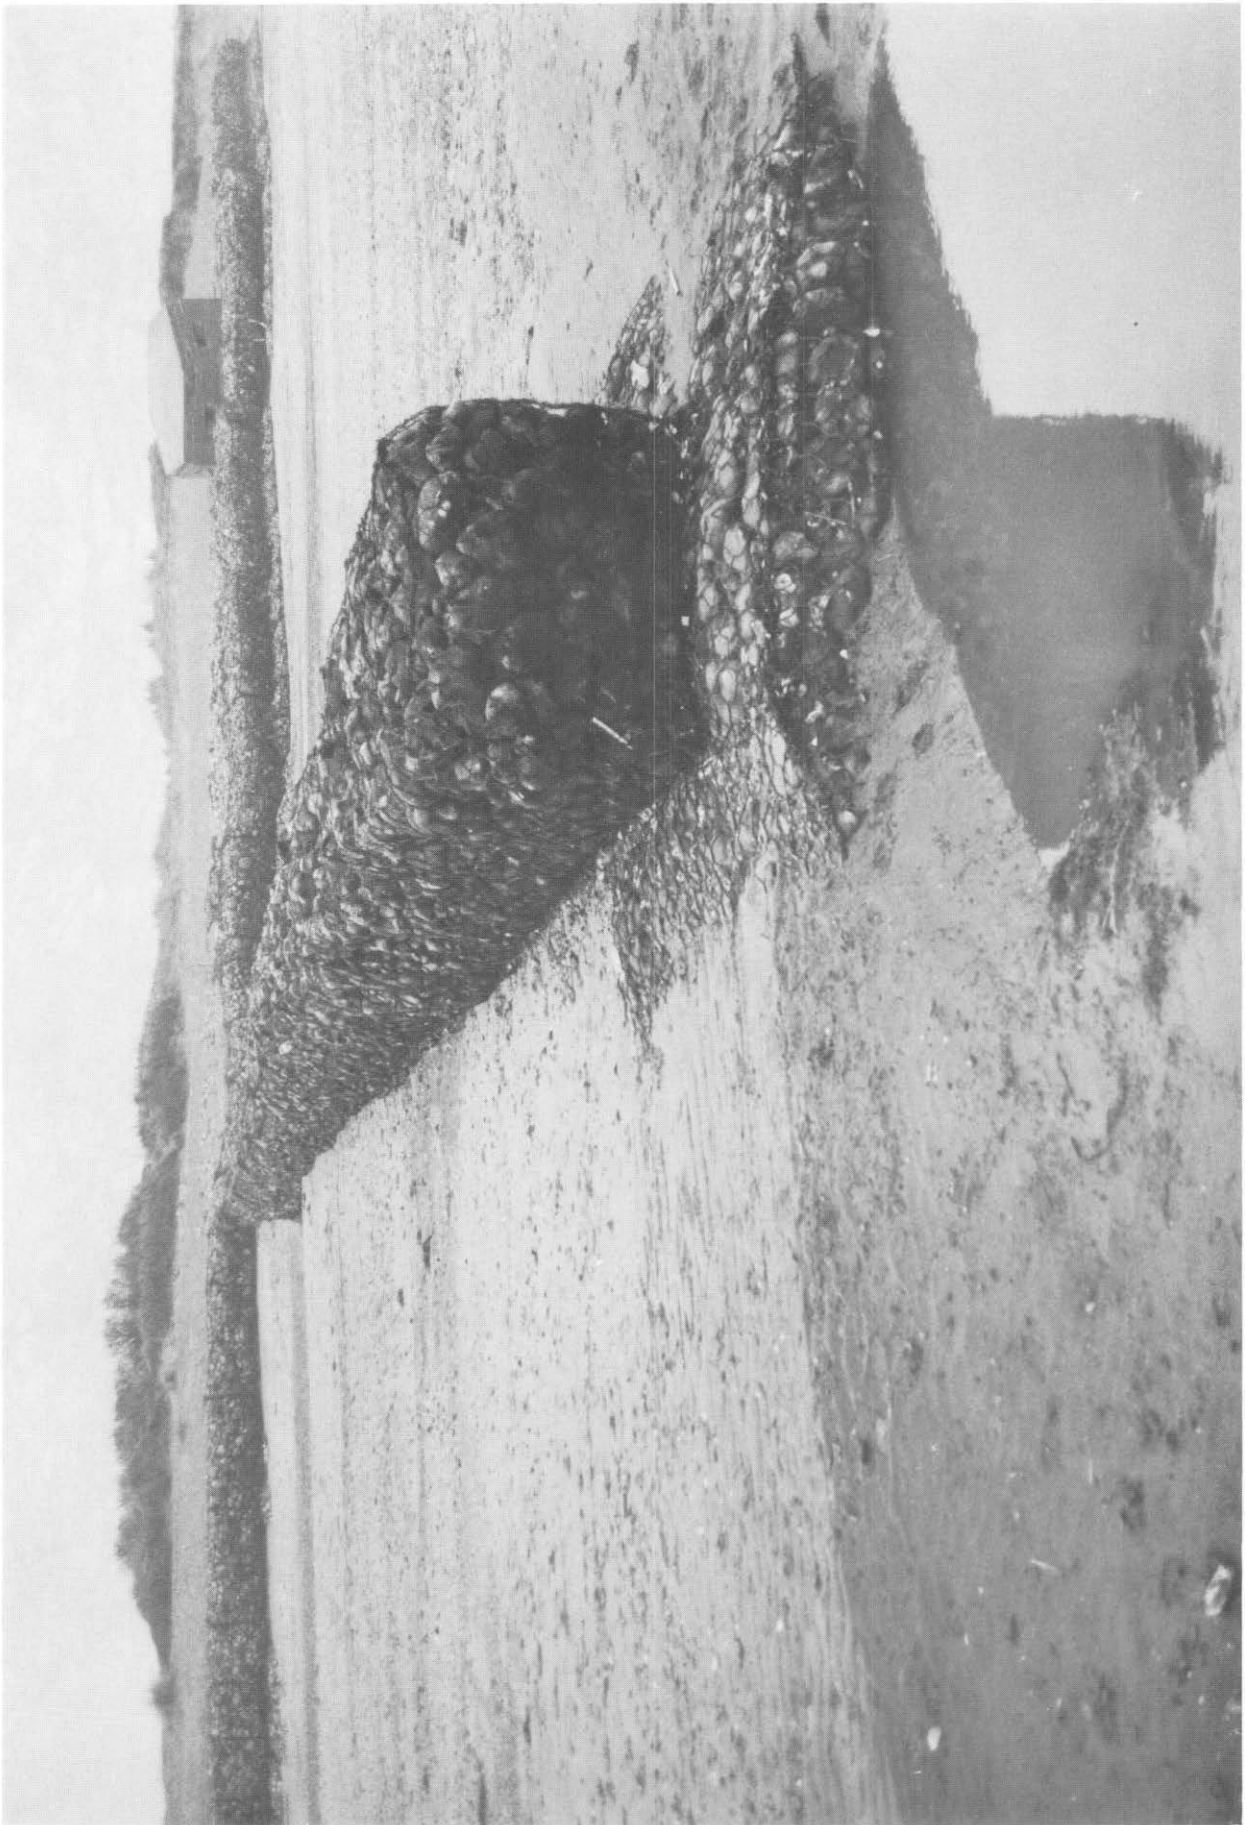
**Plate 10** "Maccaferri" type groyne showing foundation pad and scour hole,  
Old Hunstanton

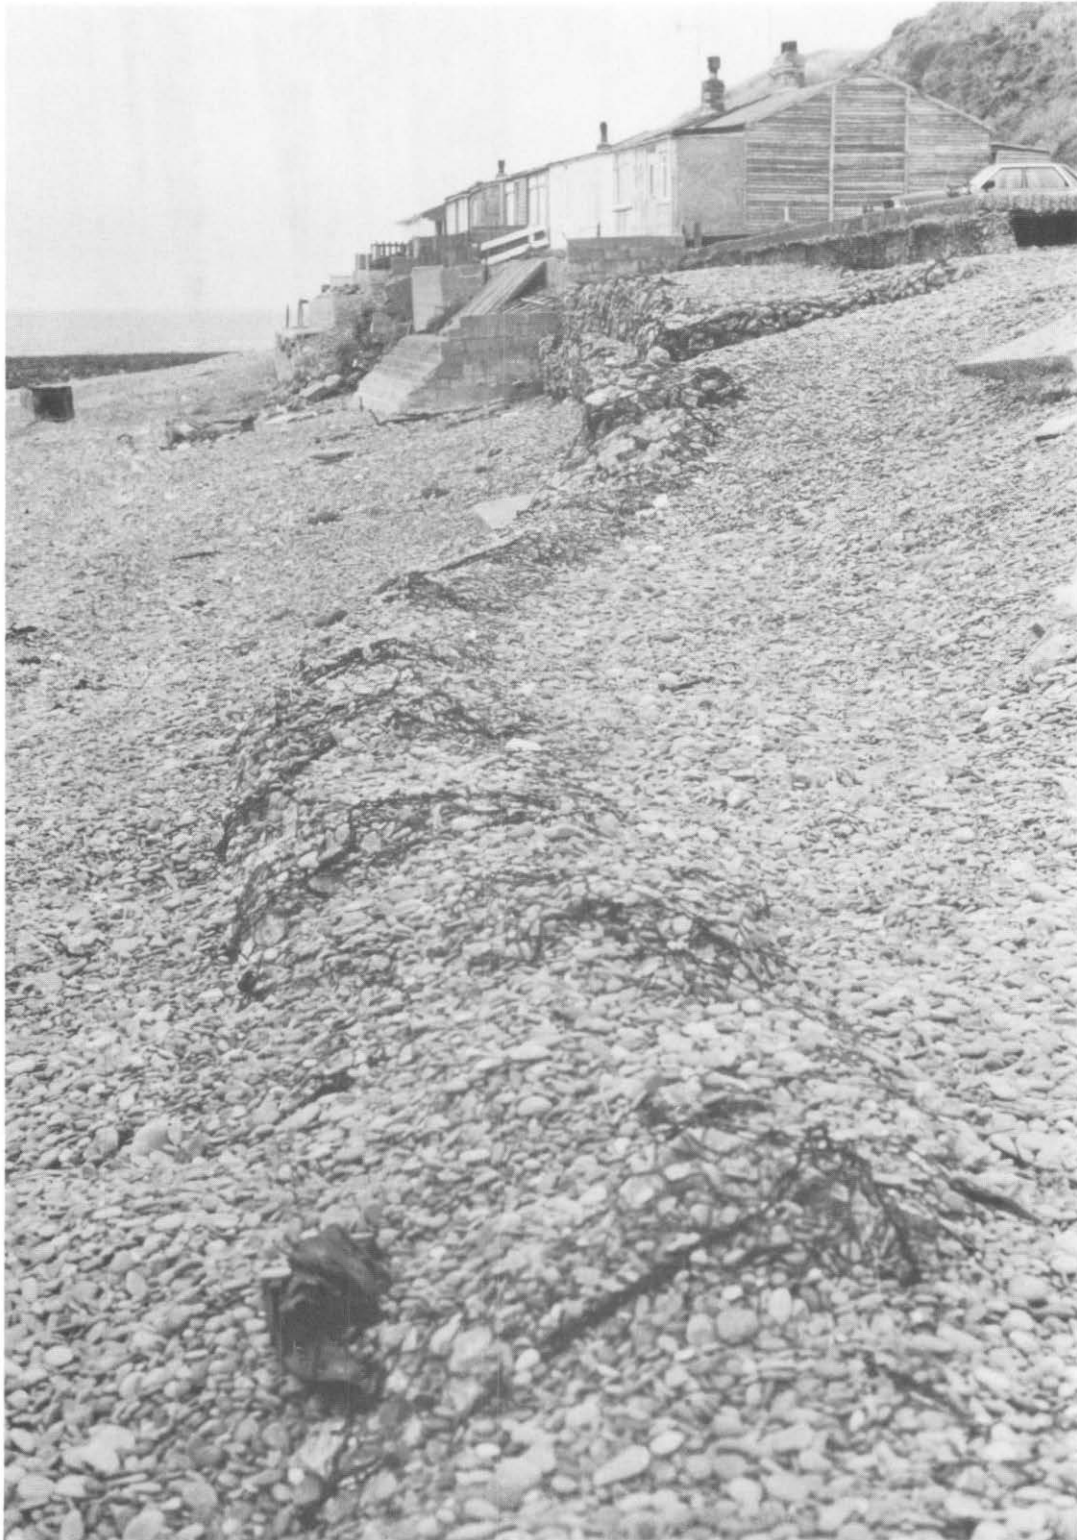
**Plate 13**    Damaged sea wall on shingle beach

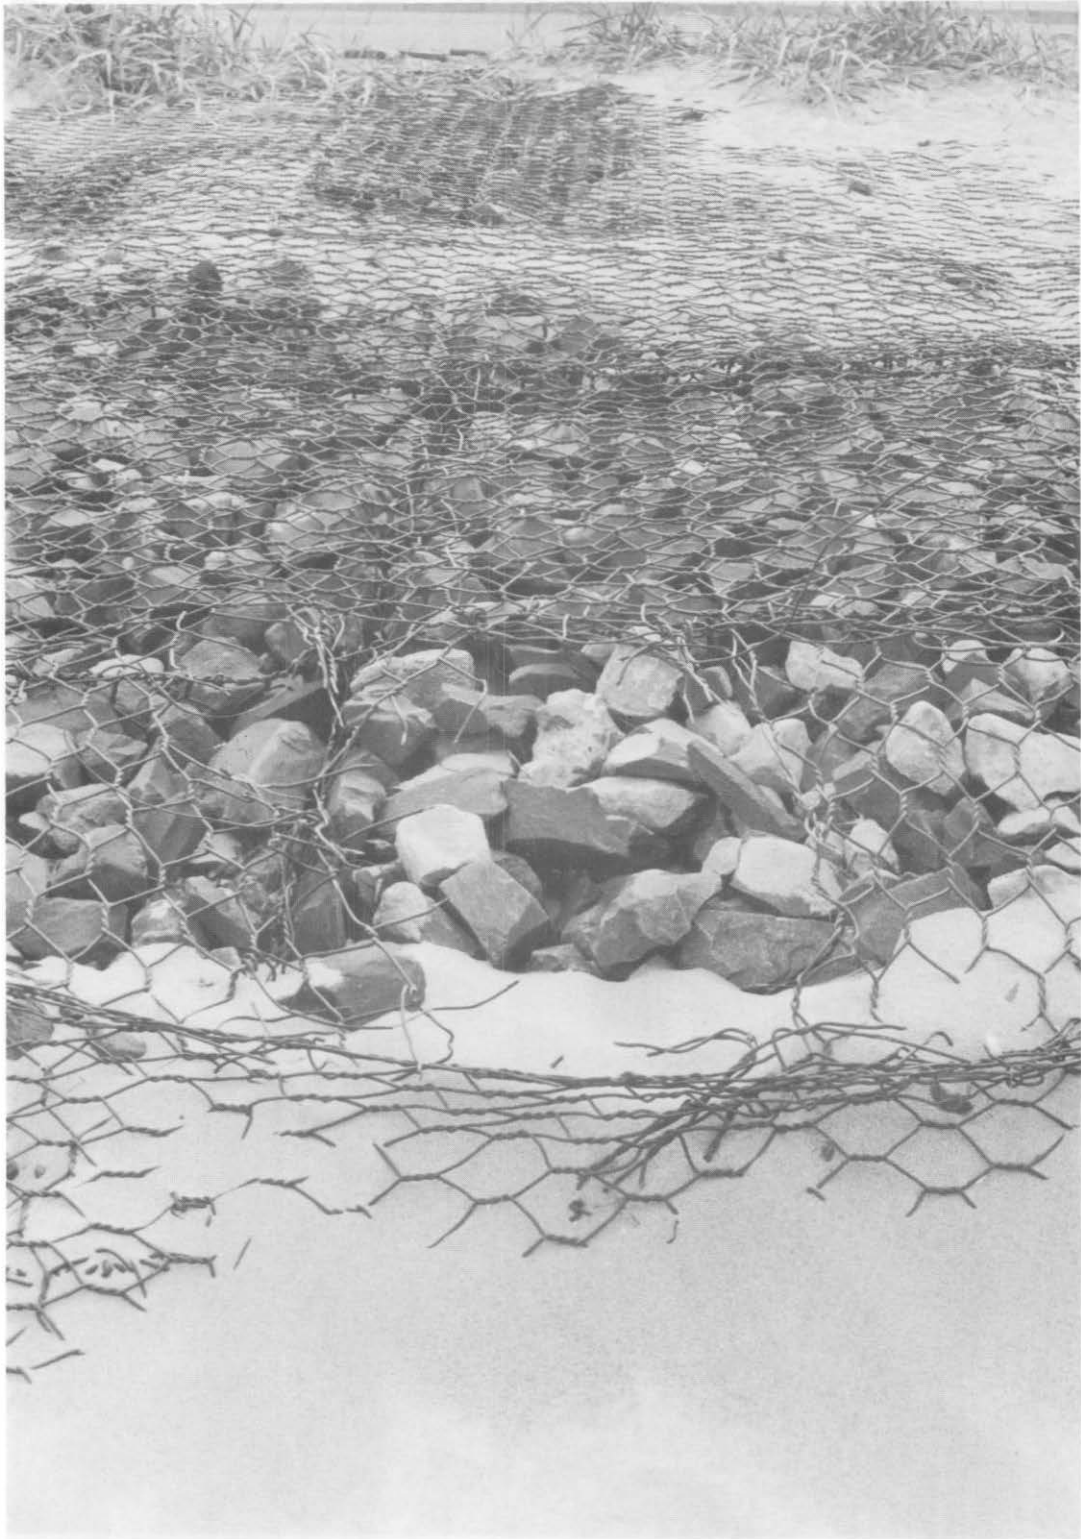
3. Regular monitoring and repair is essential, especially in the more popular holiday areas and in places where gabions are subjected to beach movement and wave activity is high. It is usually possible to repair the mesh type gabion quickly by rewiring if the damage is localised. Unless baskets are repaired quickly, broken wires can become a hazard to holidaymakers (see Plate 15).

Plate 15 Example of damaged gabion revetment
