**Highways Agency
Contract No: 3/323 F**

**Resilience of the HA
Network:**

**Review of flooding incidents in
Autumn 2000**

**Report SR 584
March 2001**

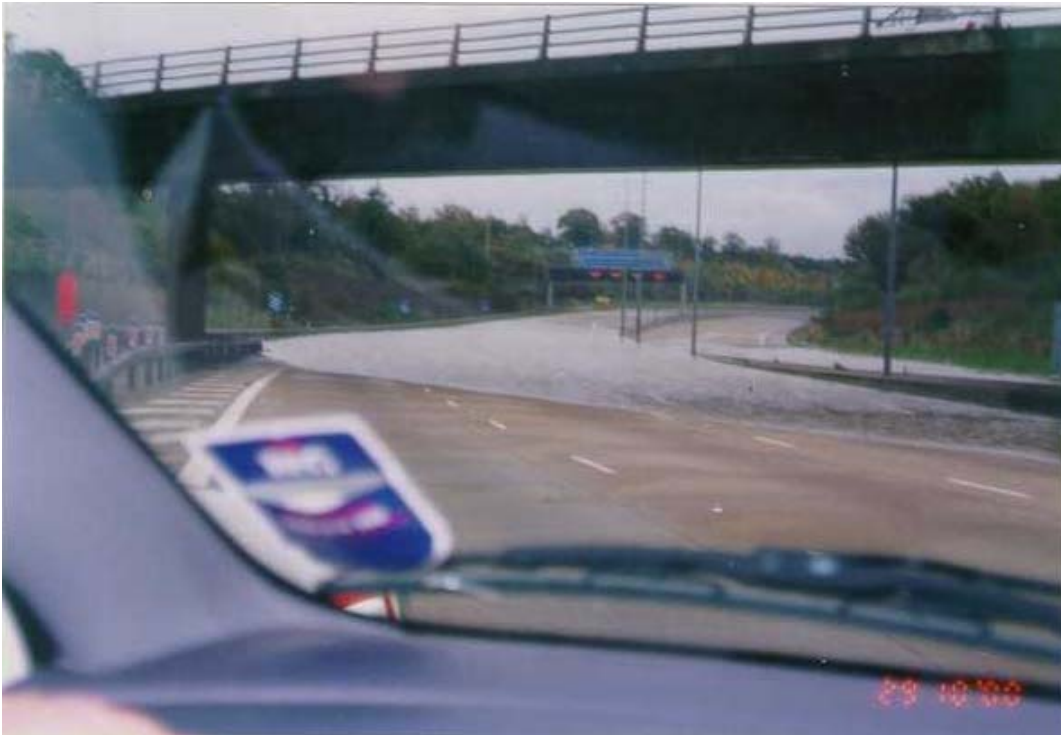
The severe storm that affected southern England on 29th and 30th October 2001 resulted in serious flooding on this section of the M25 and eventually led to all lanes having to be closed to traffic. The first signs of flooding became apparent at about 1:20 am when water began flowing down the face of a section of cutting a short distance before the off-slip for Junction 9 on the anti-clockwise route of the motorway. The flow was caused by runoff from a relatively small but steep catchment that lies to the north of the motorway and is the site of a golf course. The A244 and the A243 roads approach the M25 from the north at this point and reports suggest that, at the height of the storm, water was flowing down the A243 onto the M25 via the slip-road at Junction 9.

The safety barrier caused the water to pond on the anti-clockwise carriageway until all three lanes and hardshoulder were inundated. The amount of flooding increased until it extended over a distance of about 300 m and the depth at the lowest point reached about 1.1 m (see Plate 1). Water then spilled over the top of the concrete barrier and flooded the full width of clockwise carriageway for a distance of about 150 m. .

The section of motorway was closed for approximately 12.75 hours between about 2:45 am and 3:30 pm on 30th October. During this time, maintenance staff tried to clear blockages from the drainage system in the central reserve, but the depth of water and high winds made it too difficult and hazardous. After the end of the storm, the runoff from the natural catchment decreased and allowed the water on the motorway to drain away. Traffic disruption due to the flooding was made worse by the simultaneous closure of the A3 at Bolder Mere, about 1km from Junction 10 of the M25 (see 6.1(b)). Similar but more limited flooding occurred on the M25 at Junction 9 on 6th November 2001 but this only affected the anti-clockwise carriageway and cleared by 10 am.

Plate 1 Flooding on the M25 at Junction 9 on 30/11/00 (NB not 29/11/00 as shown)

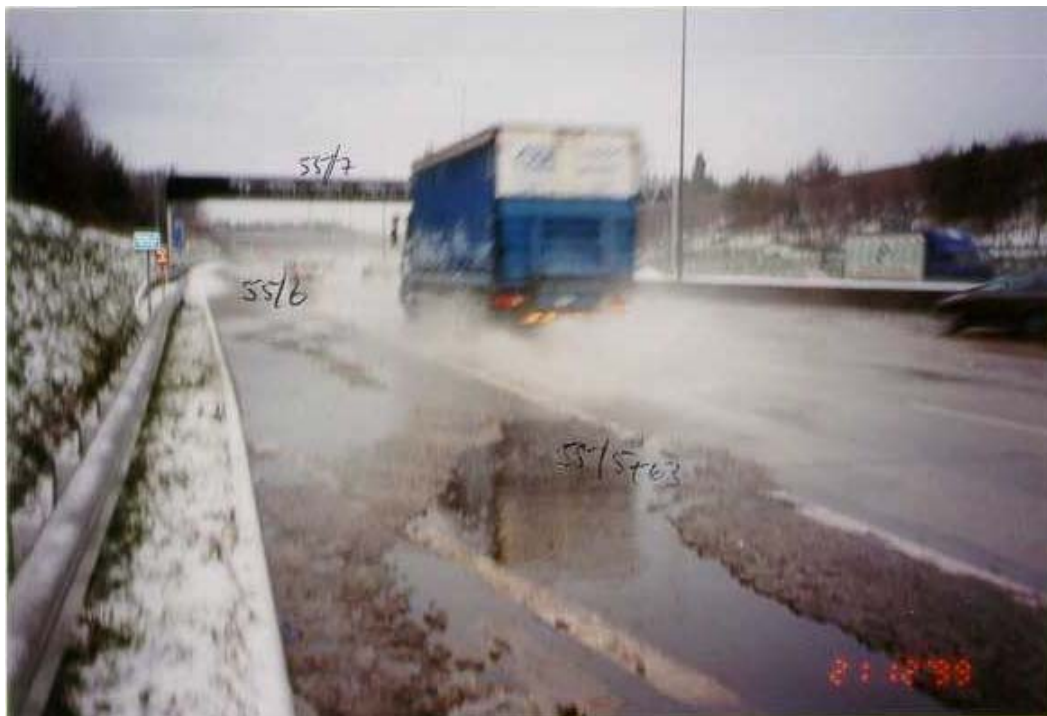
There are several points along the M25 and at least one on the A3 where lack of transverse or longitudinal fall on the carriageway causes ponding of water during wet weather (see Plates 2 and 6). All the flat spots are on concrete pavements and are either associated with transitions between normal camber and super-elevation around bends or to resurfacing work. The ponding is a matter of concern to the Maintaining Agents as several accidents have occurred due to skidding or excessive spray. The following locations of flat spots were mentioned by the Maintaining Agents for Area 3:

M25: between Junctions 8 and 9 on the A carriageway; two points between Junctions 10 and 11 on the B carriageway; between Junctions 10 and 9 on the B carriageway; between Junctions 9 and 8 on the B carriageway; and the on-slip near Junction 6 at Godstone.

Plate 2 Ponding on M25 (Route A) between Junctions 8 and 9 due to lack of camber

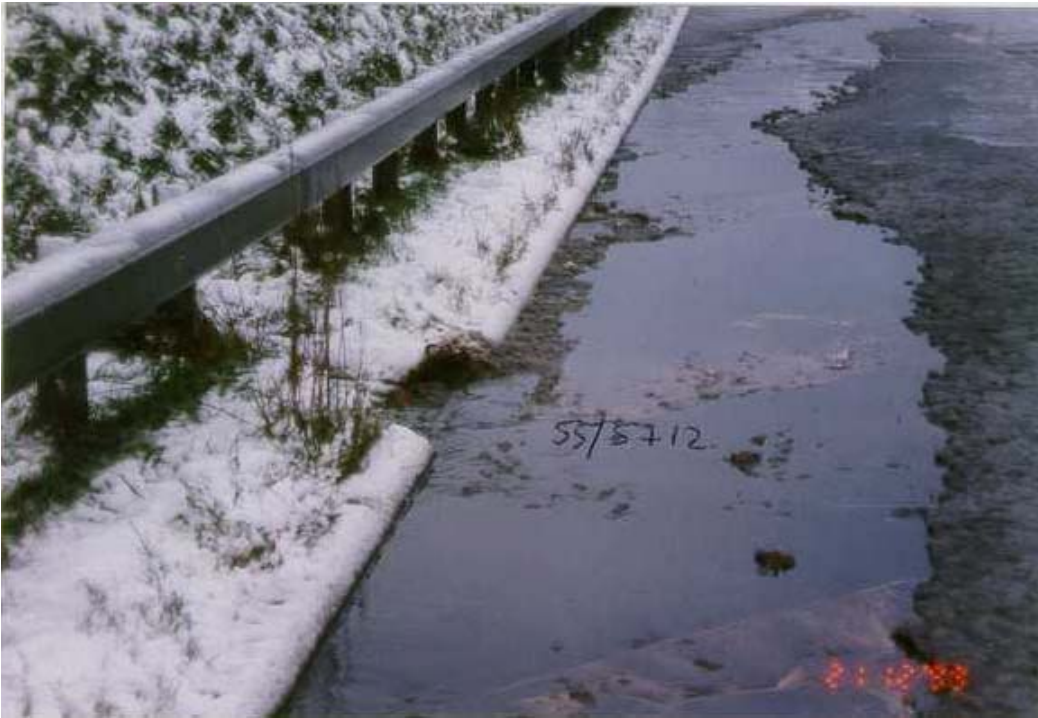
Plate 3 Flow by-passing recessed gully on M25 (Route A) between Junctions 8 and 9

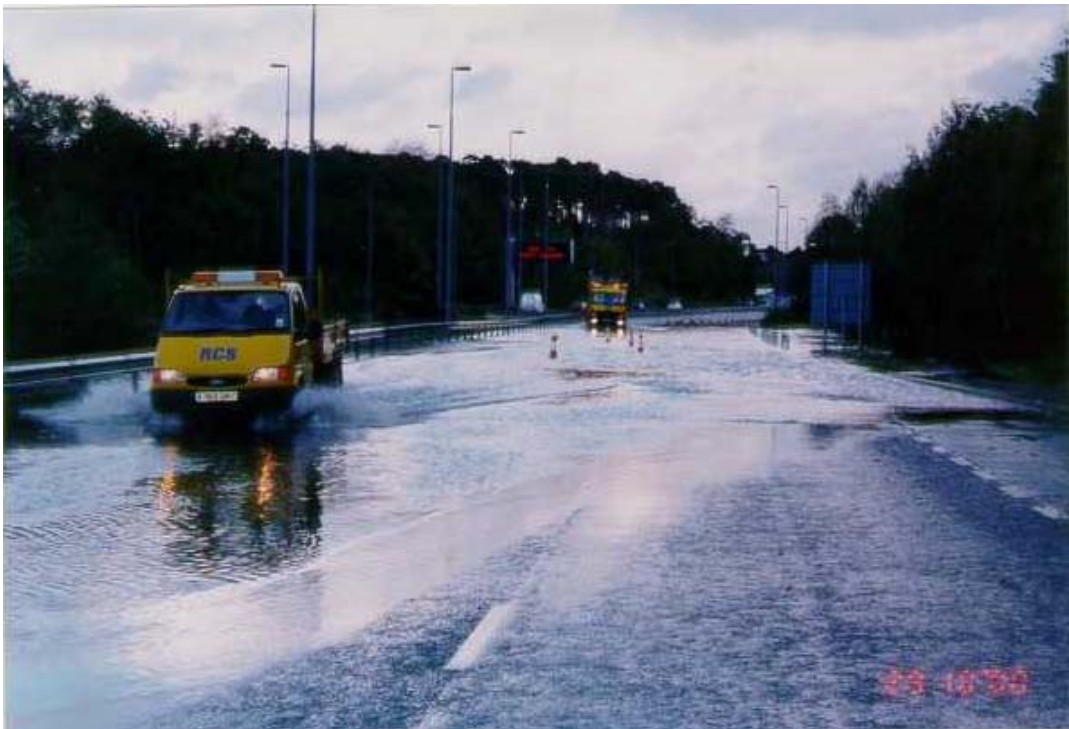
The same storm that produced flooding on the M25 on 30th October 2000 also caused flooding on the A3 approximately 1km west of its junction with the M25. Runoff from the disused airfield at Wisley discharges into the Bolder Mere which borders the southern side of the A3. Water flows out of this lake through a culvert beneath the A3. Runoff from the southern carriageway of the A3 is conveyed beneath the A3 by a second adjacent culvert.

HA Maintenance staff found that there was an obstruction in the culvert that carries the highway runoff from the A3. It is not known whether the obstruction was placed intentionally but it is conceivable that its purpose was to help maintain a minimum water level in the Bolder Mere. The HA staff also found that the bar grating over the culvert taking flow from the Bolder Mere (and indirectly from Wisley airfield) was blocked by debris.

Plate 4 Flooding on A3 at Bolder Mere on 30/10/00

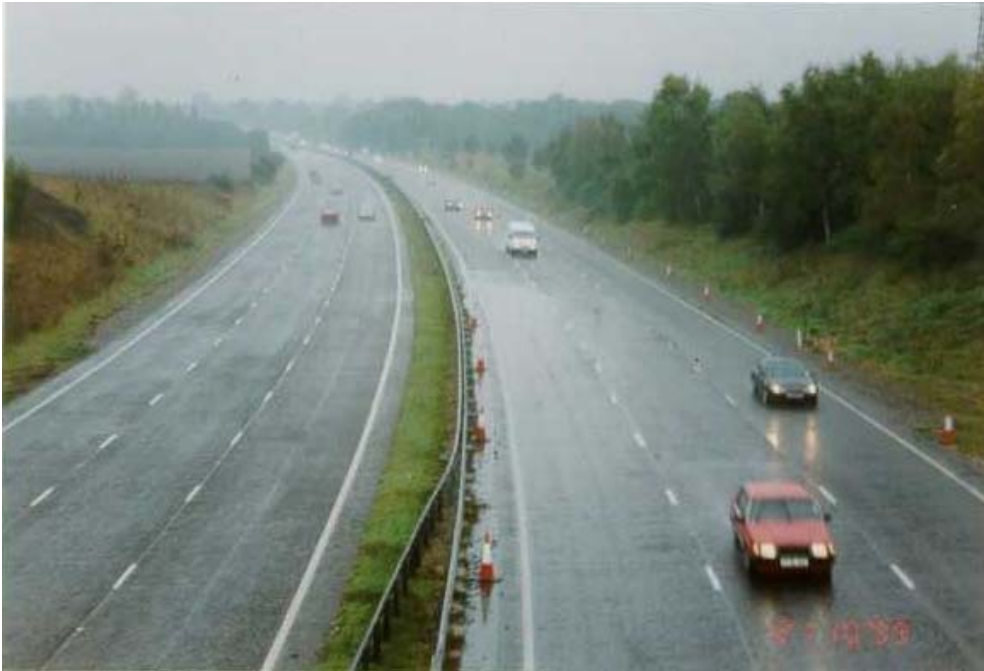
A3: near the junction with the A247.

Plate 5 Ponding on A3 near Junction with A247 due to lack of camber at transition

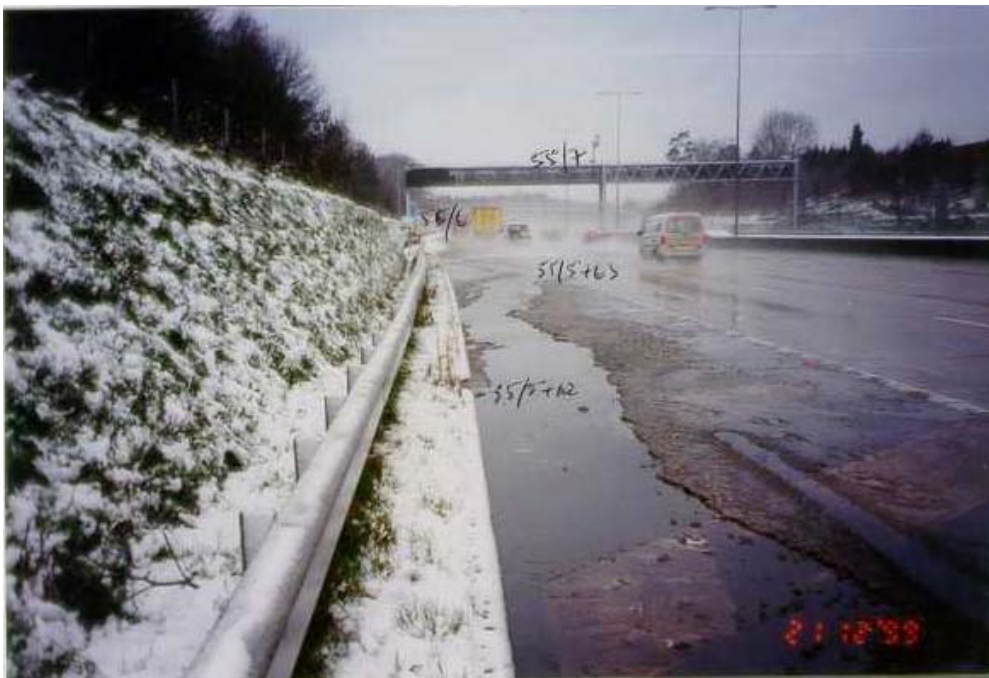
Plate 6 Ponding on M25 (Route A) between Junctions 8 and 9 due to lack of camber

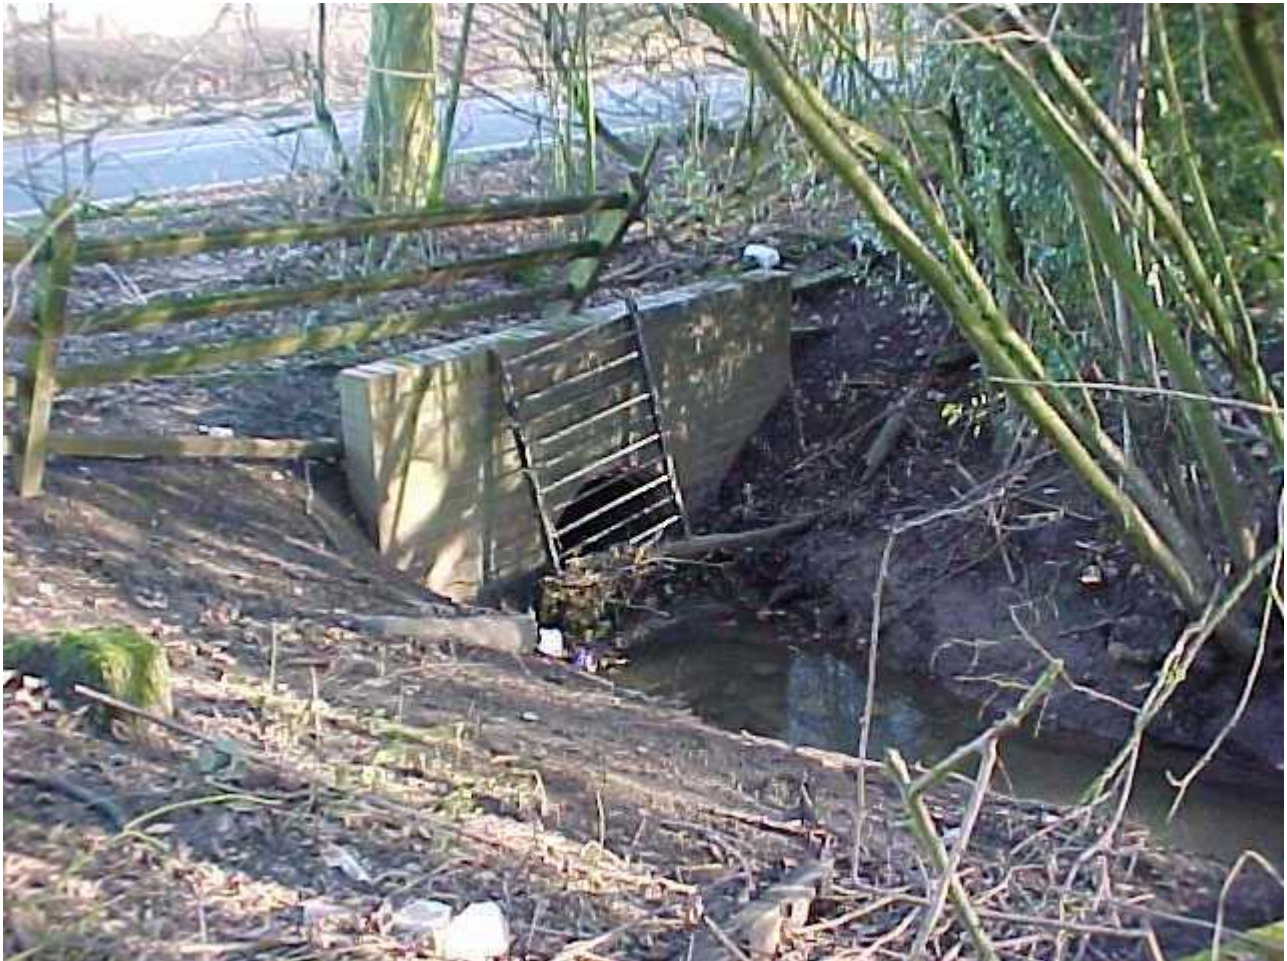
The construction of this culvert is a hotchpotch consisting of an original brick structure with a pipe at the upstream end and a cast in-situ concrete rectangular section at the downstream end (see Plate 7).

The culvert appears not to have sufficient hydraulic capacity to accommodate the flows from upstream, and hence water builds up and floods across the carriageway. There is a grill across the upstream end of the culvert that is effective in trapping debris; ensuring that the grill is regularly cleared could therefore reduce the risk of flooding. The headwall is at right angles to the flow and the grill is vertical; the headwall has no wing walls or safety balustrade to protect maintenance personnel cleaning the grating.

Plate 7 Upstream side of culvert beneath A5 at Merevale

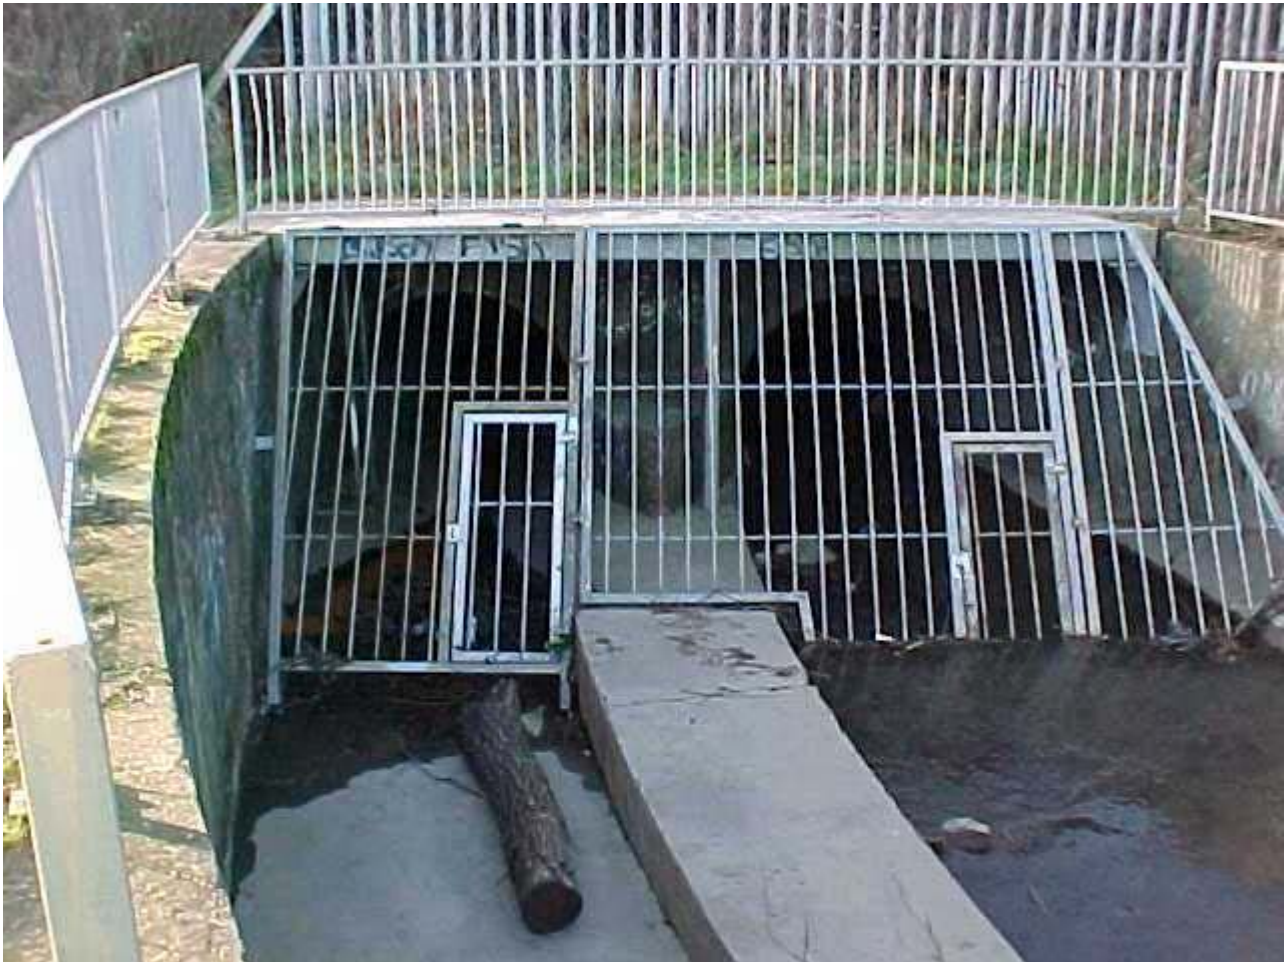
Flooding occurred at this location at a low point where the carriageway passes beneath a railway bridge. The channel discharges via a gully to a drain which, in turn, outfalls to the Kettlebrook immediately upstream of a twin pipe culvert beneath the railway embankment. The pipe diameters are not known but are of the order 900 to 1200 mm. Immediately upstream of the culverts are a dry

weather and wet weather channel (see Plate 8). The highway drain outfalls to the wet weather channel, while under dry weather flow conditions the stream is retained within the dry weather channel. In storm conditions the stream flow spills over a weir into the wet weather channel and consequently affects the outflow from the highway drain. The invert of the highway drain outlet is close to the invert of the wet weather channel and is also at 90° to the direction flow. Therefore there is no venturi effect to draw water out of the highway drain and the drain will be subjected to a head of water equal to the depth of flow in the channel. It is possible that the culverts beneath the railway became surcharged during the flooding events.

Plate 8 Upstream side of culvert beneath A5 at Kettlebrook

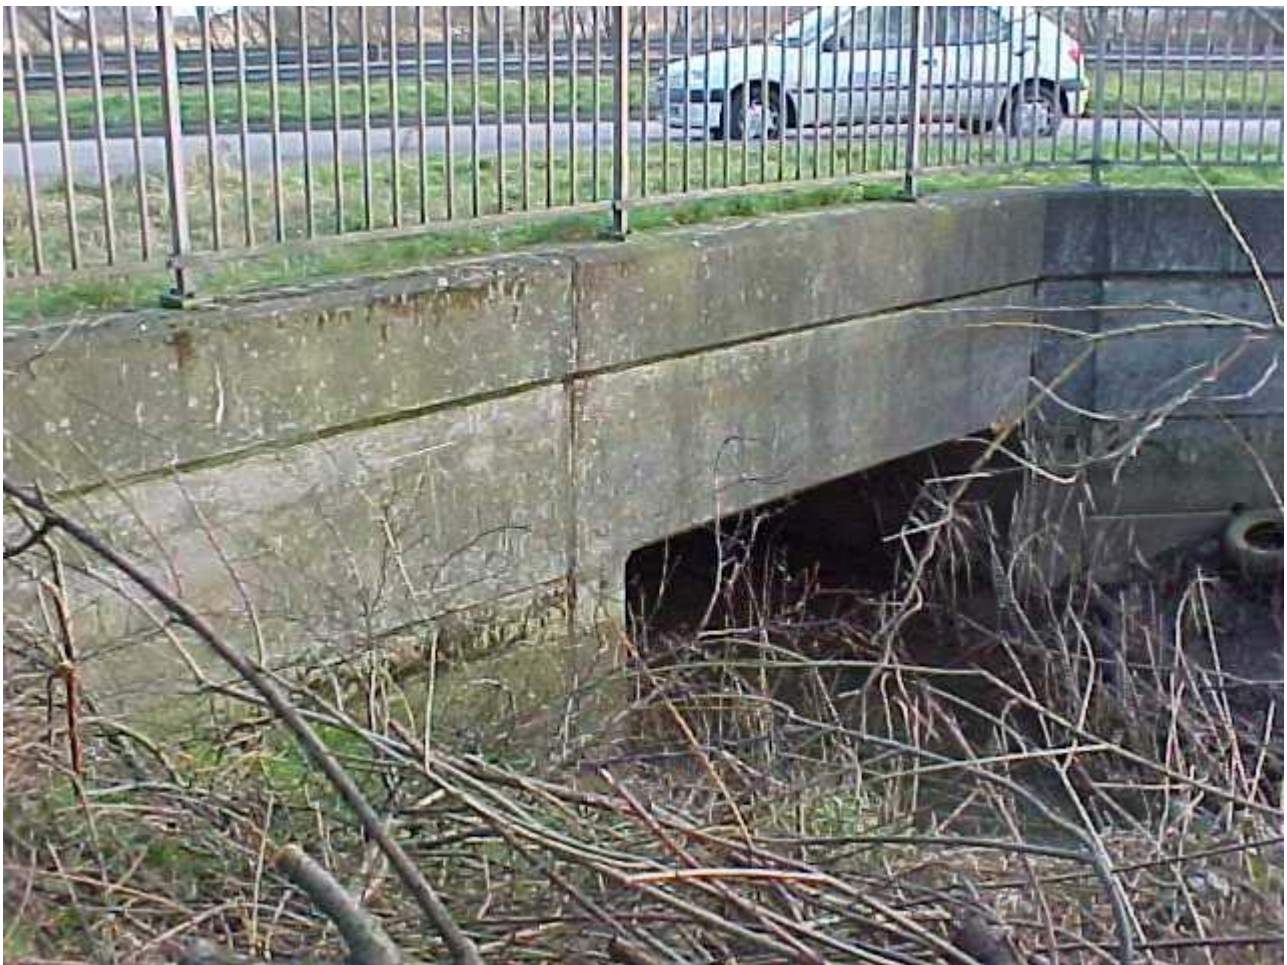
Flooding of the carriageway seems, in part, to have been due to high water levels in the River Trent which adversely affected the discharge of flows from the highway drainage system into the watercourse on the downstream side of the carriageway. Water marks on the headwall of the culvert beneath the A38 (see Plates 9 and 10) indicated that this possibly throttled the flow, allowing water levels to build up and over top the bank. However, investigations showed that the 460mm drain in the central reserve was 50% full of silt and also that a number of gullies appeared to be blocked or to have no obvious outfall. Drainage records of the system were incomplete.

It is believed that backflow occurred from the Trent tributary up the eastern ditch, which has no noticable fall; water left this ditch, possibly via gully connections, and flooded the southbound carriageway

Plate 9 Culvert beneath A38 at Branston

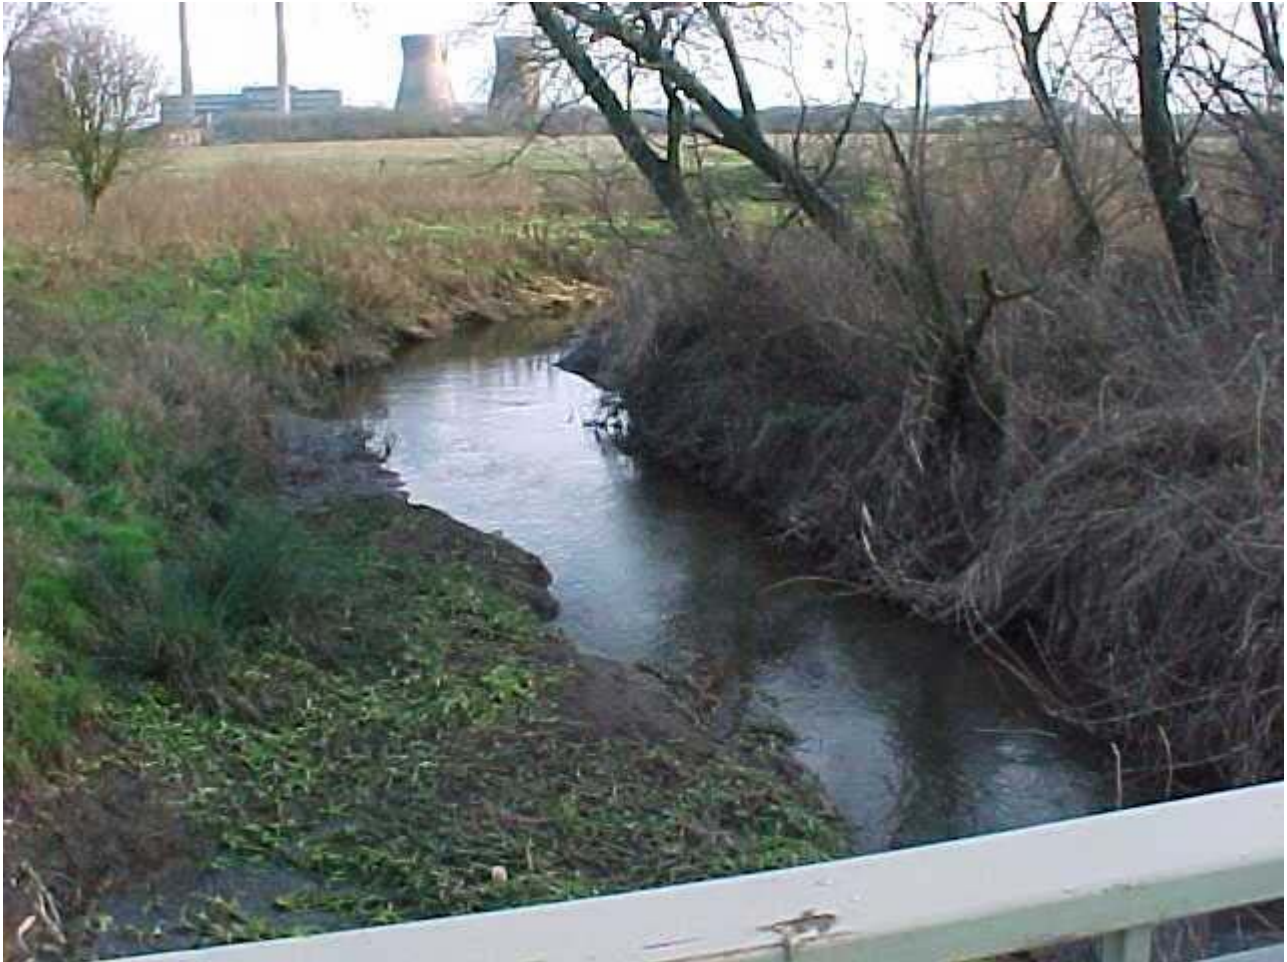
Plate 10 River Trent viewed from A38 at Branston
