A REVIEW OF NOVEL SHORE PROTECTION METHODS

Inspection of sea defences in Holland
and Belgium
17 to 21 September 1984

Report No SR 6
December 1984

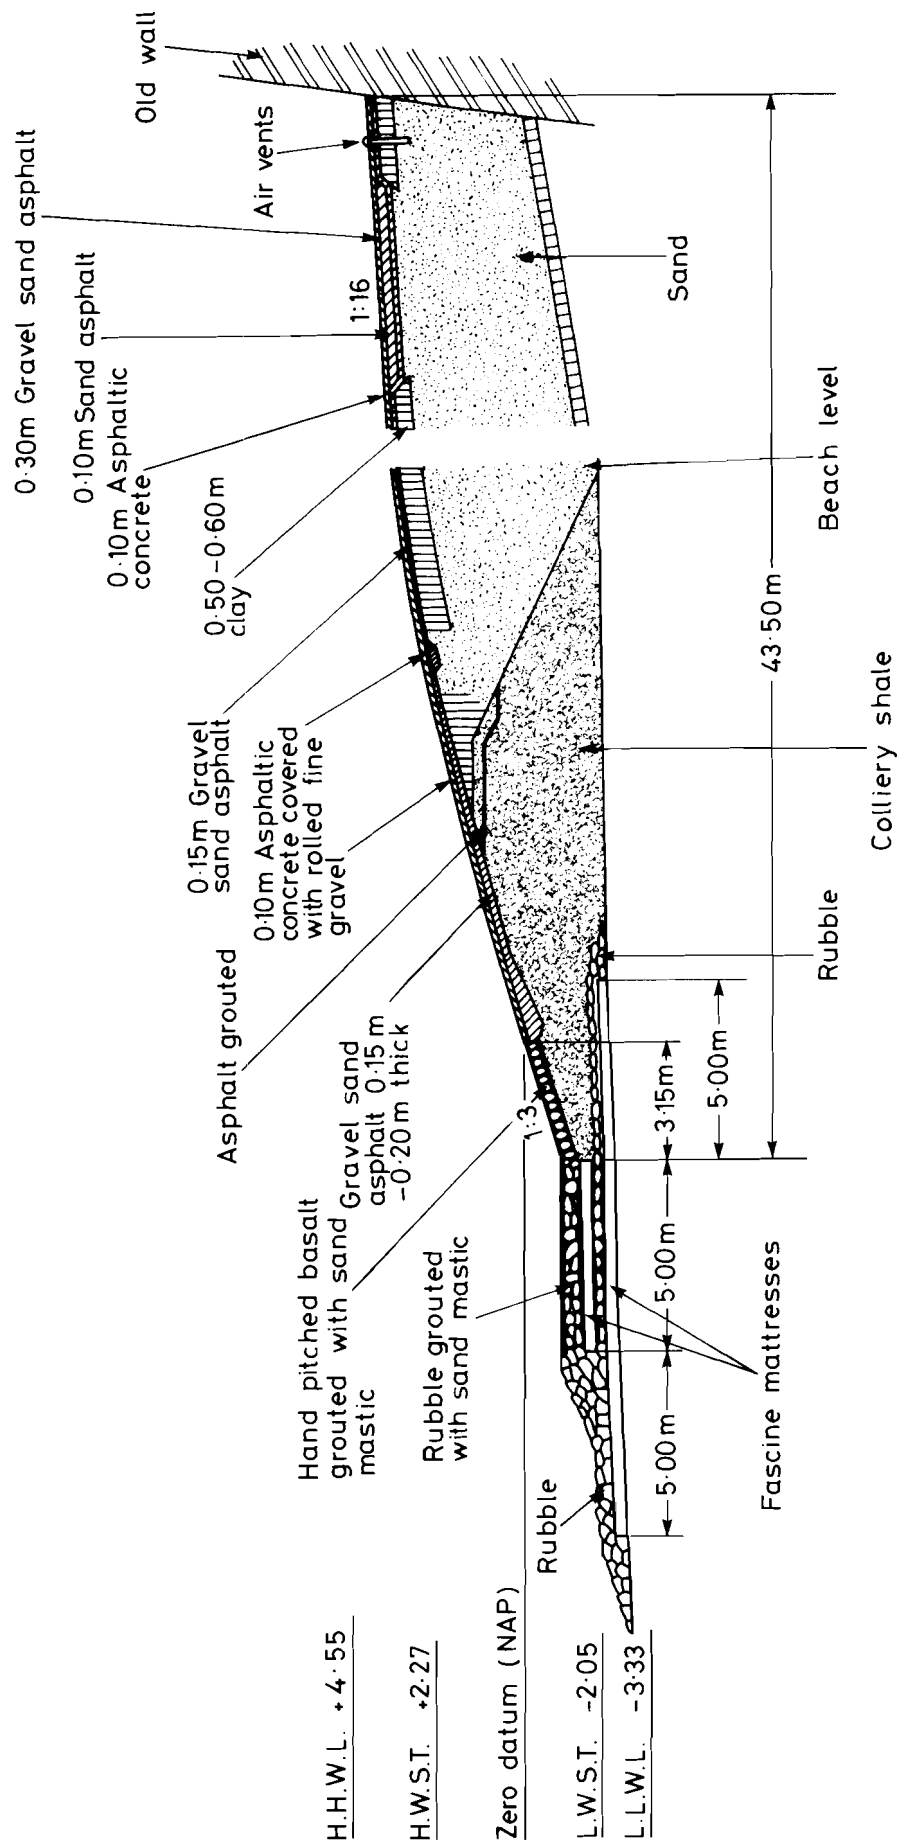
A cross-section of the revetment is shown in Fig 2. Essentially this consists of a sand core covered by an asphaltic concrete skin. The skin has two layers, the bottom one including gravel and the top one crushed stone. The two asphaltic layers are bonded together with a bituminous emulsion.

Below the mean water line the revetment is faced with basalt blocks which are asphalt grouted. Waves at this site are limited in height by a horizontal berm of asphalt grouted rubble at a level of -1.0m. (MLWST is -2.05m and MHWST is +2.27m). At the junction with the old wall the revetment is at about the level of the highest recorded water level i.e. +4.55m.

Fig 2 Asphaltic revetment, Flushing, Holland

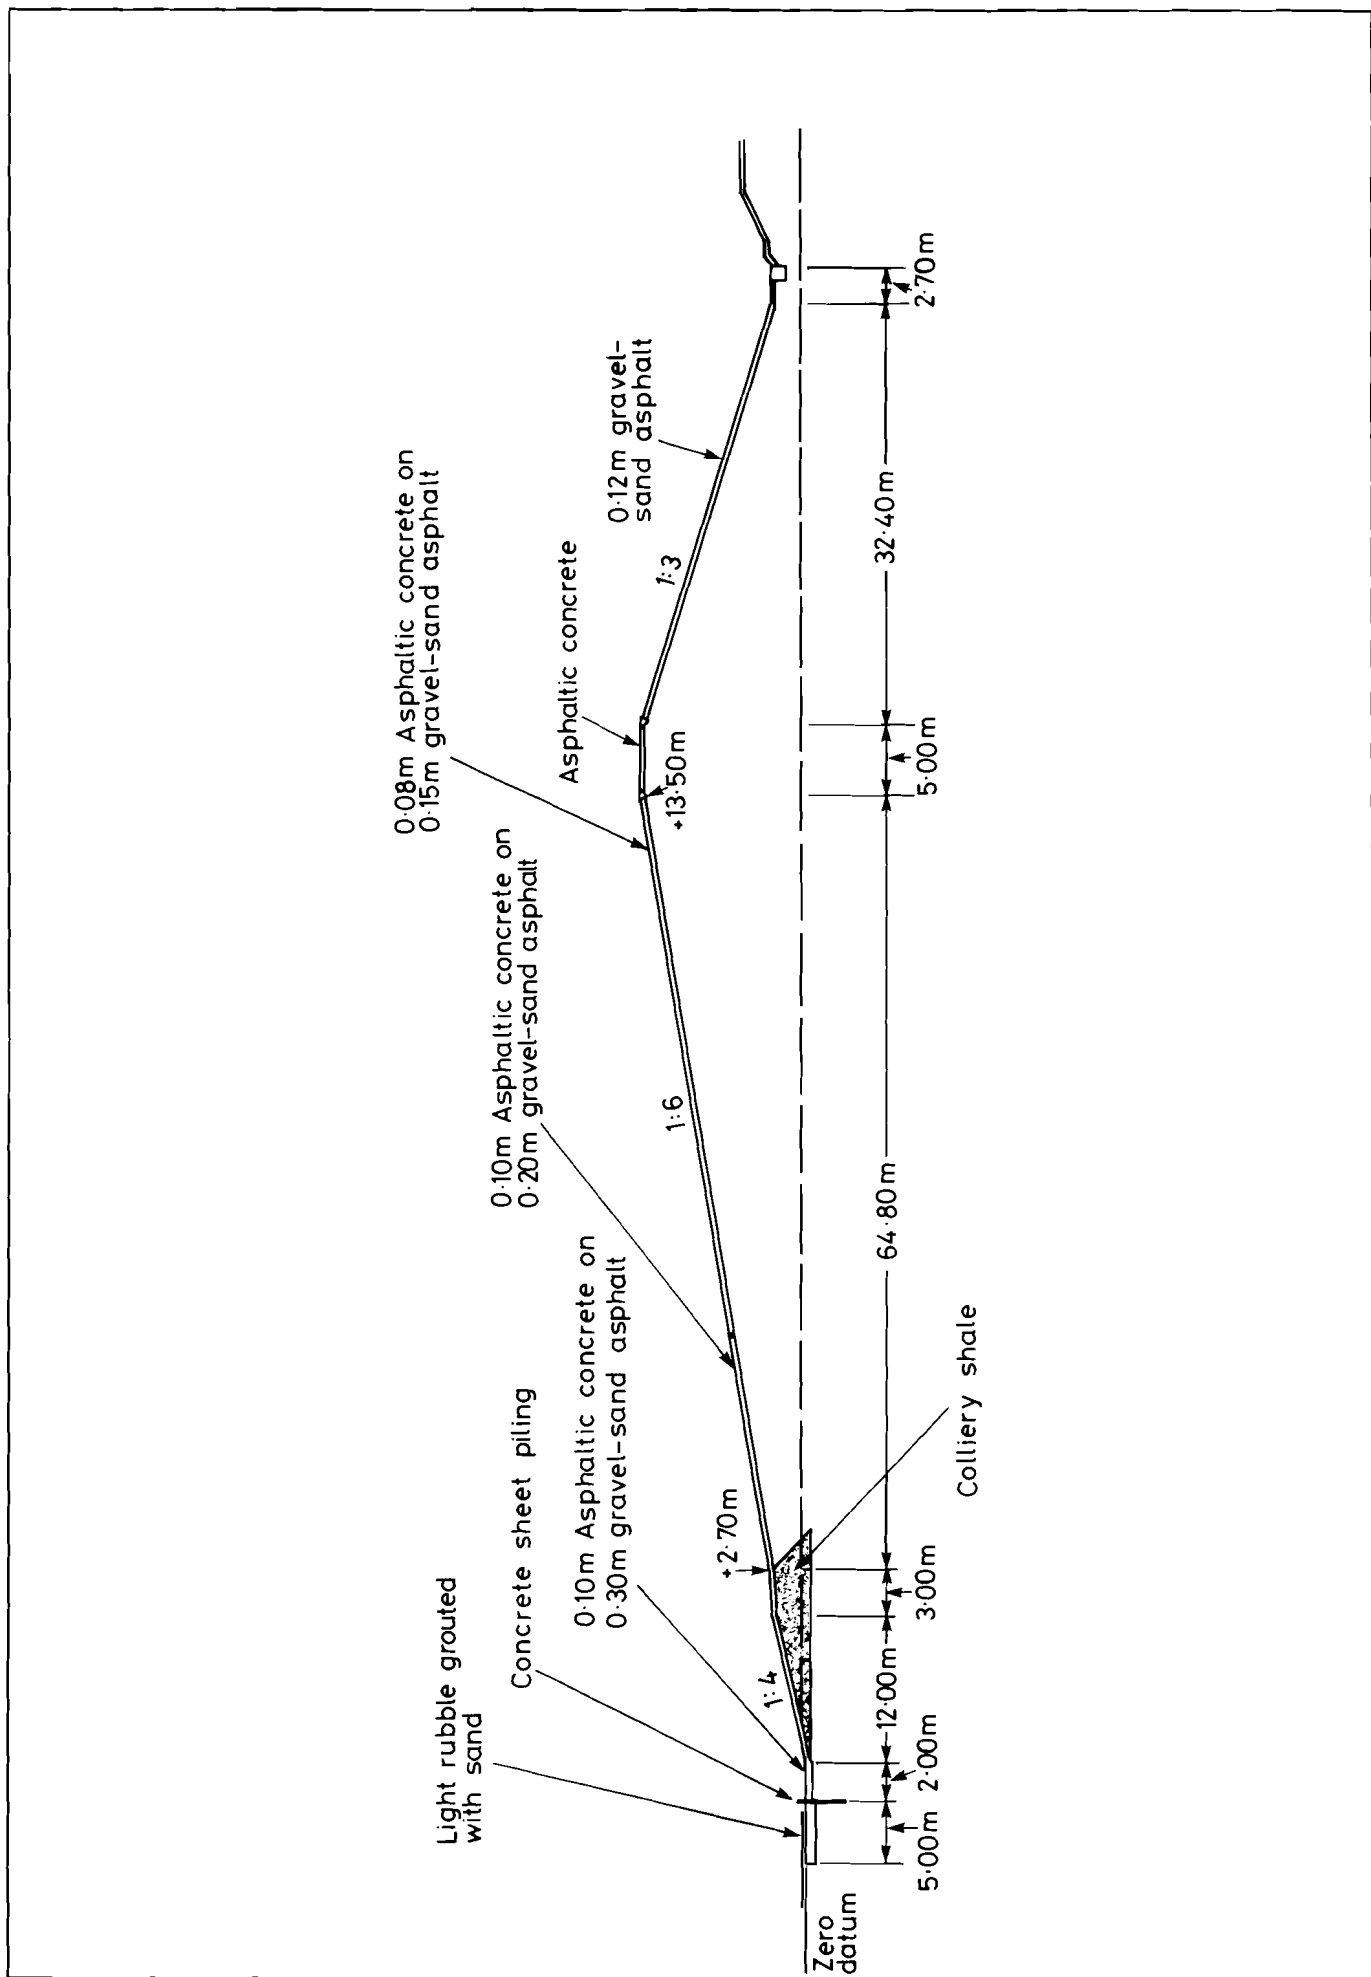
The Veersegat dam is situated at the north end of Walcheren and forms a connection to the island of Noord-Beveland. It is one of the main dams of the Delta project which was begun after the disastrous 1953 winter flood. The aim of the project is to strengthen the sea defences of the country and to shorten the coastline of the southern part of Holland. Veersegat dam consists essentially of a core of sand, dredged from the adjacent sea bed, with an asphaltic concrete skin, see Fig 3. The surface has been "blinded" by applying a course of shells and fine gravel and rolling these in while the asphaltic surface was still hot. The dam was finished in the late fifties and a wide sand beach and dunes were established to the seaward by artificial nourishment. As far as we can tell the concrete surface has not been exposed to wave action; it shows little sign of deterioration.

Fig 3 Section through Veersegat Dam, Holland

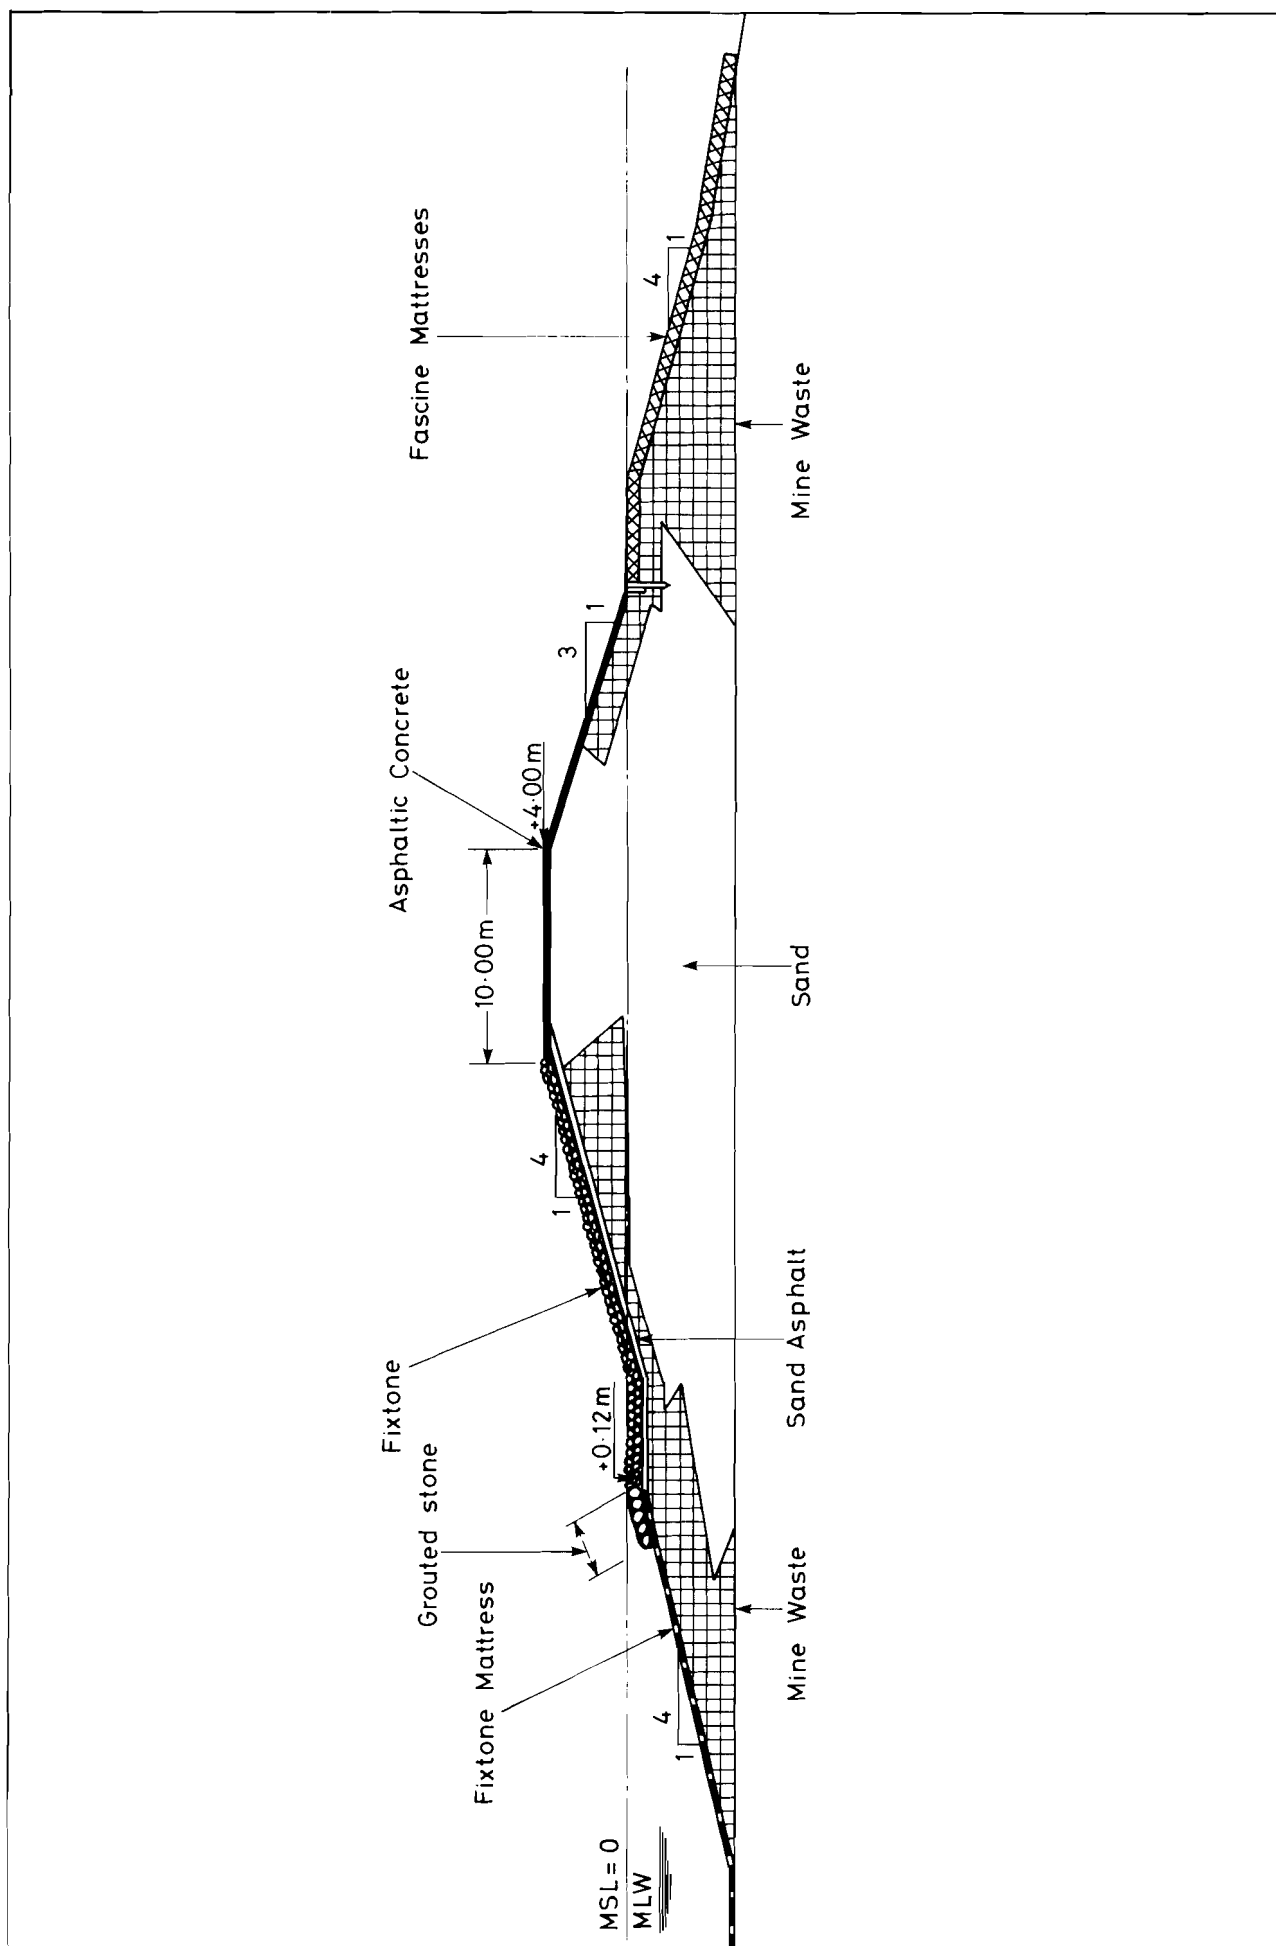
Fixtone laid in situ and in mattress form (see glossary). A typical section of one of the breakwaters is shown in Fig 4. All these revetments are of recent construction. They will be subject to varying degrees of exposure, facing both into the North Sea and into the more sheltered waters of the Eastern scheldt. The whole island is to be a showpiece of Dutch engineering expertise. It should not, therefore, prove to be difficult to obtain details of the performance of the various types of revetment from the Rijkwaterstaadt who will be maintaining these defences.

Fig. 4 Typical breakwater of the Eastern-Scheld, Holland, built in 1979

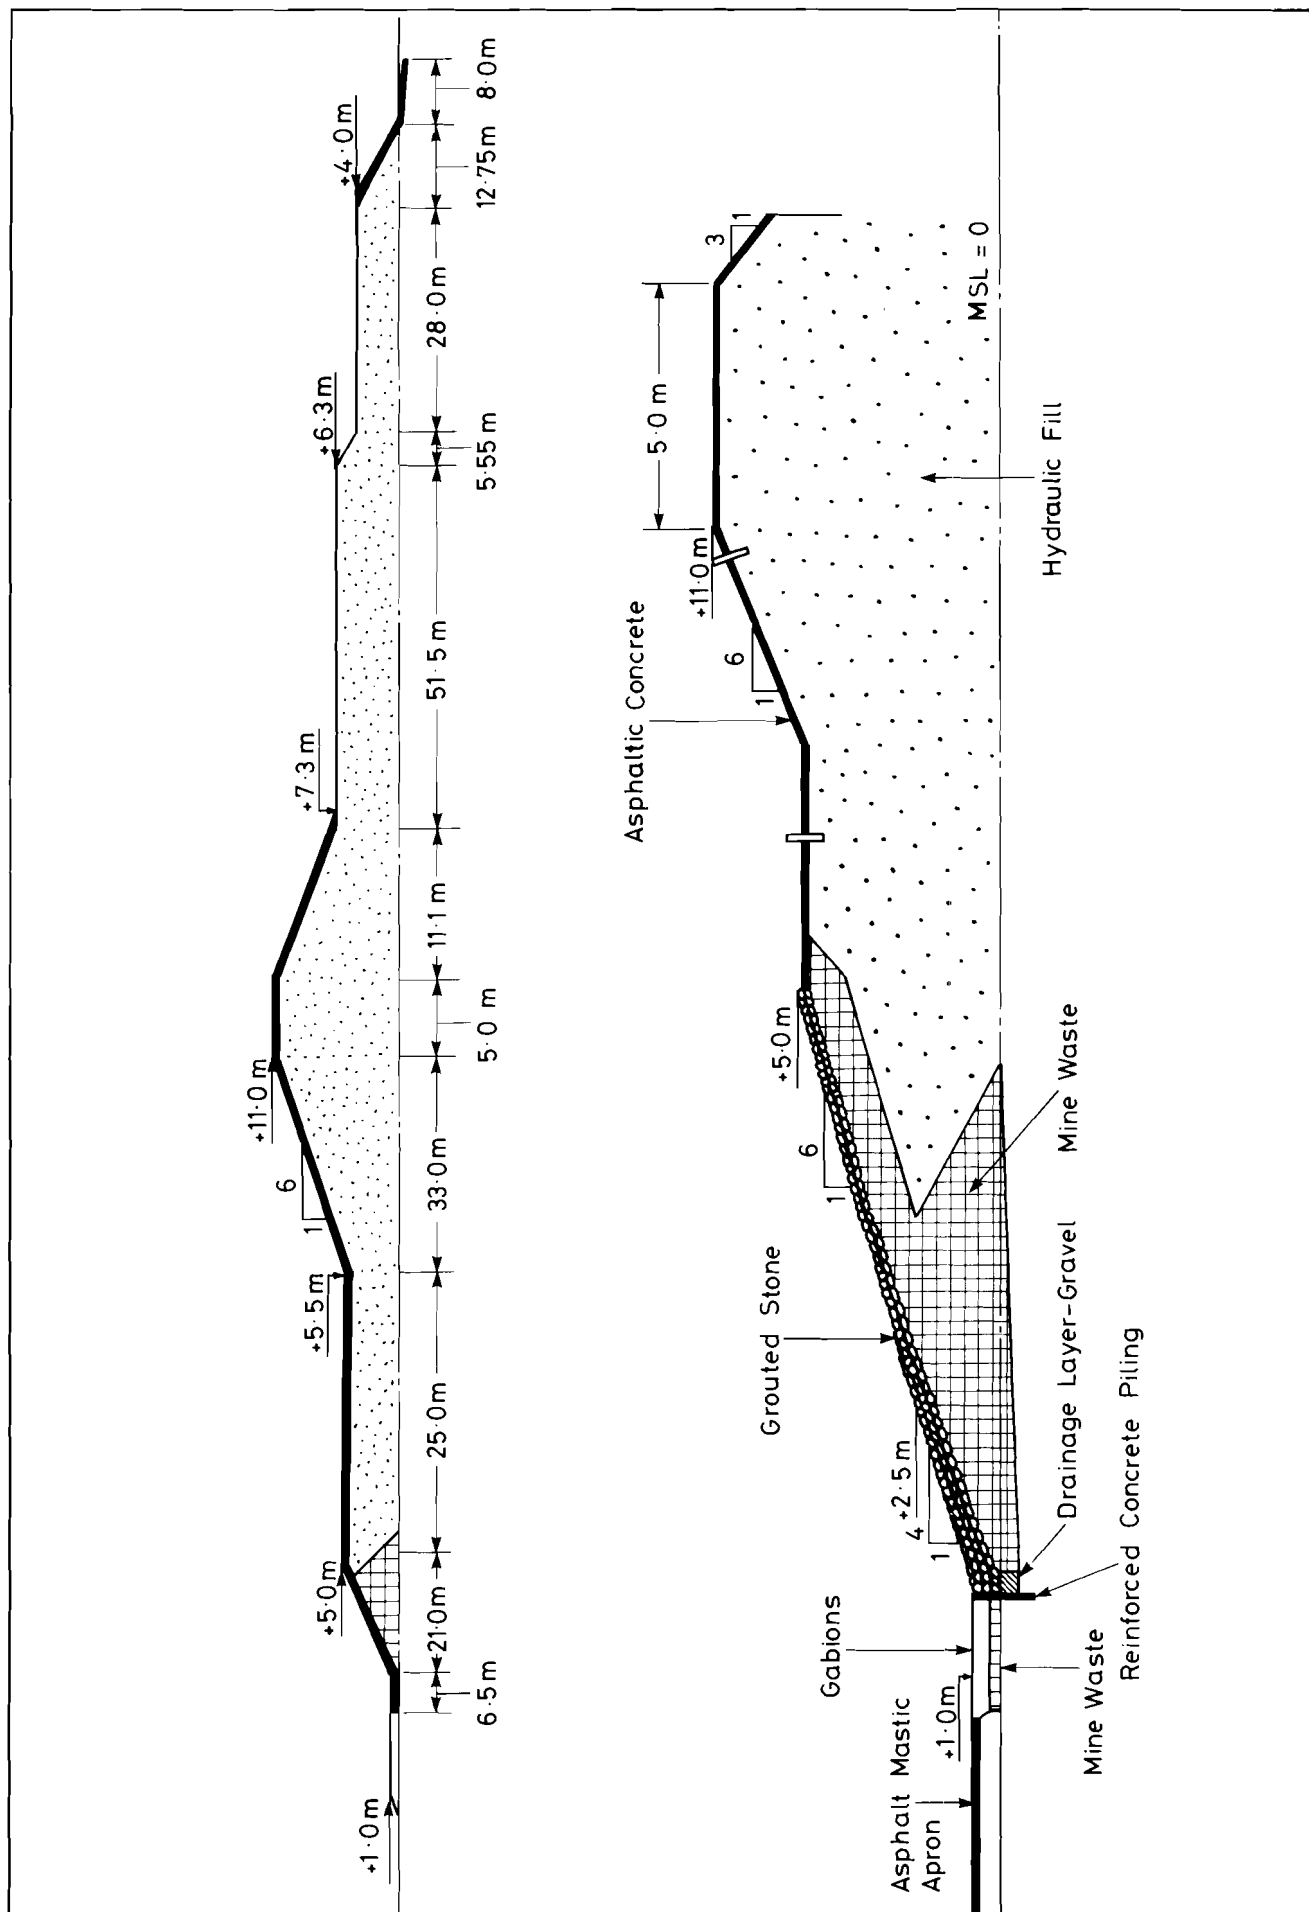
This is an enormous and impressive dam which is essentially a sand dyke covered with a skin of asphaltic concrete, see Fig 5 and Plate 5. The seaward toe of the dam is protected by a wide grouted stone revetment with gabions set into the toe for drainage (Plate 6). The dam connects the islands of Schouwen-Duiveland and Goeree-Ovevflakkee. Here again, as at Veersegat there is a belt of sand dunes on the seaward face. The belt is not continuous but where it disappears the foreshore is nevertheless wide and very flat and hence shelters the dam against severe wave activity. The toe of the dam is in very

Fig. 5 Cross section through closure dam at Brouwershaven, Holland

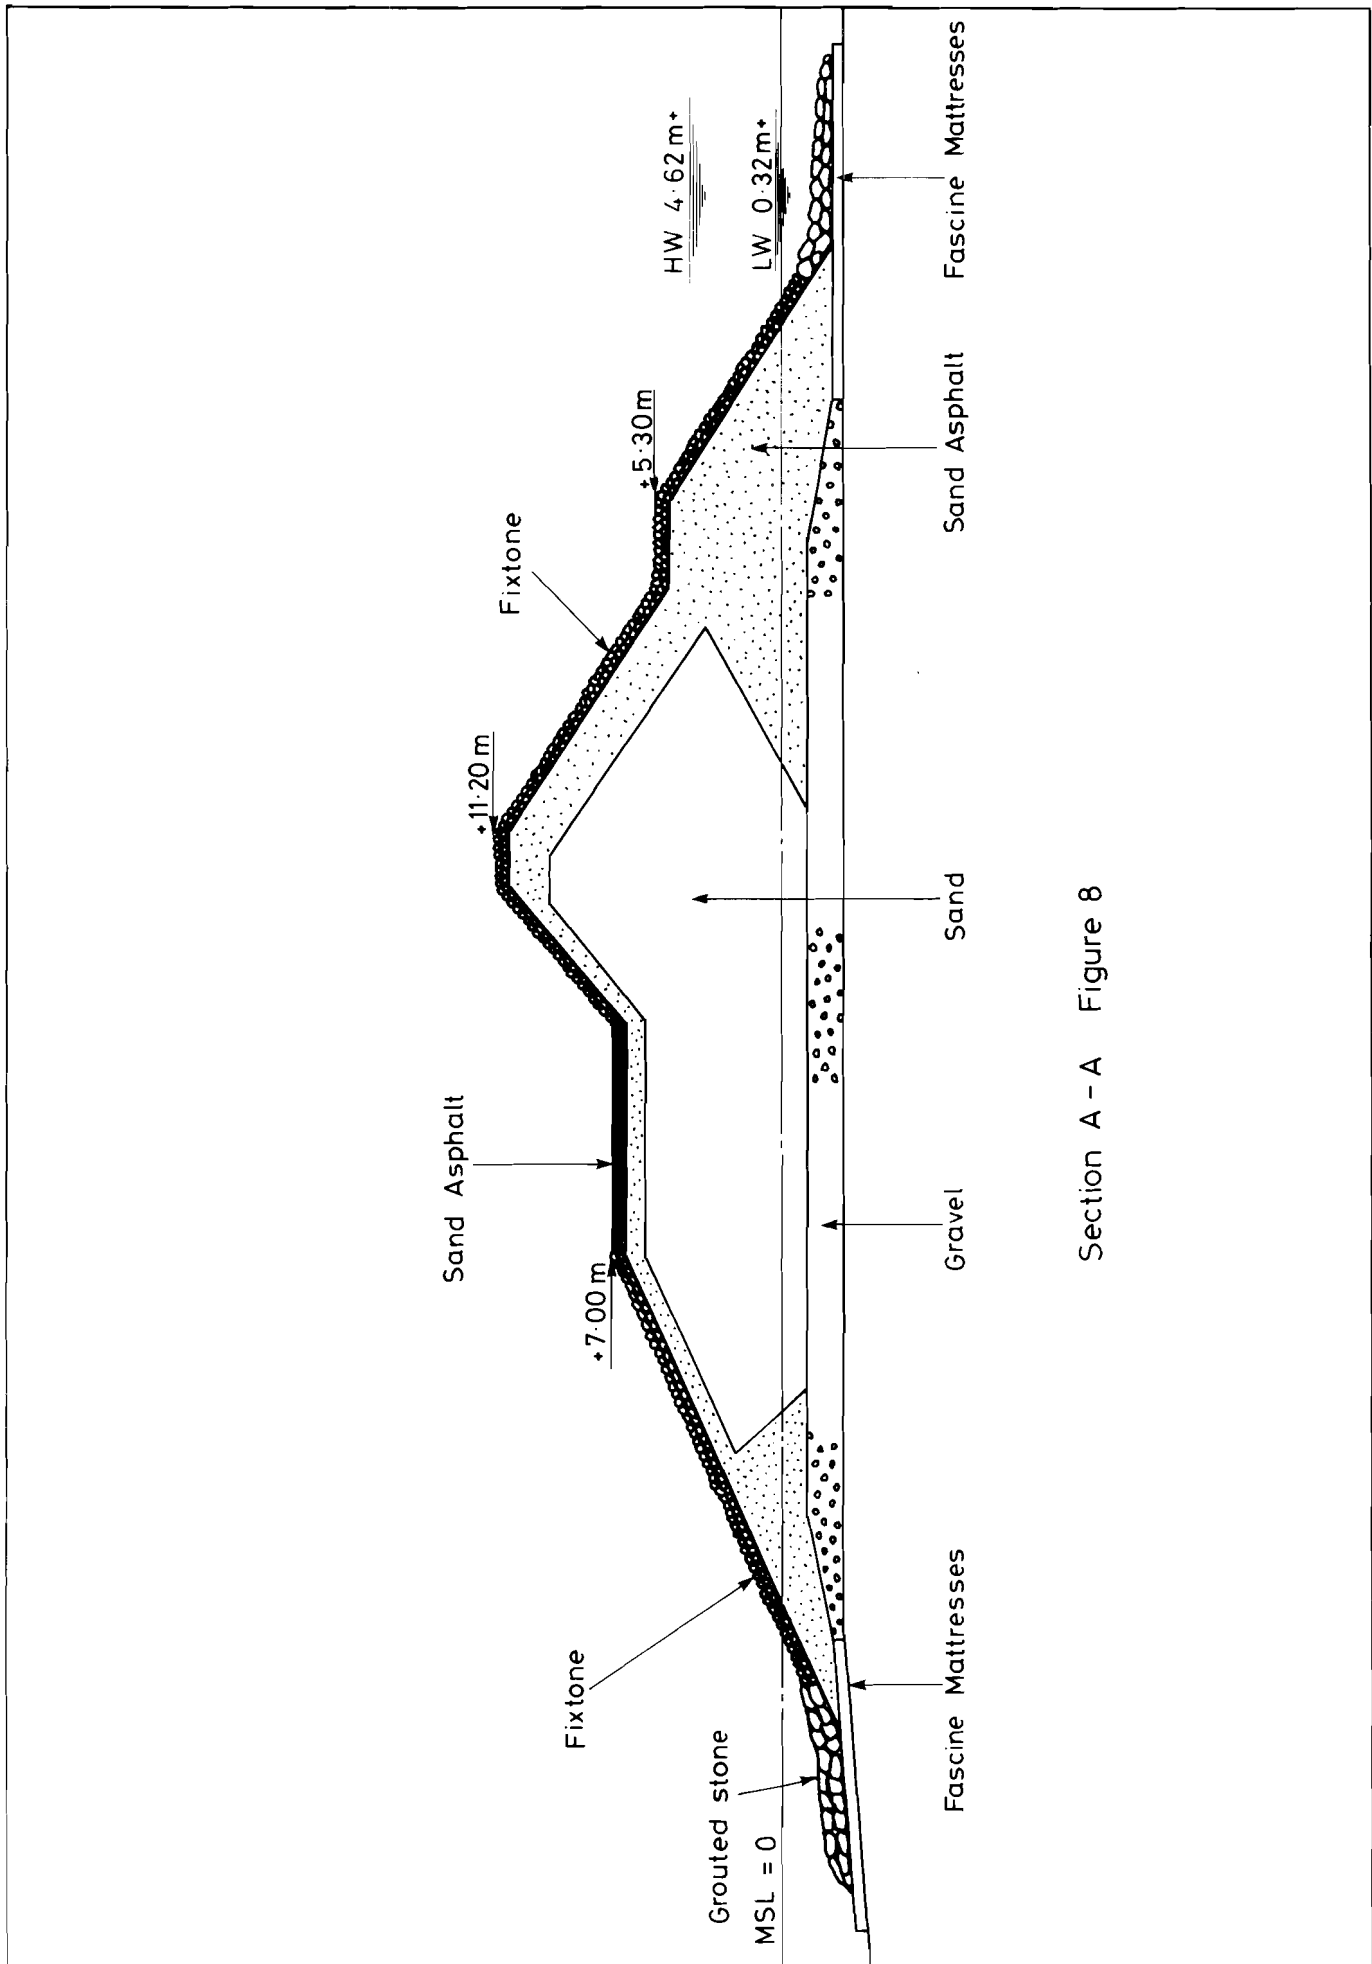
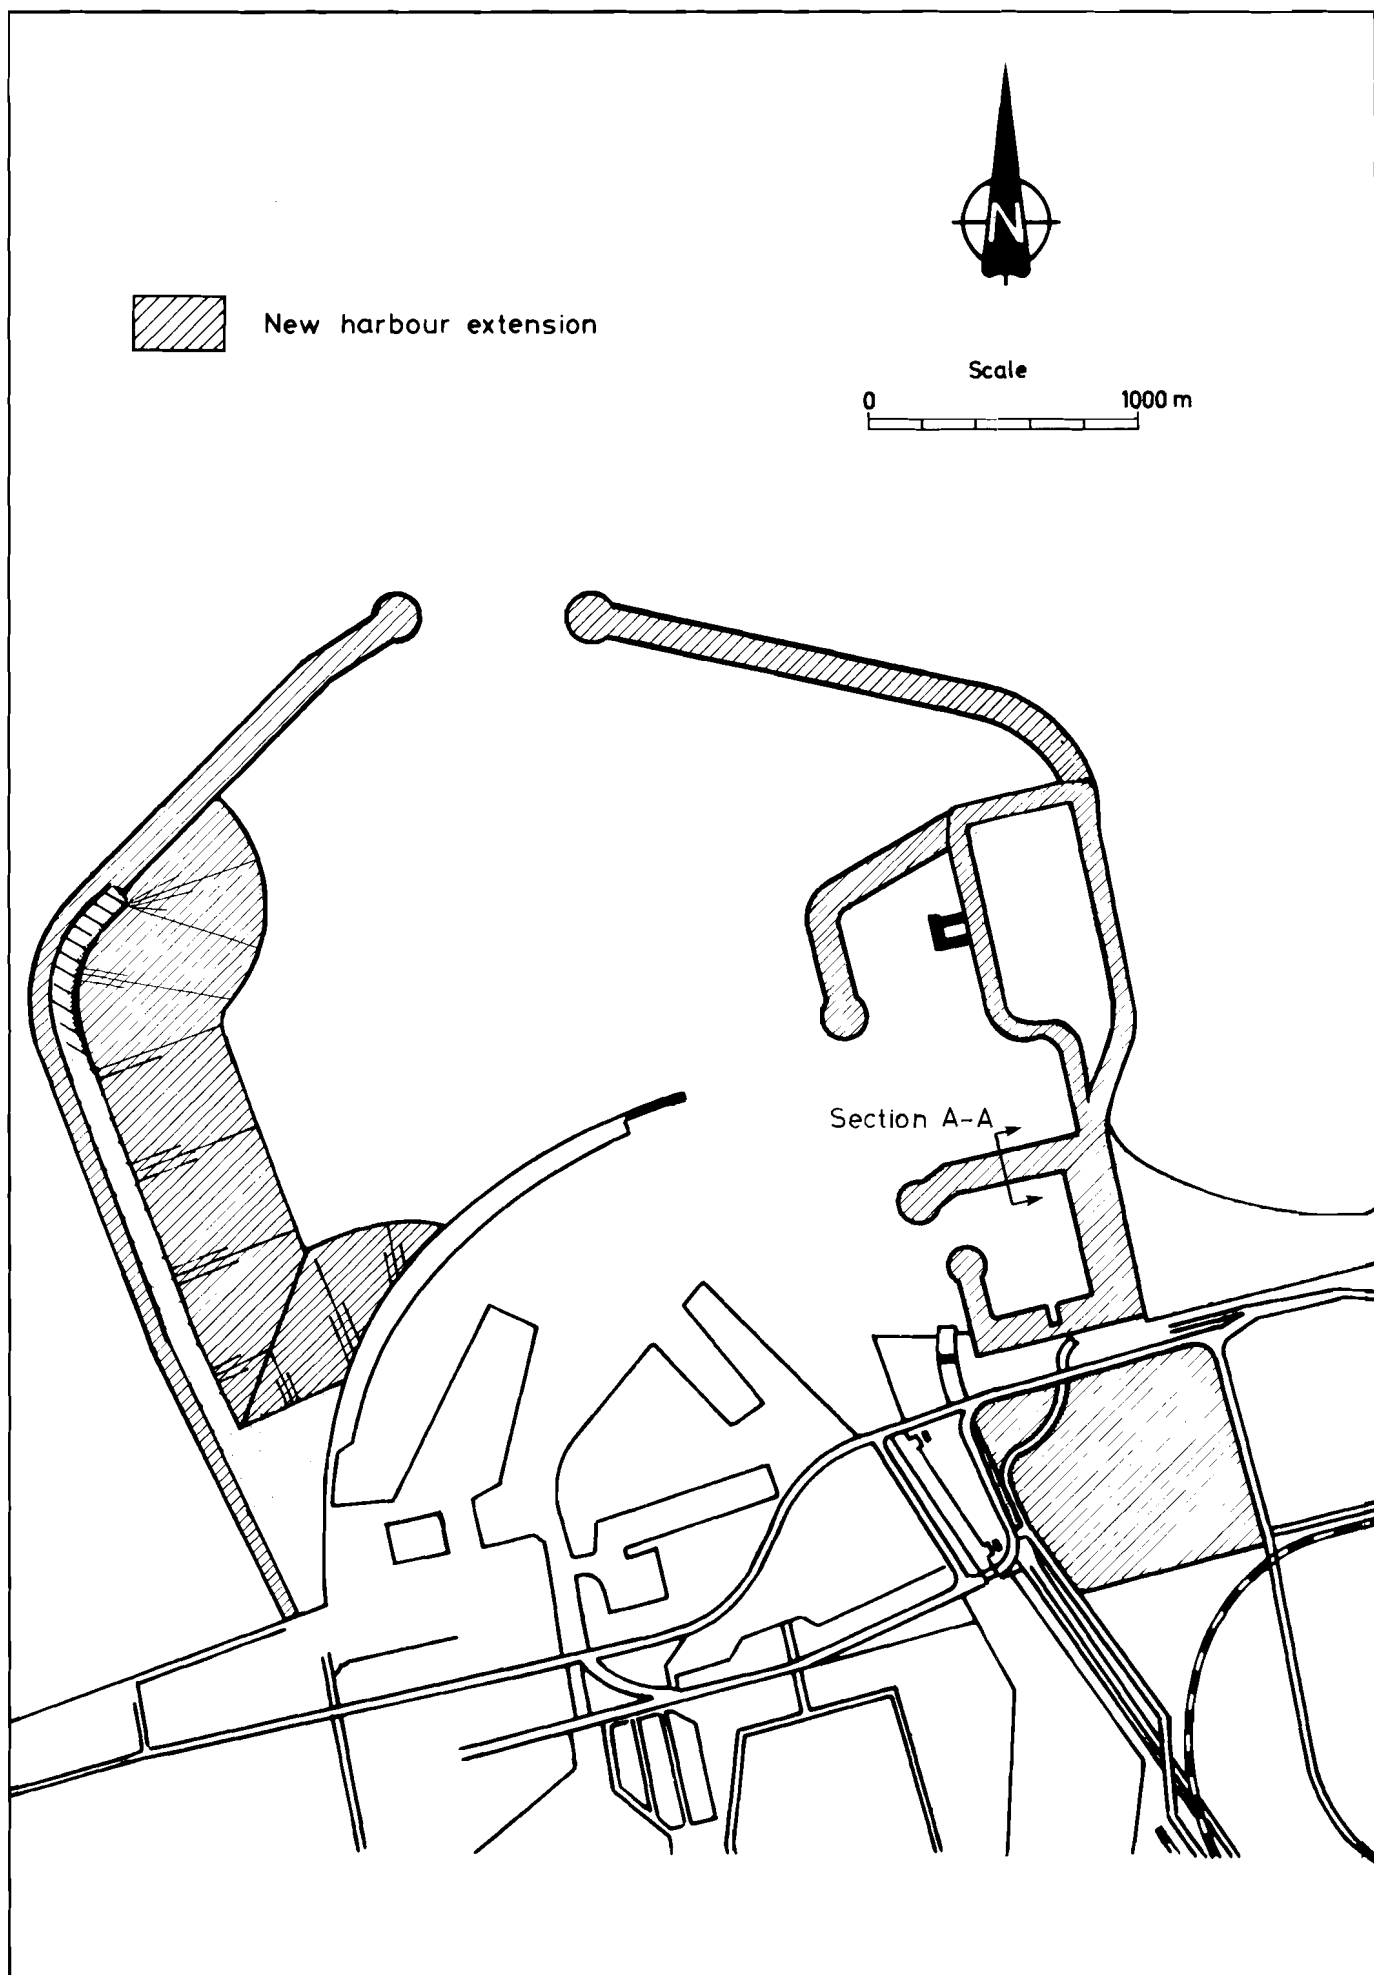
It was also interesting to see the use of Fixtone and asphaltic concrete for "inner" breakwater protection in the work harbour on the east side of the new harbour at Zeebrugge, see Figs 8 and 9 and Plate 15. All the asphaltic protection is of relatively recent date, the construction of the new harbour having only been begun in 1977. In relatively sheltered conditions Fixtone appears to be an alternative to rubble mound protection and is probably a cheaper protective covering than say a concrete or masonry revetment. Fixtone has the advantage of being able to be easily maintained and quickly constructed. Its ease of use is a positive advantage over many of the traditional methods of revetting used in the United Kingdom. (One must remember, however, that since it is permeable it requires a filter to prevent the leaching out of fines.) We feel that monitoring of the newly built Fixtone revetment would be useful since it may provide an alternative method to protecting embankments, the upper parts of sea walls, etc., in the UK.

Fig. 8 Breakwater at Zeebrugge, Belgium, built 1979

Fig. 9 Zeebrugge Harbour, Belgium

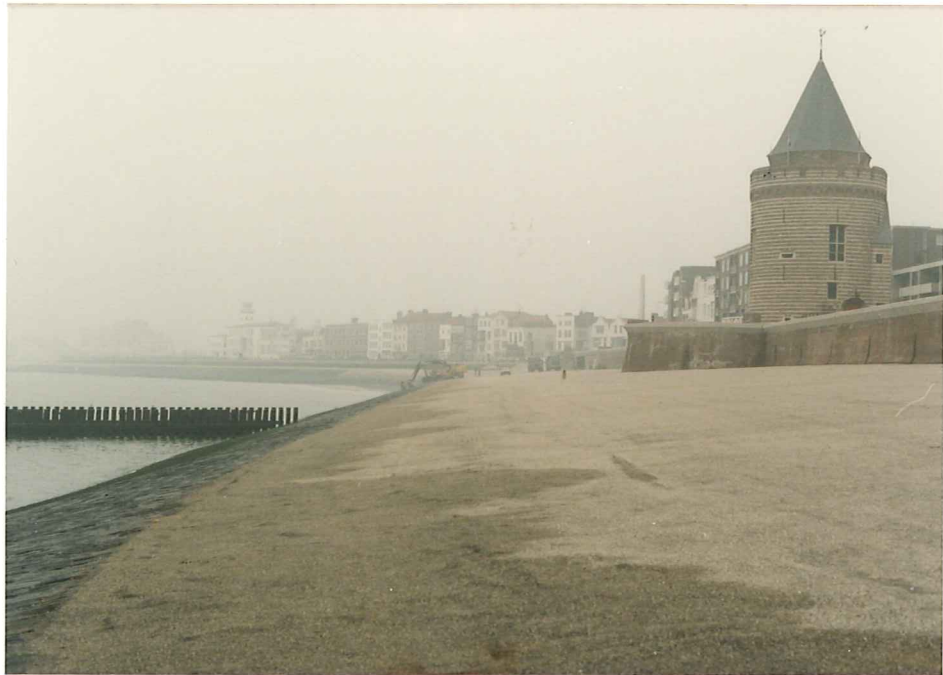
area seen in Plate 1 shows the height to which the water level rose at the previous high water (approximately mid-way between neap and spring tides).

and has required maintenance, as can be seen in Plates 1 and 2 of this report. The profile of the Vlissingen revetment was tested in the hydraulics laboratory at Delft using regular waves. It is now generally accepted that regular waves do not represent the real sea state at all well. The asphaltic revetment presently under construction at Porthcawl, South Wales, was tested in the laboratory using random waves, albeit at a small scale. In our opinion assessment of the hydraulic performance of asphaltic structures is better made from site inspection of structures already in existence. There are also "structural" problems in the design of new asphaltic revetments. The two course form of construction used at Vlissingen is not recommended and at Porthcawl the asphaltic concrete is being laid as a single layer. While there are now more efficient binders to seal adjoining layers, the single course construction avoids problems such as the intrusion of water or wind blown sand which can destroy inter layer cohesion. For fast, effective laying down and compaction of an asphaltic concrete surface in the temperate climate of Europe single layer construction where possible is strongly recommended.

Plate 1 Vlissingen. Brick sea wall protected by a wide asphaltic concrete revetment.

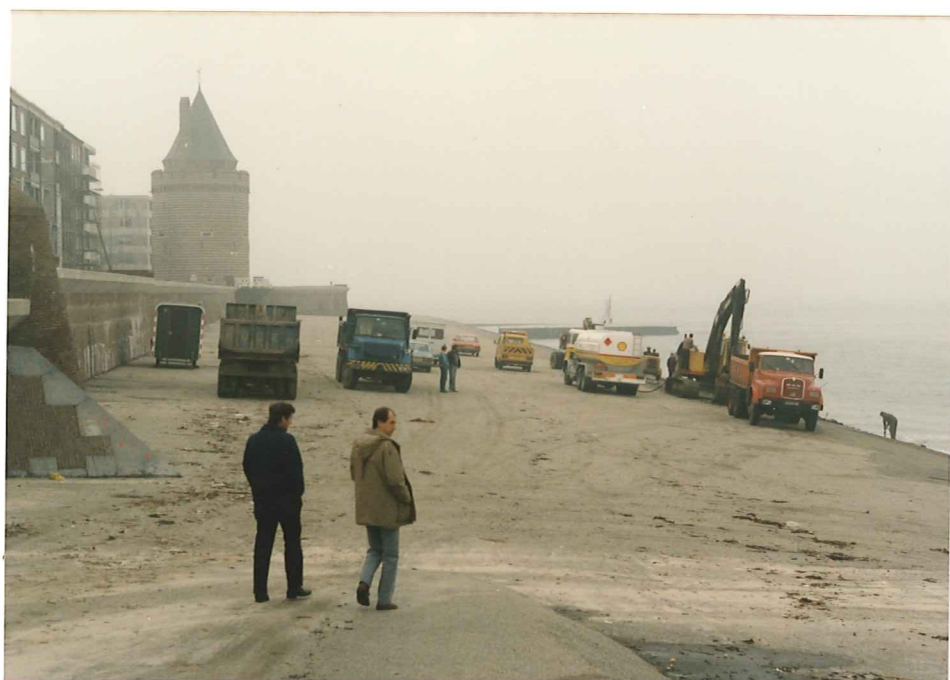
When we inspected the revetment it was clear from the position of the trash lines that wave run up does reach the base of the wall during storms, see Plate 2. The asphaltic concrete surface was in good condition, although some separation of the two asphaltic concrete layers had taken place locally. Because of the relative ease of repair it was difficult to determine how much wear and tear the surface had been subject to over the years. Also the surface had a blinding coat of crushed gravel. This tended to make it even more difficult to spot any repairs that may have been made. The hand pitched basalt set on the lower part of the revetment had obviously been damaged by wave action. Maintenance was in fact being carried out at the time of the visit (Plates 1 and 2). Because of the state of the tide it was not possible to inspect the rubble base of the revetment. Since the revetment has been protecting the sea wall for about 25 years one would assume that the coast protection authority has been satisfied with its performance. Although our assessment was quite clearly subjective, this type of construction looked impressive. It would be useful to know more about the history of maintenance of this revetment and its hydraulic performance from the authority responsible for coast protection in this area. We feel that further gathering of information is vital, particularly in view of the fact that a not too dissimilar scheme is now under construction at Porthcawl. The Porthcawl revetment will also need to be monitored carefully. The performance of these two schemes should indicate whether this type of revetment is a viable alternative to the more traditional methods of construction used in the United Kingdom.

Plate 2 Vlissingen. Repairs to asphaltic concrete revetment.

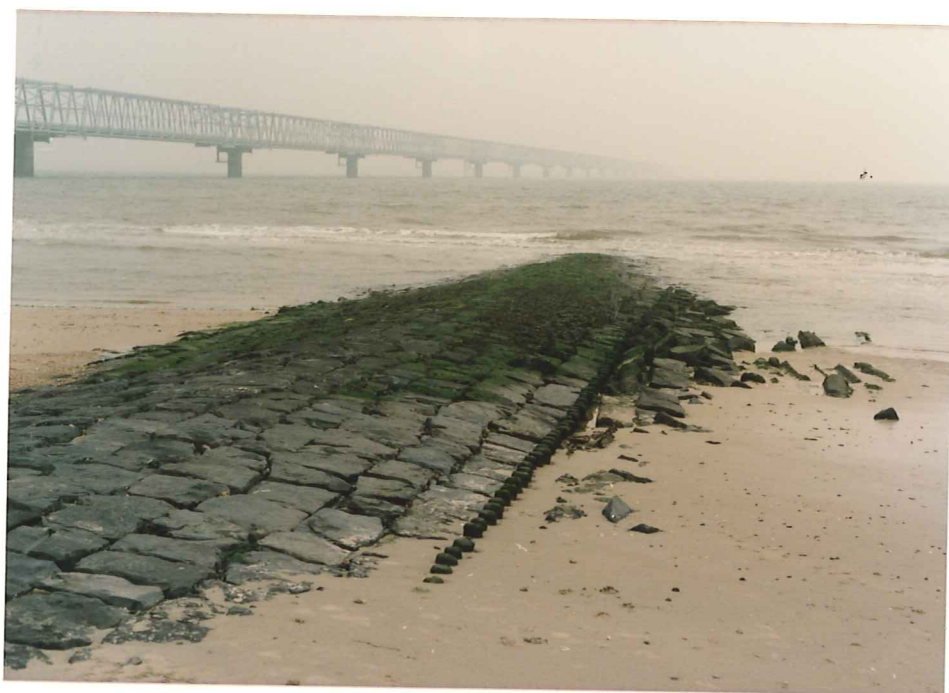
The south-west facing coastline of the island of Schouwen-Duiveland has a number of basalt groynes which have clearly been in place for several decades, see Plate 3. These groynes cross a wide sand foreshore and appear to be partially arresting littoral drift which in this area is in a net north-west to south-east direction. Because of their low profile they do not appear to have trapped large quantities of sand but seem to have been effective in maintaining stable beach levels. The dunes are protected by a sloping asphaltic concrete revetment with a toe of grouted stone, see Plate 4. The asphaltic concrete is beginning to show signs of deterioration. Further north-west, where the dunes face the open sea and where the foreshore increases in width beach protection consists of groynes but the dunes are unprotected. Attempts are being made (by means of brushwood fencing) to make good wind induced erosion. Erosion is slight and the dune stabilization measures stand a fair chance of success.

Plate 3 Westenschouwen. Low profile type stone groyne.

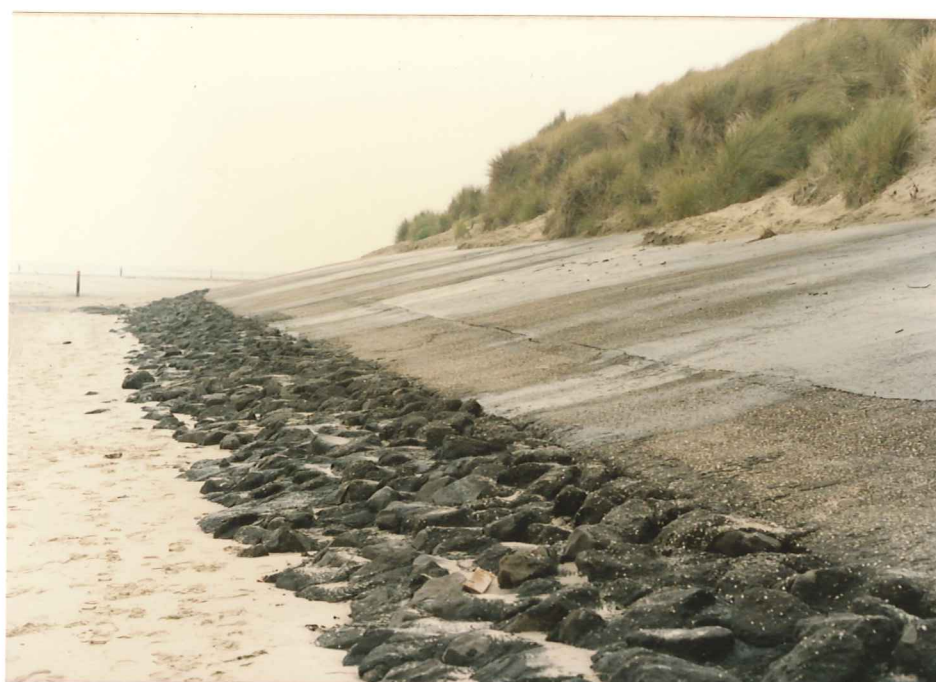
Plate 4 Westenschouwen. Asphaltic protection to toe of dunes.

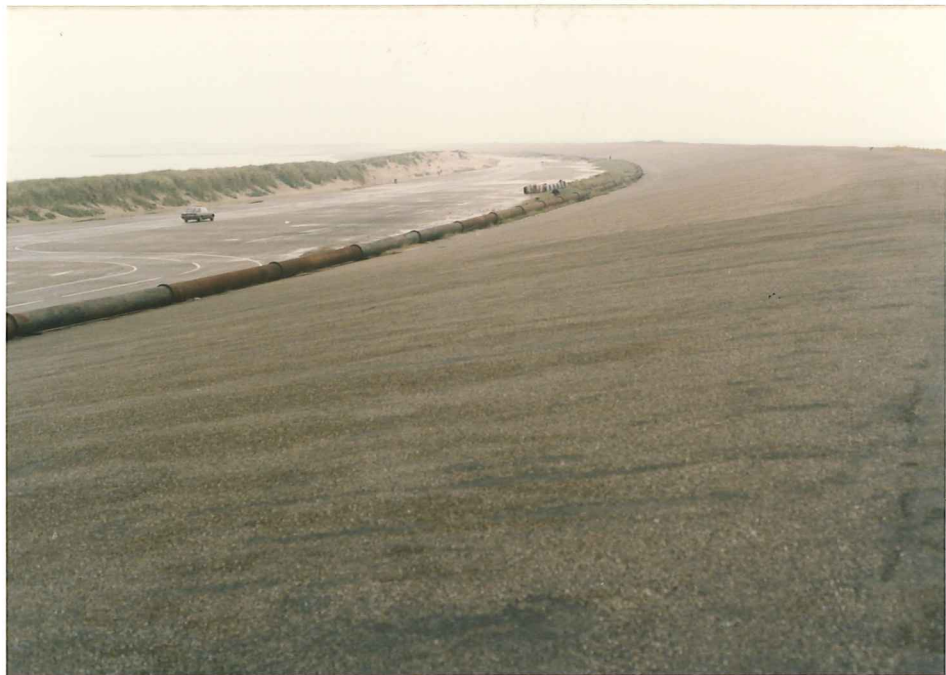
Plate 5

Brouwersdam. Southern end. Artificial sand nourishment and dune development seaward of dam.

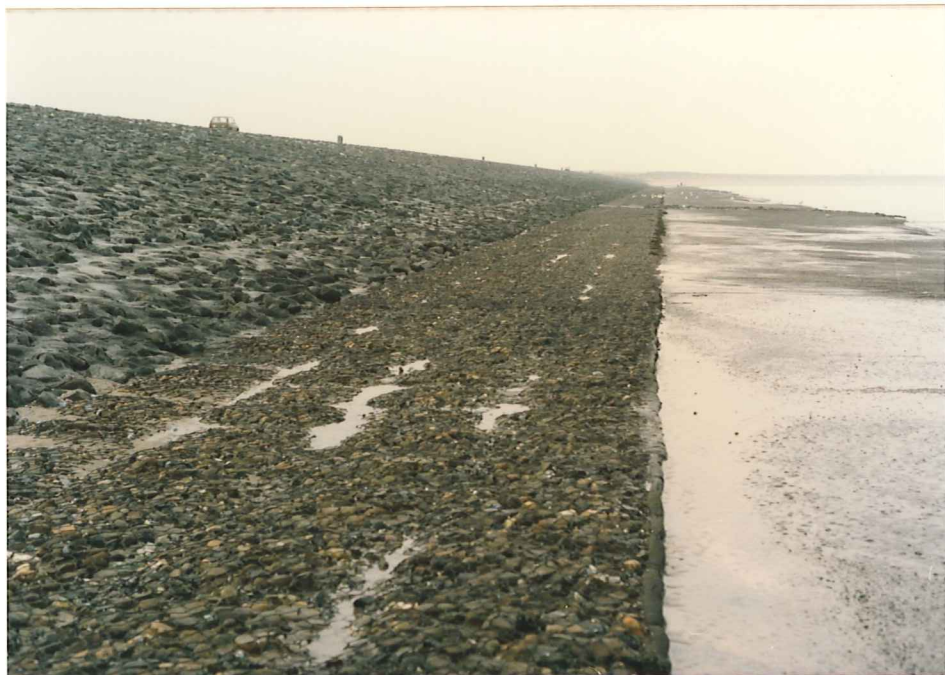
Plate 6

Brouwersdam. Northern end. Asphalt grouted stone armouring, gabion drainage layer and flexible sand asphalt toe.

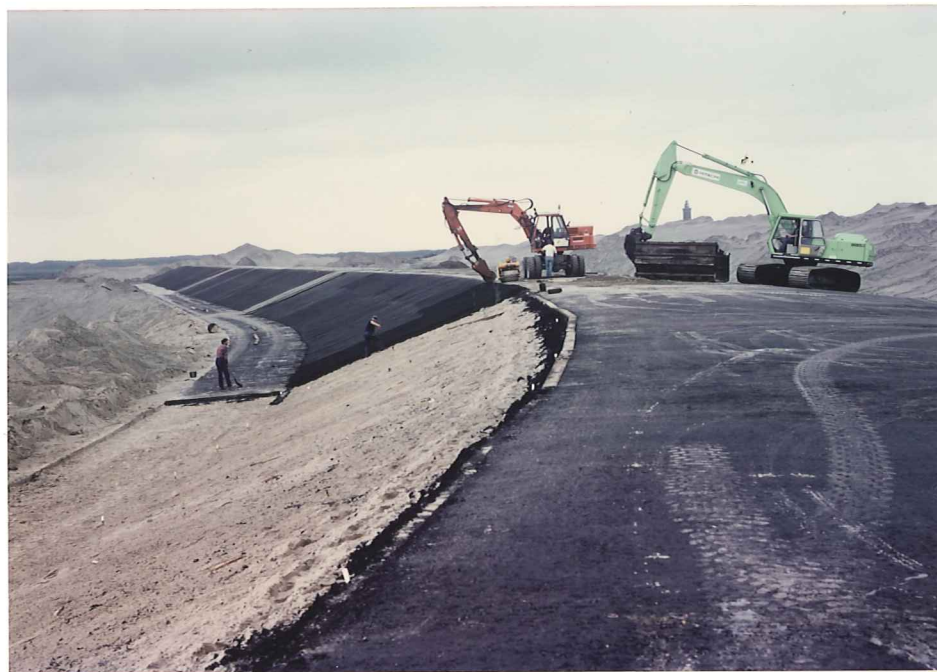
Plate 7

The sea defences in this area are being upgraded and an asphaltic concrete revetment is being constructed over a sand core, see Plate 7. For protection against wave attack during the construction stage a line of temporary bunds were built some distance to the seaward. Shortly before our visit the bunds were overtopped by wave action although no damage, as far as one could tell, was done to the revetment. The area will clearly be subjected to wave attack, unless massive sand nourishment is carried out on the foreshore. The performance of the asphalt grouted stone at the toe of the revetment (Plate 8) will be well worth monitoring in future years.

Ouddorp. Surfacing of the landward face of the sand dyke using asphaltic concrete.

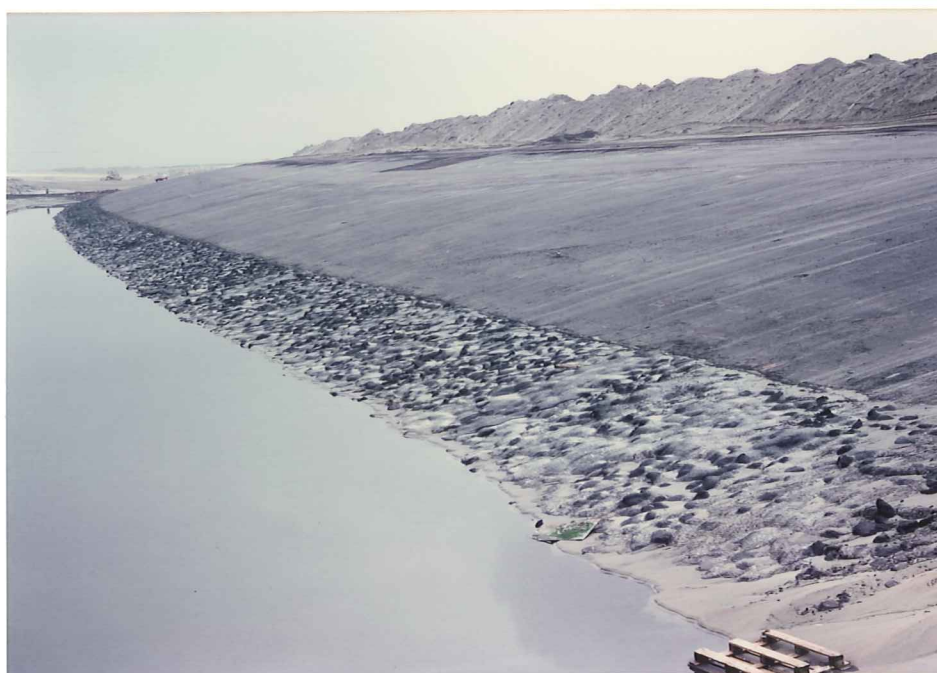
Plate 8

Ouddorp. Asphalt grouted toe to seaward face of dyke.
