A REVIEW OF NOVEL SHORE PROTECTION METHODS

Inspection of sea defences in Holland
and Belgium
17 to 21 September 1984

Report No SR 6
December 1984

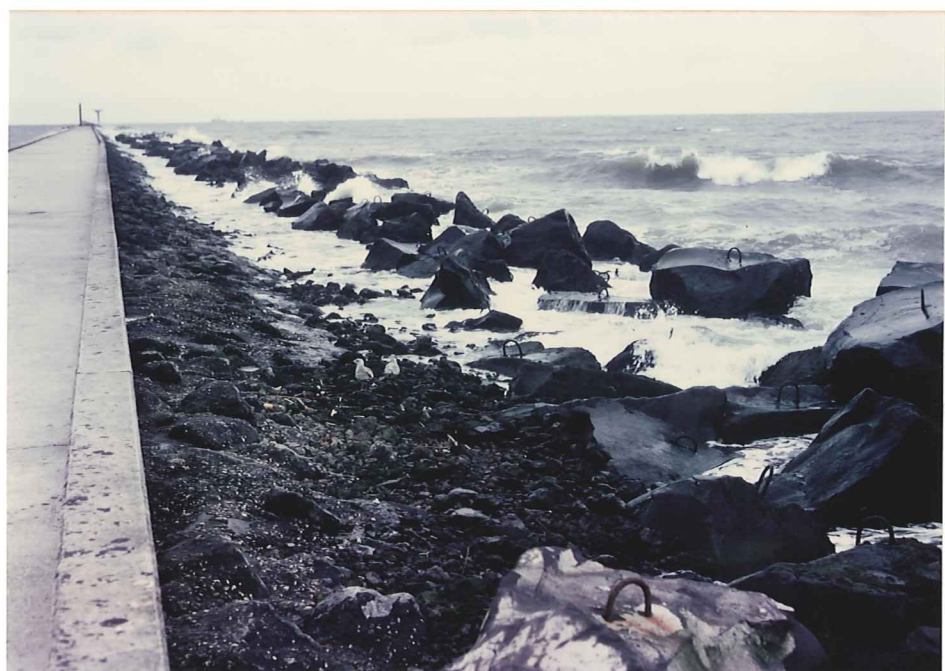
The asphaltic grout of the breakwater shows surface deterioration, but it still seems to be performing satisfactorily. The seaward end of the breakwater is in relatively deep water and wave attack is such that the rock core has had to be protected by armouring with very large precast concrete cubes. These are randomly placed and their movement subsequent to construction is being monitored. Monitoring consists of recording the position of a number of the blocks which have been painted so as to resemble giant dice! Presumably their position is determined by means of aerial photography.

Plate 10 Hoek van Holland. North breakwater protected by asphalt grout and by a reef of large rocks.

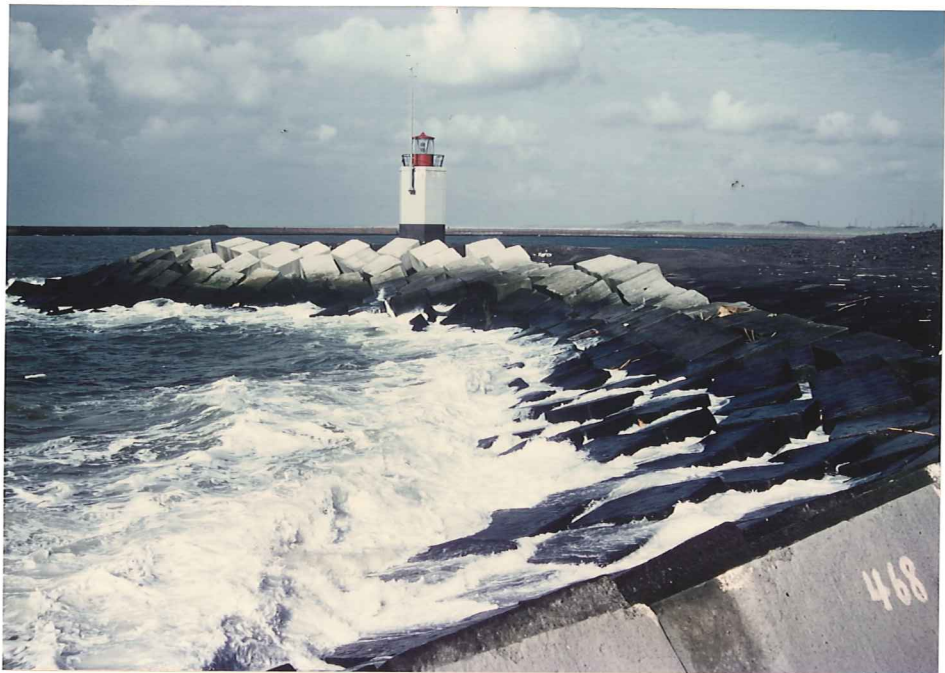
relative exposure to wave action along the length of the breakwater.) Plate 13 shows cubical armour blocks protecting a spur breakwater on the south side of the harbour.

Plate 13 Ijmuiden. Spur breakwater armoured with large concrete armour units.

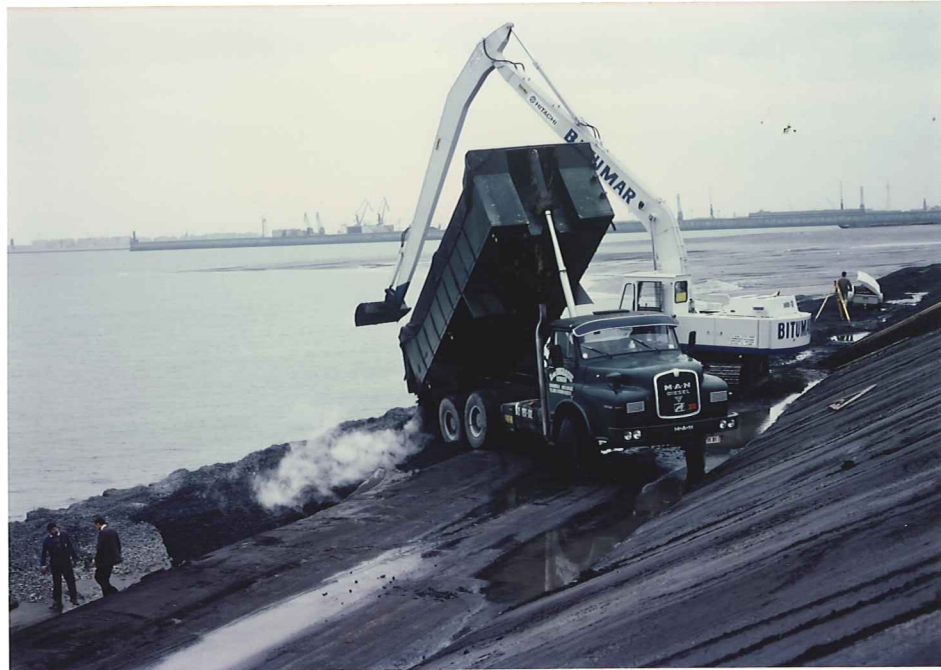
Plate 15

It was also interesting to see the use of Fixtone and asphaltic concrete for "inner" breakwater protection in the work harbour on the east side of the new harbour at Zeebrugge, see Figs 8 and 9 and Plate 15. All the asphaltic protection is of relatively recent date, the construction of the new harbour having only been begun in 1977. In relatively sheltered conditions Fixtone appears to be an alternative to rubble mound protection and is probably a cheaper protective covering than say a concrete or masonry revetment. Fixtone has the advantage of being able to be easily maintained and quickly constructed. Its ease of use is a positive advantage over many of the traditional methods of revetting used in the United Kingdom. (One must remember, however, that since it is permeable it requires a filter to prevent the leaching out of fines.) We feel that monitoring of the newly built Fixtone revetment would be useful since it may provide an alternative method to protecting embankments, the upper parts of sea walls, etc., in the UK.

Zeebrugge. Construction of Fixtone revetment over a sand asphalt core.
