Successful Overtopping Protection Projects in the Eastern U.S.

T. Hepler¹, J. Young², B. Crookston², and J. Crowder³

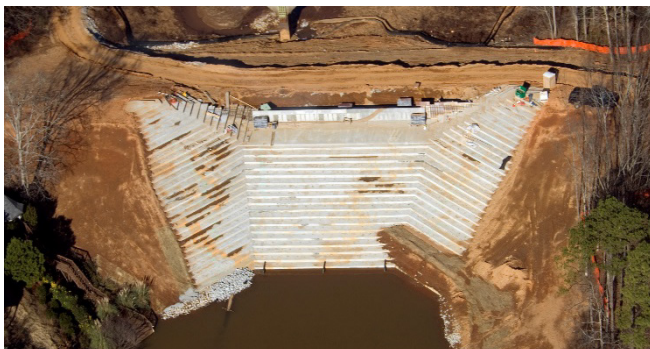
Figure 1. Y-16 Dam RCC Protection during Construction.

Construction on the US\$1.8 million rehabilitation project began in July 2007, with final completion in February 2008. Approximately 2,300 m³ of RCC were delivered from an off-site plant and placed in 0.3 m thick horizontal lifts during construction.

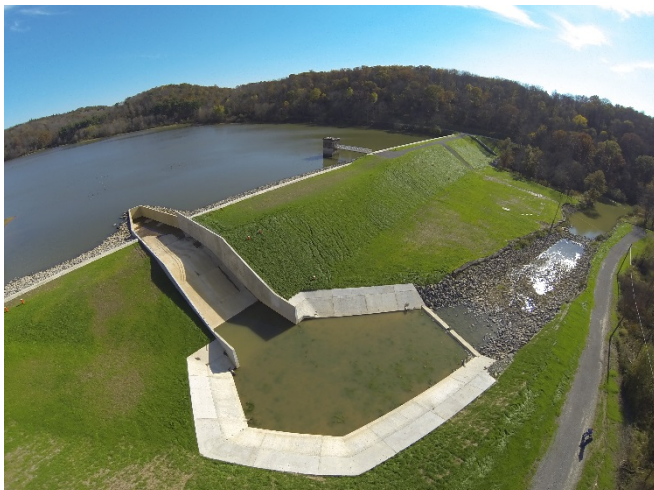
Figure 2. Lake Oneida Dam with Buried RCC Protection.

Construction was completed with a fully operational pool in 2013. The total RCC volume placed was about 11,000 m³, with a unit price of US\$133.

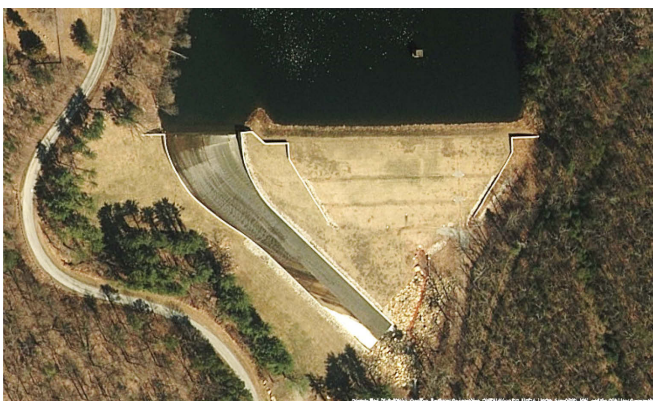
Figure 3. Stoney Creek Dam with Buried RCC Protection.

Four standpipe piezometers were installed through the RCC overtopping protection to permit monitoring of the phreatic surface within the dam embankment. Construction was successfully completed in May 2012 for a final cost of US\$5.3 million. Total volume of the RCC overtopping protection was 7,600 m³.

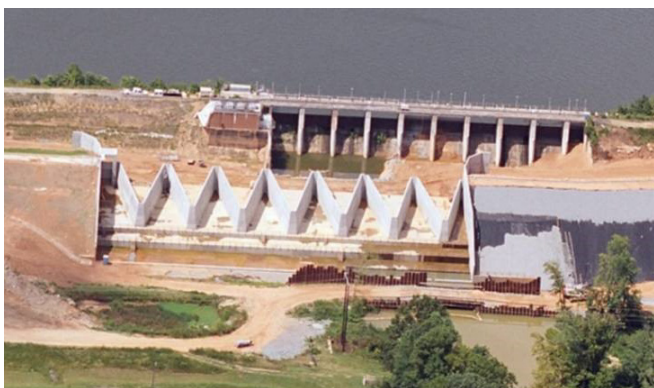
Figure 4. Lake Townsend Dam during Construction (ACBs being placed on both sides of new concrete labyrinth spillway).

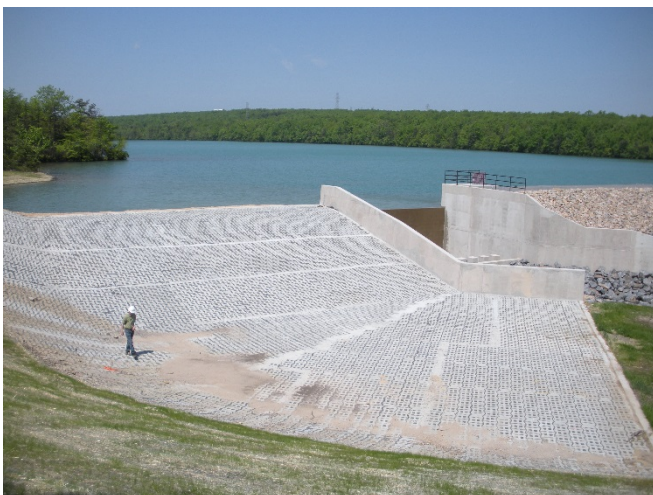
Figure 5. Mount Laurel Dam with ACB Armored Spillway.

The ACB armored auxiliary spillway was designed for 1.2 m of overtopping following methods presented in National Concrete Masonry Association’s (NCMA) *Articulating Concrete Block Revetment Design – Factor of Safety Method, TEK 11-12* (NCMA, 2002). The auxiliary spillway was constructed to the right of the replacement spillway using 15 cm thick, open cell, tapered ACBs (ShoreBlock SD-900 OCT). The upstream edge of the ACBs were cast into a concrete starter wall that was constructed integral with a sheet pile cutoff driven to rock. Minor rock excavation was necessary on the right side of the spillway, but the rock was generally rippable. At the downstream terminus, a concrete cutoff was constructed on rock. Construction was completed with a fully operational pool in 2013 for US\$3.9 million. Approximately 750 m² of ACBs were installed.

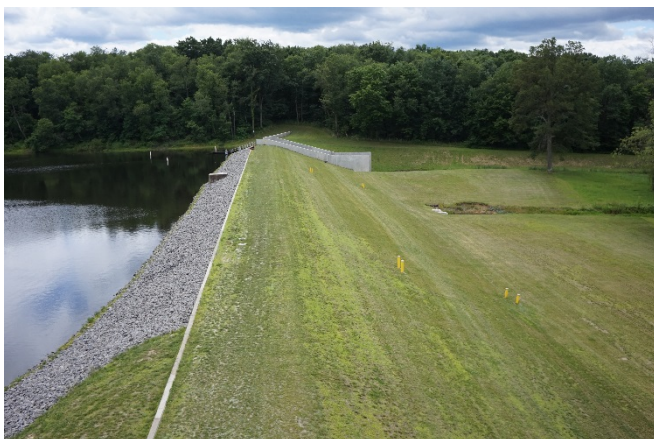
Figure 6. Glade Run Lake Dam with ACB Armored Slope.

Construction was completed with a drained reservoir in 2016 for US\$2.9 million. Approximately 4,800 m² of ACBs were installed and covered with seeded topsoil.

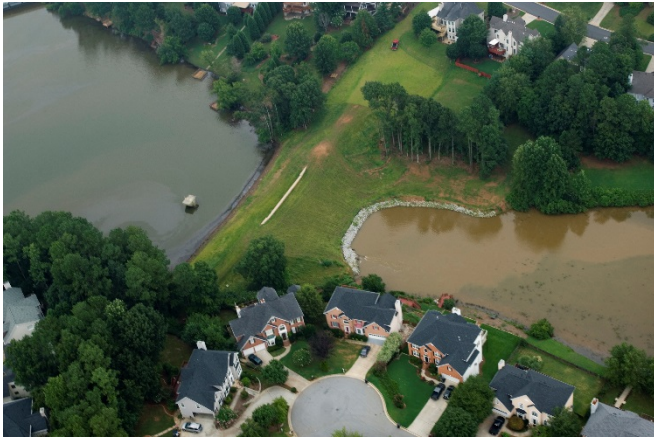
Representatives of Schnabel performed a site reconnaissance on September 21, 2009 to observe the condition of the Y-16 Dam. Figure 7 shows water discharging from the storm events in the preceding hours. A subsequent reconnaissance was performed after flow ceased to inspect the integrity of the RCC section. The riprap, which separated the topsoil from the normal pool of Taylor Lake, had also been removed by the flow over the spillway. The extension pipes for the internal drain outlets, which extended through the riprap, had also been removed by the flow. The extension pipes were designed to be sacrificial, should the spillway engage. No damage to the RCC was noted. Figure 8 shows the exposed RCC section after the discharge over the auxiliary spillway had ceased.

Figure 7. Y-16 Dam Following RCC Modifications.

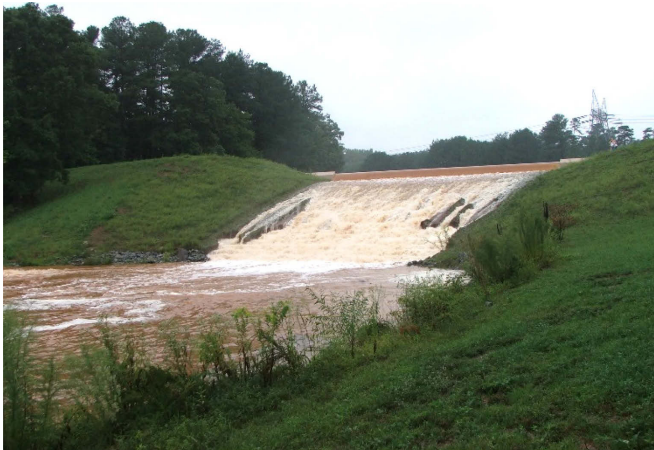
On September 20 and 21, 2009, Gwinnett County, as well as other parts of northern Georgia, experienced exceptionally high amounts of intense rainfall. During this rainfall event, stormwater runoff within the Yellow River Basin was discharged from the reservoir through the RCC auxiliary spillway at Y-16 Dam. This discharge resulted in erosion of the layer of grassed topsoil covering the RCC.

Figure 8. Y-16 Dam During Overtopping Event.
