25 years of fixing bridges on gravel mined rivers in California

Catherine M.C. Avila, P.E.

ABSTRACT: The degradation caused by instream and off channel gravel mining and its resultant impact on bridges is investigated. Three case studies in California are utilized to illustrate the cost of fixing bridges impacted by channel bed degradation. Revisions to California regulations are suggested to increase awareness and decrease taxpayer costs.

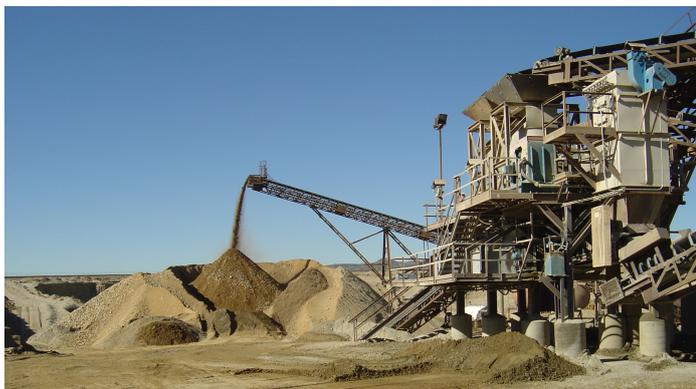
Figure 1: Gravel sorting operation (photo by author)

With the upturn in the California economy, there is an increased demand for sand and gravel (Figure 1) used in construction activities. California is the nation's leading producer of construction aggregates using 240 million tons on average¹. The California Department of Conservation (DOC) estimates that 20 percent of construction aggregate comes from instream sources (Avila, 1998). In 1996, 289 instream operations produced 22.8 million tons of sand and gravel valued at \$114 million (DOC, 1998). The average annual bedload sediment yield for all the rivers in California is only about 13 million metric tons (Kondolf, 1995). Thus, instream operators extract almost twice the sediment yield in an average year.

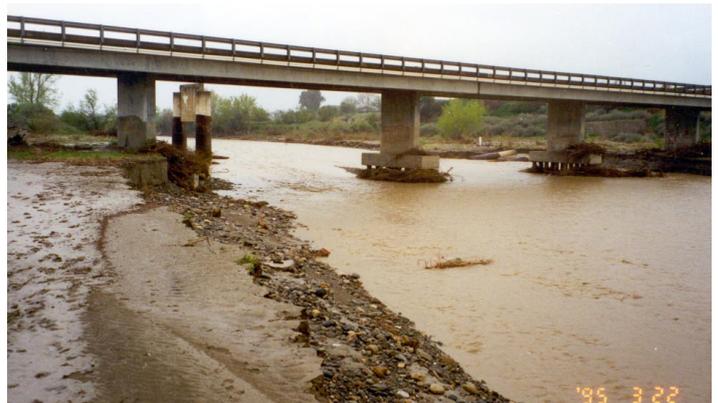
Figure 3: Looking downstream at the exposed footings and piles of the Union Cienega Road Bridge in 1995 (photo by author)

Cumulative excavations upstream and downstream of the Union Road Bridge over the San Benito River caused over 3 meters of degradation between 1959 and 2004. This degradation exposed the footings and piles of the bridge as shown in Figure 3 and caused the bridge to be closed to traffic in 1995 until scour countermeasures could be installed at an equivalent 2016 cost of \$950,000. The Union Road Bridge is constructed of 4 piers founded on 8 meter long “raymond step taper cans” pile foundation with a 0.6 meter pier cap between the piles and the pier wall as shown in Figure 3. These pile caps were buried approximately 0.6 meters deep when the bridge was originally constructed. If the foundations had been buried more, it would have required very expensive excavation to first drive the piles, then form the pile cap and finally construct the pier wall. CISS pile dot not require the construction a pile cap and thus no need for deep and expensive excavation and are ideal for bridge construction in historically gravel mined channels. The bridge is currently scheduled for replacement with very deep Cast in Steel Shell (CISS) piles to allow for potential future degradation at the bridge at a cost of \$21M.

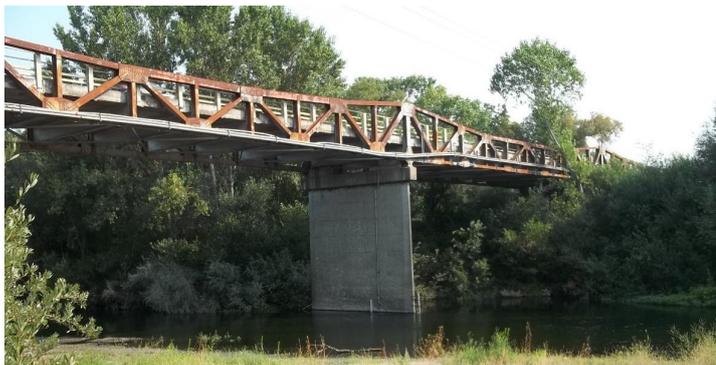
Figure 9: Existing bridge pier looking upstream at the downstream face of the Alexander Valley Road bridge depicting lateral channel migration

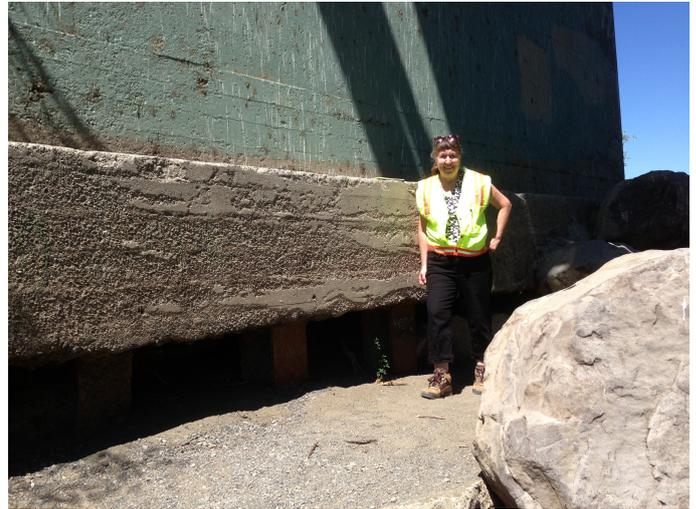
Figure 10: Pier 2 footing of the Alexander Valley Road Bridge with author

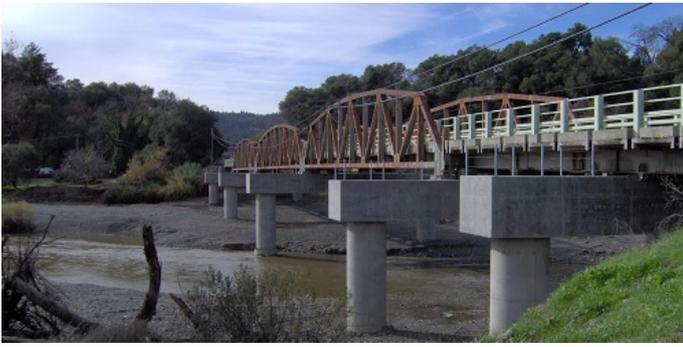
Figure 11: Crocker Road Bridge following outrigger bent construction (photo from Sonoma County)

Often when the channel degrades significantly, structural countermeasures are required at the bridge. Hydraulic countermeasures, such as placing armorment around the pier, do not mitigate the exposure of the pier or the increased vulnerability of the bridge to seismic forces associated with the exposed footings and undermined piles. Five structural countermeasure alternatives were considered for the Alexander Valley Road Bridge as outlined in Table 1. The recommended alternative is Alternative 2, construction of an outrigger or superbent. The Crocker Road Bridge upstream of the Alexander Valley Road Bridge has already had a similar countermeasure installed as seen in Figure 11. The structural integrity of the bridge has been restored while the aesthetics are up to debate.

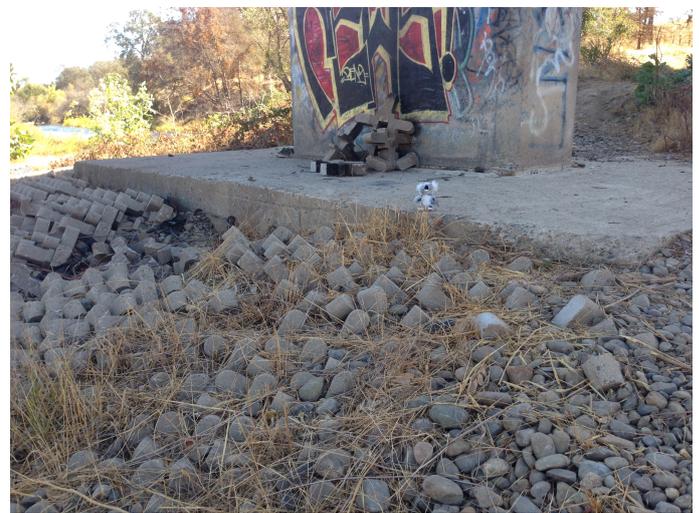
Figure 15: Exposed Hickman Road footing protected by "A-Jax"

According to the National Bridge Inventory System (NBIS), scour is currently given a rating of 3, which means that the bridge has been determined to be scour critical (FHWA, 1995). Scour has been repeatedly noted during biennial inspections due primarily to exposure of the pier footings. Scour countermeasures in the form of A-Jax were installed in 2004 by Stanislaus County. These A-Jax have not performed well since their installation as documented in the BIRIS reports which note deterioration, settlement and displacement (Stanislaus, 2011). Like the Alexander Valley Road bridge documented above, the Hickman Road Bridge has foundations at differing elevations assuming the channel migration does not occur.
