A case of severe channel-morphology change due to human influences in the Touqian River, Taiwan

ABSTRACT: One reach that locates in the midstream of the Touqian River in northern Taiwan was subjected to various human disturbances; the channel morphology in the reach changed severely as a result. This case study looks into the role of human disturbance on channel evolution by exploring the chronological change in channel morphology due to human influences in the studied reach. The major human influences in this reach include gravel mining, bridge construction and its protection works, and weir construction. Channel morphology downstream the bridge was transformed from an alluvial channel to a bedrock channel since the installation of a massive protection work. Later on, the bridge and its protection work were broken in recent years. After their failure, the reach started to take re-deposition and has returned to an alluvial channel. Chronological data including aerial photographs, cross-section surveys and hydrological data were compiled and analyzed. Also, field geology was conducted to characterize the distribution of bedrock outcrop and the erosion processes in the studied reach

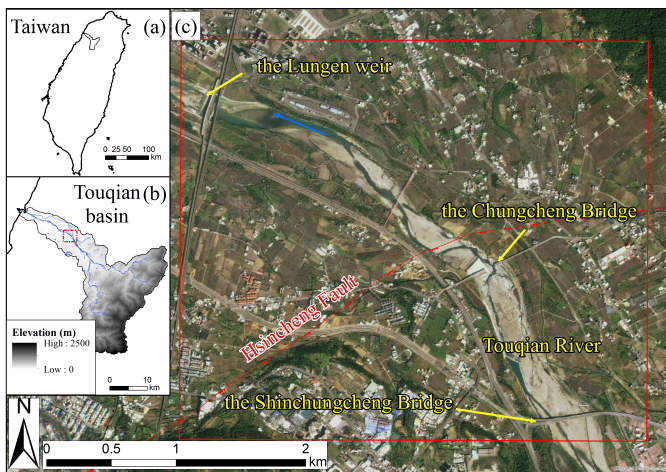
Figure 1. Site location map.

The Touqian River is a major river in northern Taiwan. Its drainage basin is 565 km² with a trunk length of 63 km approximately. The length of the reach covered in this study is about 4 km, located about 12 to 16 km from the river mouth (Figure 1). The peak discharge recorded in the reach is 8560 m³/s, which occurred in July 2013 during typhoon Soulik. The average discharge within the reach over the period 1990 – 2014 is 20.24 m³/s (WRA, 2014).

Major human activities have affected the reach including: 1) gravel mining in 1970s-1990s; 2) the Chungcheng Bridge and its protection works; 3) the Longen weir (Figure 1). In addition to these anthropogenic changes, there are a number of other structures, including five bridges and levees, that might also contribute, to a lesser degree, to the effects leading to the observed changes to the channel in this reach. However, the channel changes were dominated by the three major human activities that will be presented in this study.

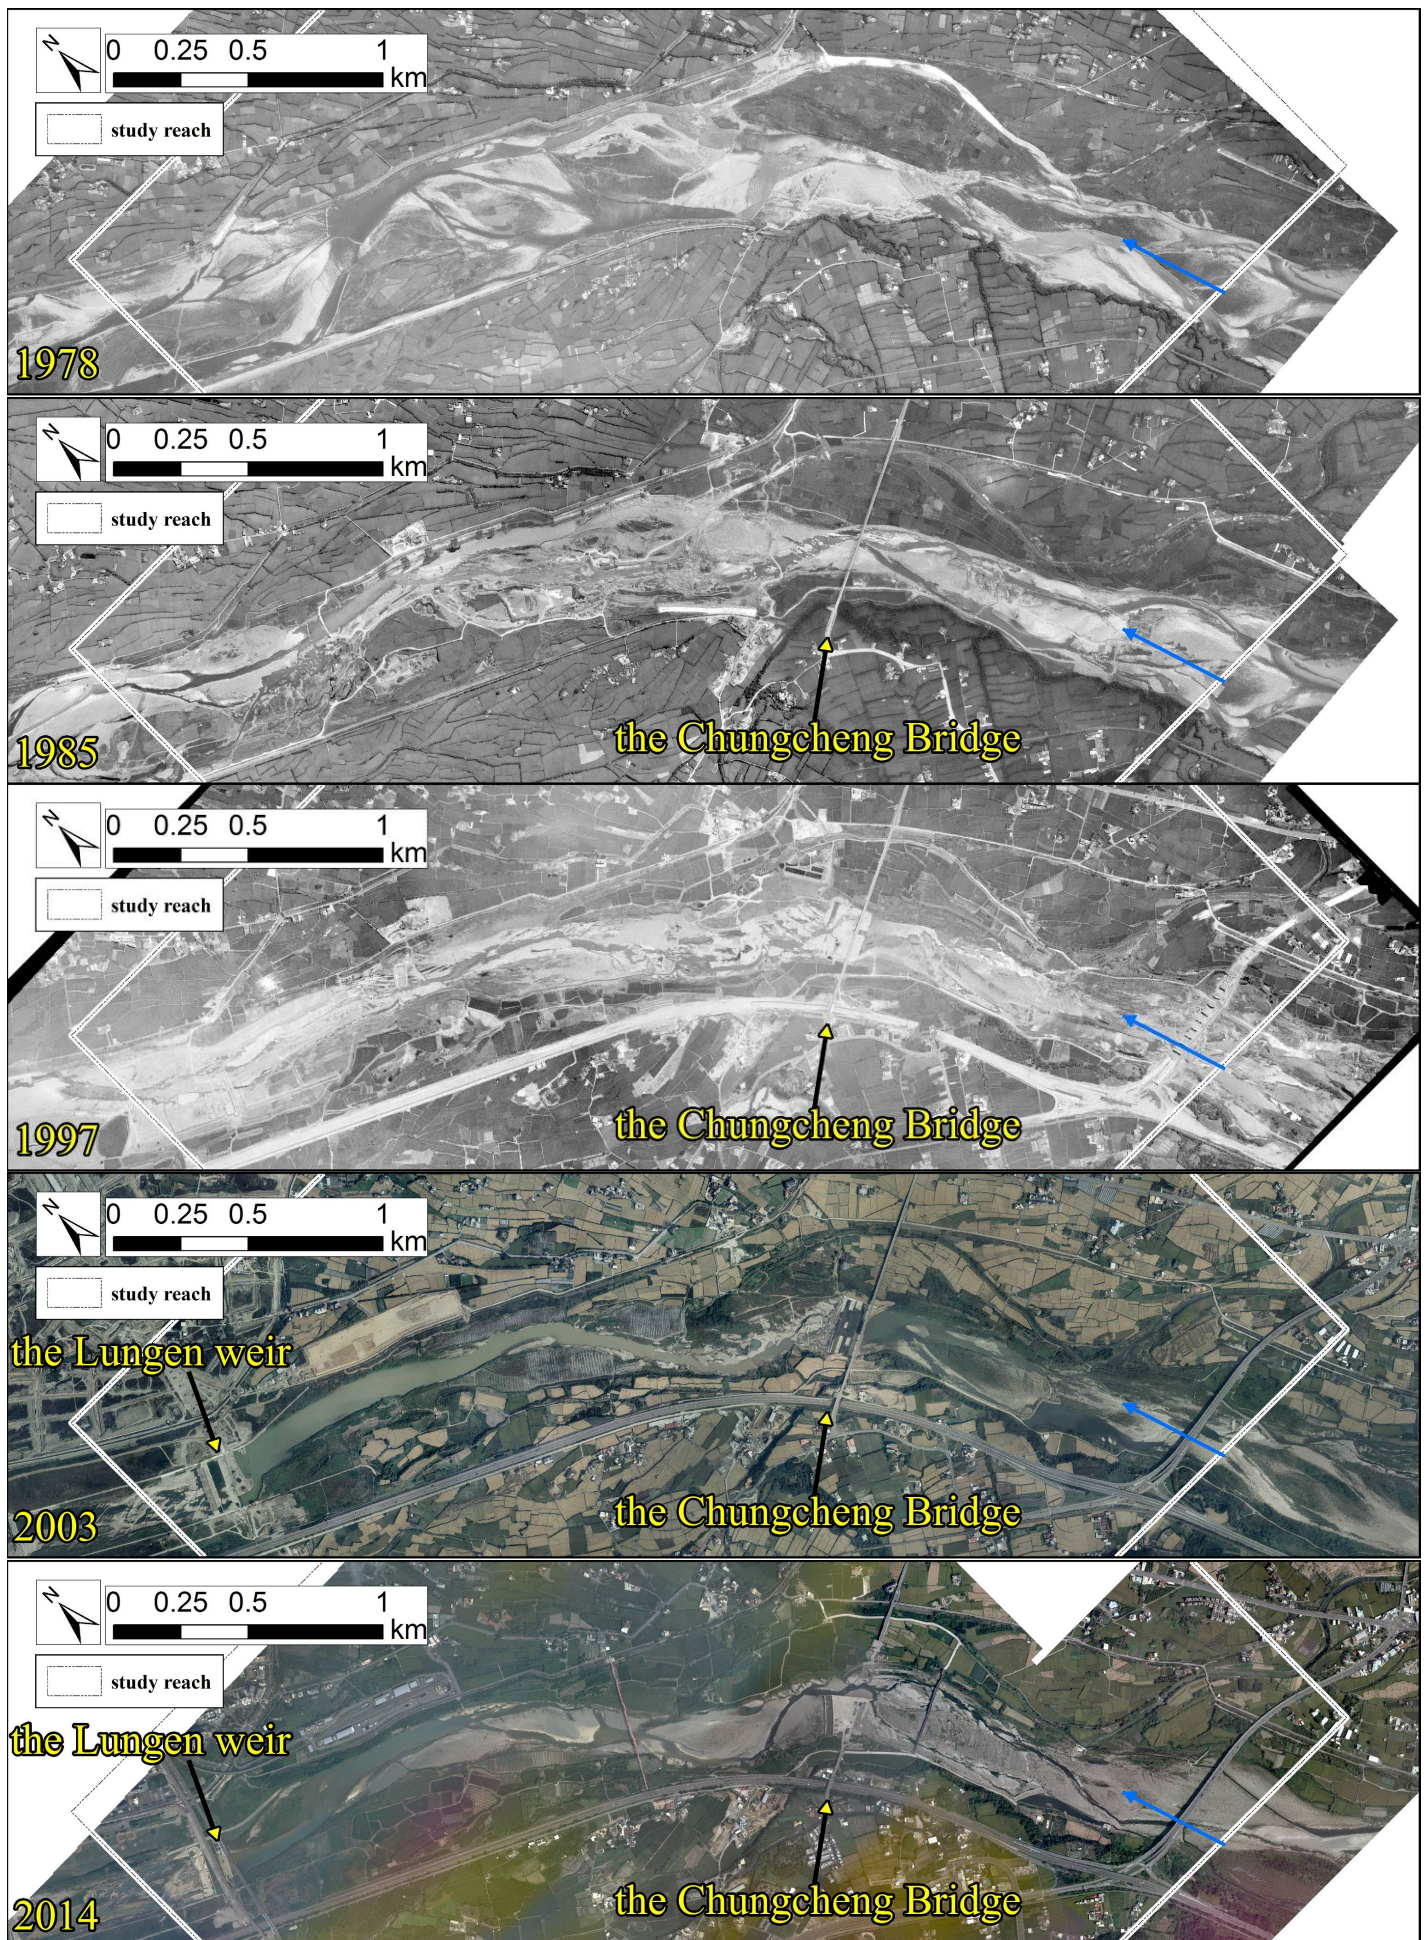
Figure 2. Historical aerial orthophotographs of the study reach: 1978, 1985, 1997, 2003, and 2014 from top to bottom.

2005, 2008, 2012. Multi-stage digital surface models (DSM) and aerial orthophotographs (Figure 2) are derived from the aerial photographs using a commercial program with a set of ground control points (GCP). The aerial photographs in dry season are selected in order to obtain the maximum exposed area of channel bed. The cross-sections were surveyed by the river management agency for understanding the lateral channel topography including the inundated channel area every 500 m distance along longitudinal channel direction. The chronological aerial orthophotographs are used to observe the changes of channel planform. The digital surface models and the cross-sectional survey data are both used to quantify the changes in longitudinal channel direction.

Gravel mining started in the 1970s in this reach. The patterns due to bar skimming and mining pits can be observed in the middle of the reach in the 1978 photograph presented in Figure 2. The footprint of the gravel mining had become widespread across the entire reach by the time of the 1985 orthophotograph. Finally, the gravel mining was banned in 1997 because of the global channel degradation and the safety impacts to the various infrastructures within the river.

2. The first massive protection works (2003 in Figure 2): After typhoon Herb in 1996, a three-stage concrete gravity dam with a piled foundation was built as protection works downstream of the bridge. In addition, concrete pavements and side walls were also built to enclose the entire area of the bridge piers. This massive structure gradually collapsed from the downstream side due to local scouring and riverbed incision. The downstream third-stage pavement and piles were broken during typhoon Aere in 2004 (Figure 3 top). After the 2008 wet season, two of the three-stage protection works were severely damaged (Figure 3 bottom). Emergency protection works were started construction in 2008, destroyed during typhoon Morakot in 2009, and finally completed in 2009. However, these emergency protection works were not long-lasting and were destroyed during typhoon Saola in 2012. One of the Chungcheng Bridge pier foundation was exposed in the deep incised riverbed after typhoon Saola in 2012 (Figure 4 top).

3. The second massive protection works (2014 in Figure 2): After typhoon Saola in 2012, another three-stage concrete gravity dam with piled foundation was built to protect the bridge. The massive concrete structure did not enclose the region of the exposed pier; instead, the channel was diverted away from the right bank to flow over the protection works. However, the channel diversion was not successful and severe damage was caused to the bridge during typhoon Soulik in 2013. The exposed pier and two segments of the bridge decks were removed during the typhoon (Figure 4 bottom). Afterward, the Chungcheng Bridge was rebuilt by the type of a long-span cable bridge to cross the widening and deep-incised main channel.

The Lungen weir located downstream of the reach and was completed in 1998 (2003 in Figure 2). The weir is a low dam combined with two types of concrete structure: a 40 meters long overflow dam and a 160 meters long semi-permeable dam. It sets a new base level in the reach.

The channel changes are closely related to and affected by the human activities described above. The morphological evolution of the reach can be derived clearly from historical aerial photographs (Figure 2). In 1978, the braided channel consisted of multiple small channels and abounded with alluvial deposits. Intensive gravel mining had comprehensively changed the original channel morphology by 1985. Then the local scouring downstream of the bridge protection works induced large area erosion leading to the exposure of the bedrock. The channel bedrocks belong to young sedimentary rocks and dis-

turbed by the active fault are not resistant to flow erosion. The channel downstream of the bridge transformed rapidly from an alluvial-type channel to a gorge-type channel by 2003. The failure of the protection works caused the upstream deposit materials to be transported downstream in considerable quantities. Then, the downstream reach abounded with alluvial deposits again, but oppositely in upstream reach that the riverbed started exposed owing to the armor material loss and suffered severe erosion from the processes of knickpoint migration in 2014 (2014 in Figure 2; Figure 4).

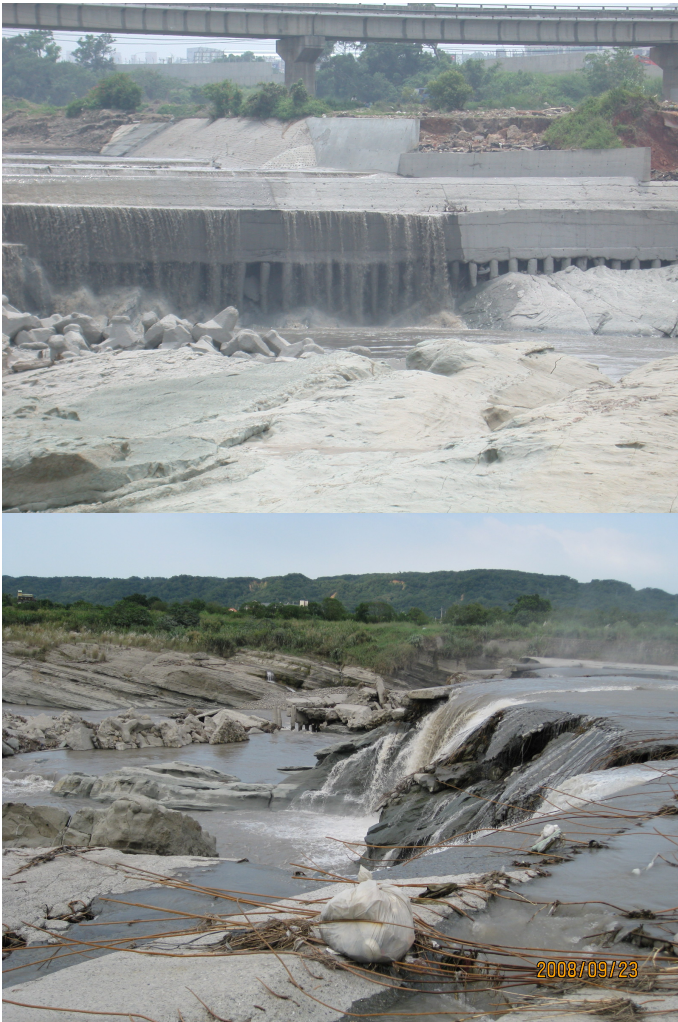
Figure 3. Damaged conditions of the first massive protection works of the Chungcheng Bridge in September 2004 (top) and September 2008 (bottom).

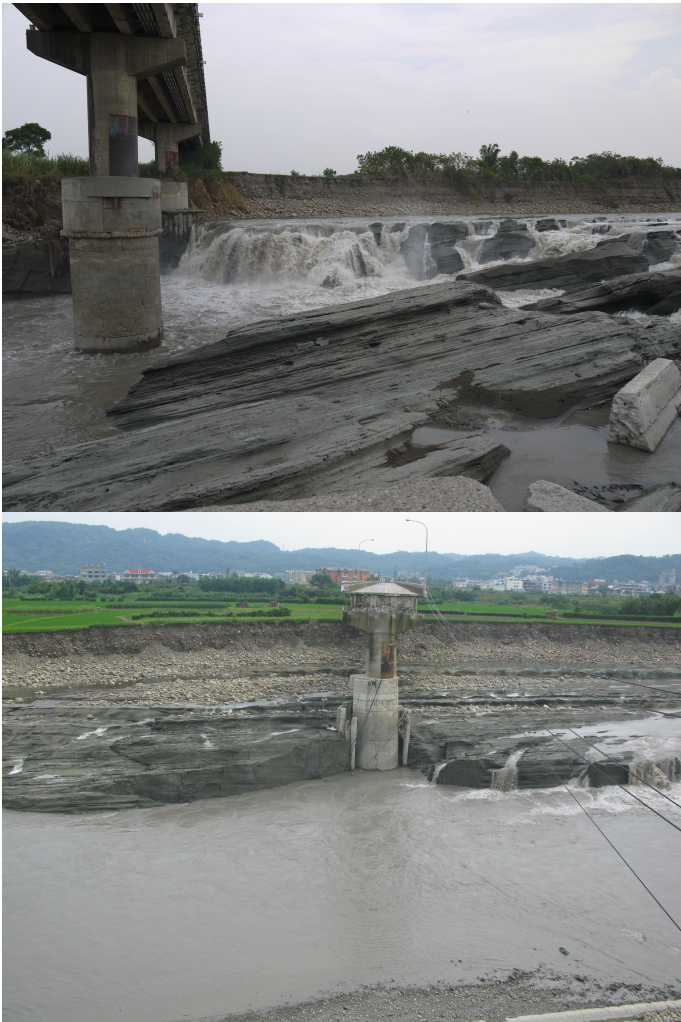
Figure 4. The protection works of the Chungcheng Bridge were destroyed leading to a bridge pier to be exposed completely after typhoon Saola in 2012 (top); the exposed pier and two segments of the bridge decks were removed during typhoon Soulik in 2013 (bottom).

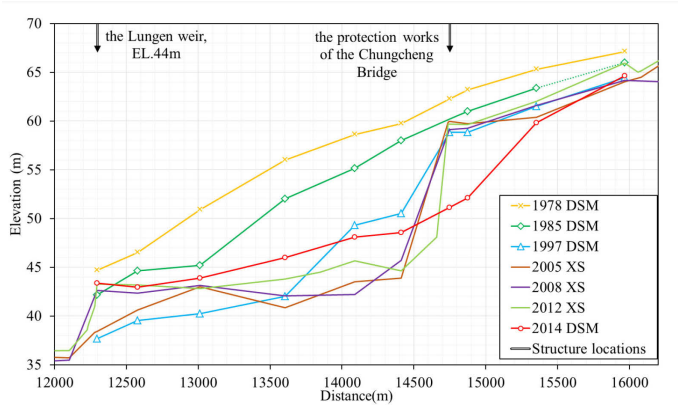
Figure 5. The historical longitudinal profiles of the study reach.

In addition to the changes to the channel plan-form, the historical channel change could also be analyzed in the longitudinal channel direction. Figure 5 presents the longitudinal profiles derived from the cross-section survey data and digital surface model for the reach. The channel changes can be divided into the following stages:

1. Global channel degradation caused by intensive gravel mining from 1978 to 1985. This lead to the riverbed elevation being decreased by 2-6 m.
2. A series of protection works built downstream of the Chungcheng Bridge between 1985 to 2012. Local scouring was extremely active downstream of the bridge. The maximum erosion depth was up to 15 m, whilst upstream of the bridge, there was no significant change in riverbed elevation.
3. The construction of the Lungen weir set a new local base level downstream of the reach, and caused sediment deposition upstream of the weir.
4. A new channel developed close to the right bank (after 2012). The 2013 Soulik typhoon widened the new main channel, and sediments were transported from upstream to downstream. The event caused the headward erosion of rock river-bed and channel knickpoint migration.
