Application of wireless tracer GPRS riverbed scour monitoring for disaster warning

ABSTRACT: River incision after long-term general scour due to the existence of river-crossing structures, always has a huge influence on riverbed stability and hydraulic structure safety. The severe short-term riverbed general scour, bridge and bend/levee scour, and scour downstream of a grade-control structure (GCS) occurs frequently, causing bridge failures, levee damages, and headcuttings during typhoon-induced floods in the intermittent rivers in Taiwan. For examples, bridge collapse and embankment damage events resulted in the loss of life and vehicles due to falling into rivers in 2008 and 2009. Now, the wireless tracer GPRS real-time scour monitoring technique has been developed to monitor bridge and general scour, bend and toe scour and scouring below GCSs in real time during high flows, with the approach trialled within a gravel-bed reach in the lower Dachia River during 2015. The result indicates that the proposed method has the potential to be used as a tool for the practical application of disaster warning for monitoring the safety of bridge and embankment.

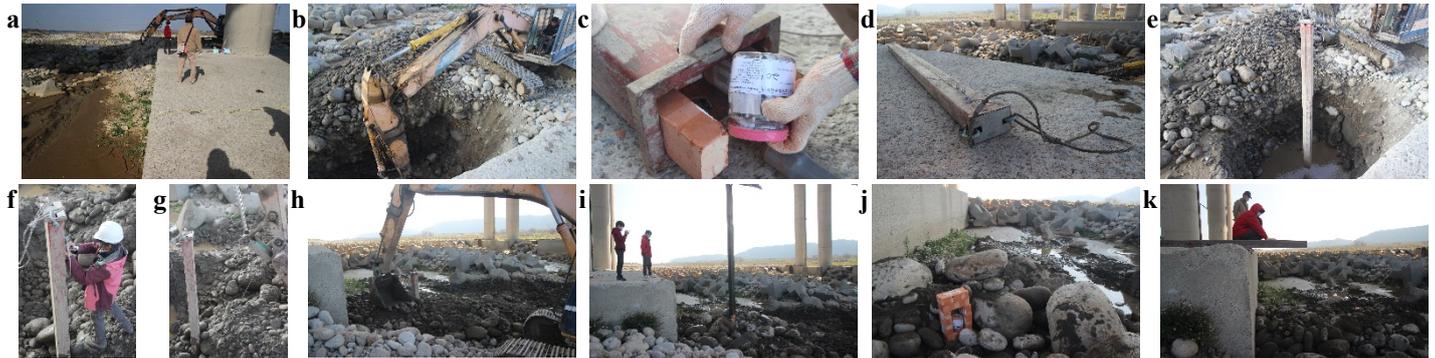
Figure 5. Laying devices procedures for P2 bridge scour monitoring at the Formosa Super Highway Bridge.

Figure 5 shows the procedure of laying wireless tracer float-out devices at the P2 bridge scour monitoring position. The procedures of laying devices for the main channel in an intermittent river are as follows:

- Two excavators excavate a 5 m deep hole at the measurement position
- Numbered bricks and coded wireless tracers are placed order into the hollow steel column; a wireless tracer protected by two vertical numbered bricks
- 11 m long steel cable wrapped vertically around the steel column
- The steel column is lifted up and lowered into the hole
- The hole is infilled
- The steel cable is removed
- The hollow steel column is removed leaving the instruments inside the riverbed
- Measurement positions located by transit survey

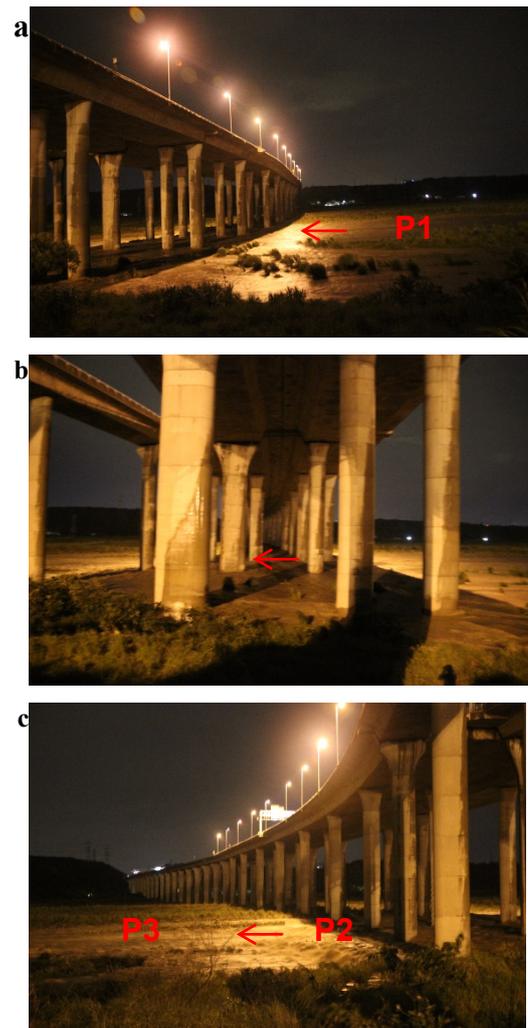
Figure 10. Flow condition near flood peak during Monsoon 520-induced flood: (a) upstream; (b) bridge piers; and (c) downstream of the Formosa Super Highway Bridge, photos by author at 01:45 am May 27, 2015.

Figure 9 shows the flow discharge hydrograph and the result of real-time scour monitoring during Monsoon 520-induced flood. Figures 10(a), (b) and (c) present the photographs of the flow condition around monitoring point P2 near the Formosa Super Highway Bridge at peak flood.
