HR Wallingford
Working with water

Green approaches in river engineering

Supporting implementation of Green Infrastructure

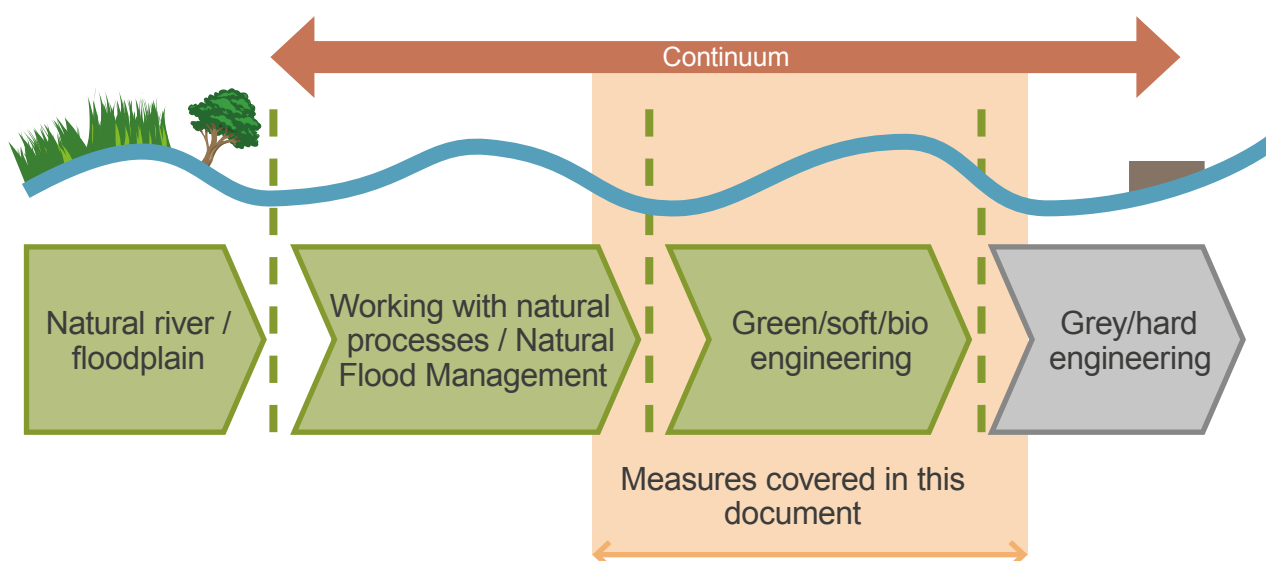
In this document we will use preferentially the terms Green, Green-Grey and Grey to describe the different measures presented but other terminology is also used in the literature as shown in the figure.

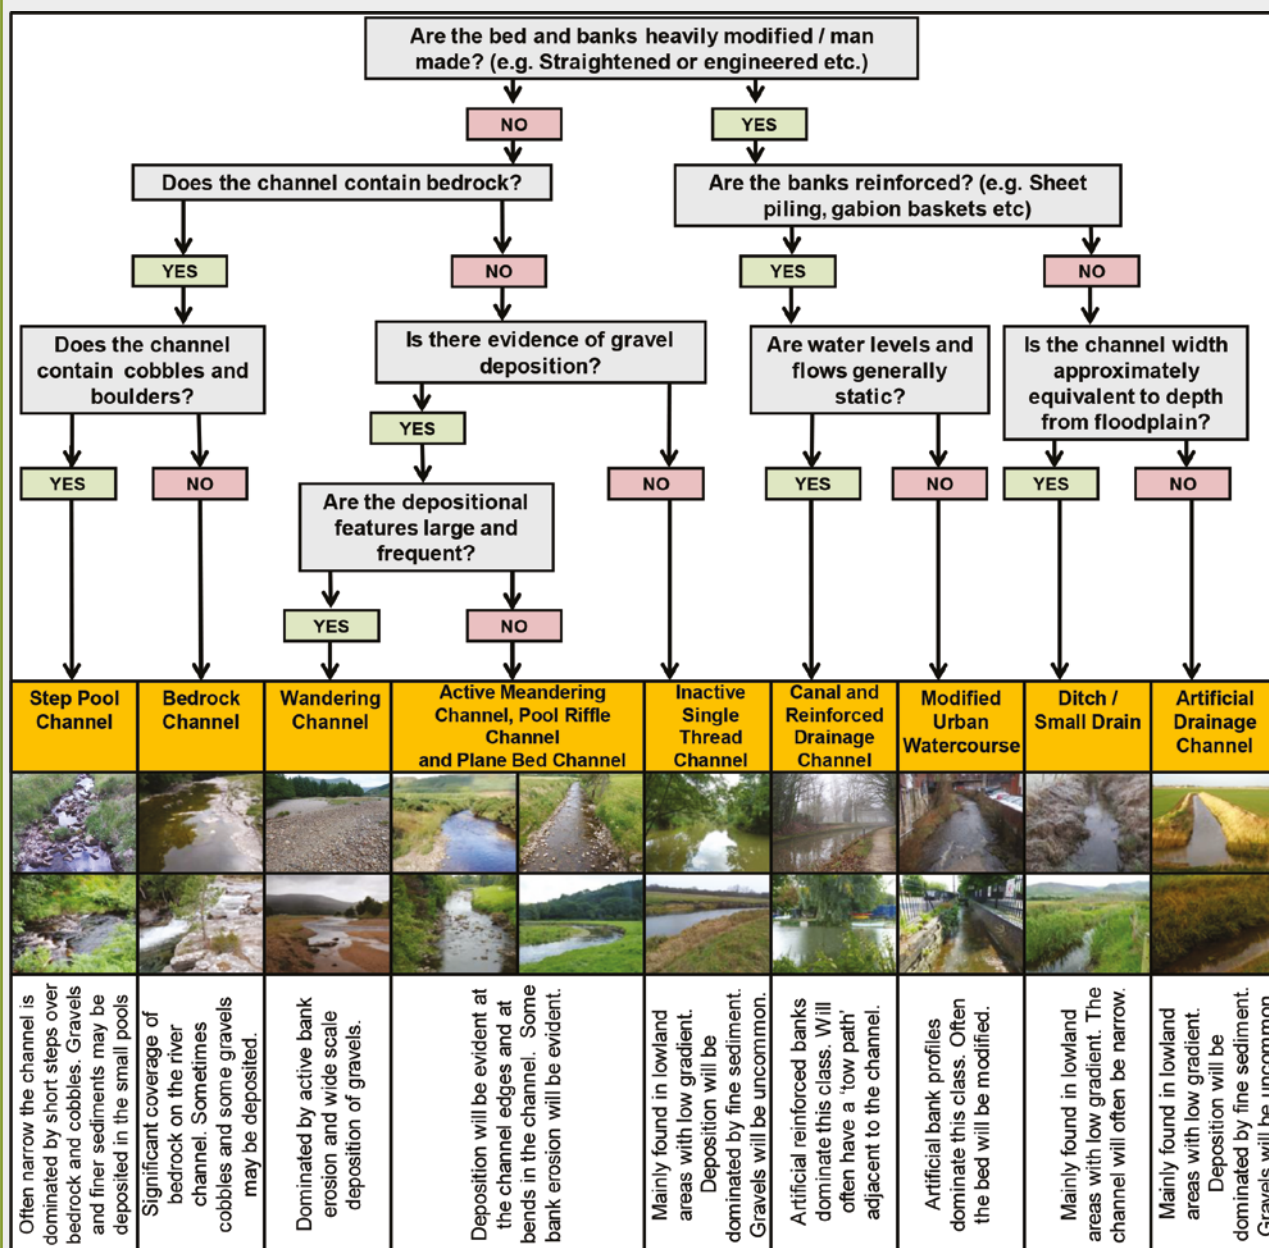
Source: Flowchart for identifying geomorphic watercourse type extracted from the Environment Agency guidance "Aquatic and riparian plant management: controls for vegetation in watercourses".

Detailed descriptions of each typology can be found in "Aquatic and riparian plant management: controls for vegetation in watercourses" or in the "Channel Management Handbook", both Environment Agency publications (references provided in Chapter 5). Here, only a very brief description of the expected behaviour of the river is provided.

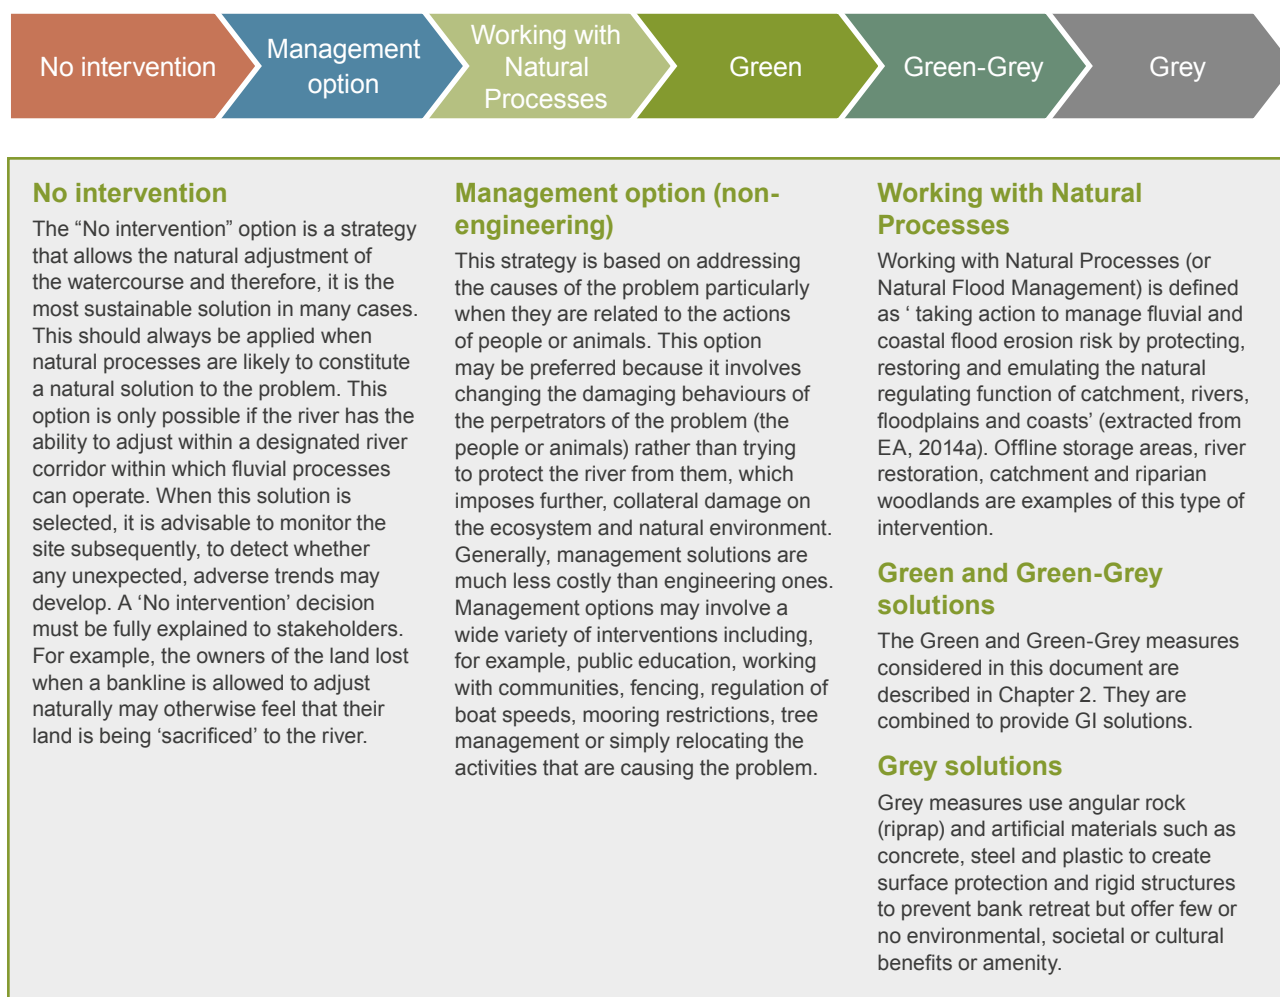
At the Business Case level, the options identified are the ones defined in the figure below. “No intervention” and “Management option” favour natural adjustment of the river and, where appropriate, these are the most sustainable and cost-efficient approaches.

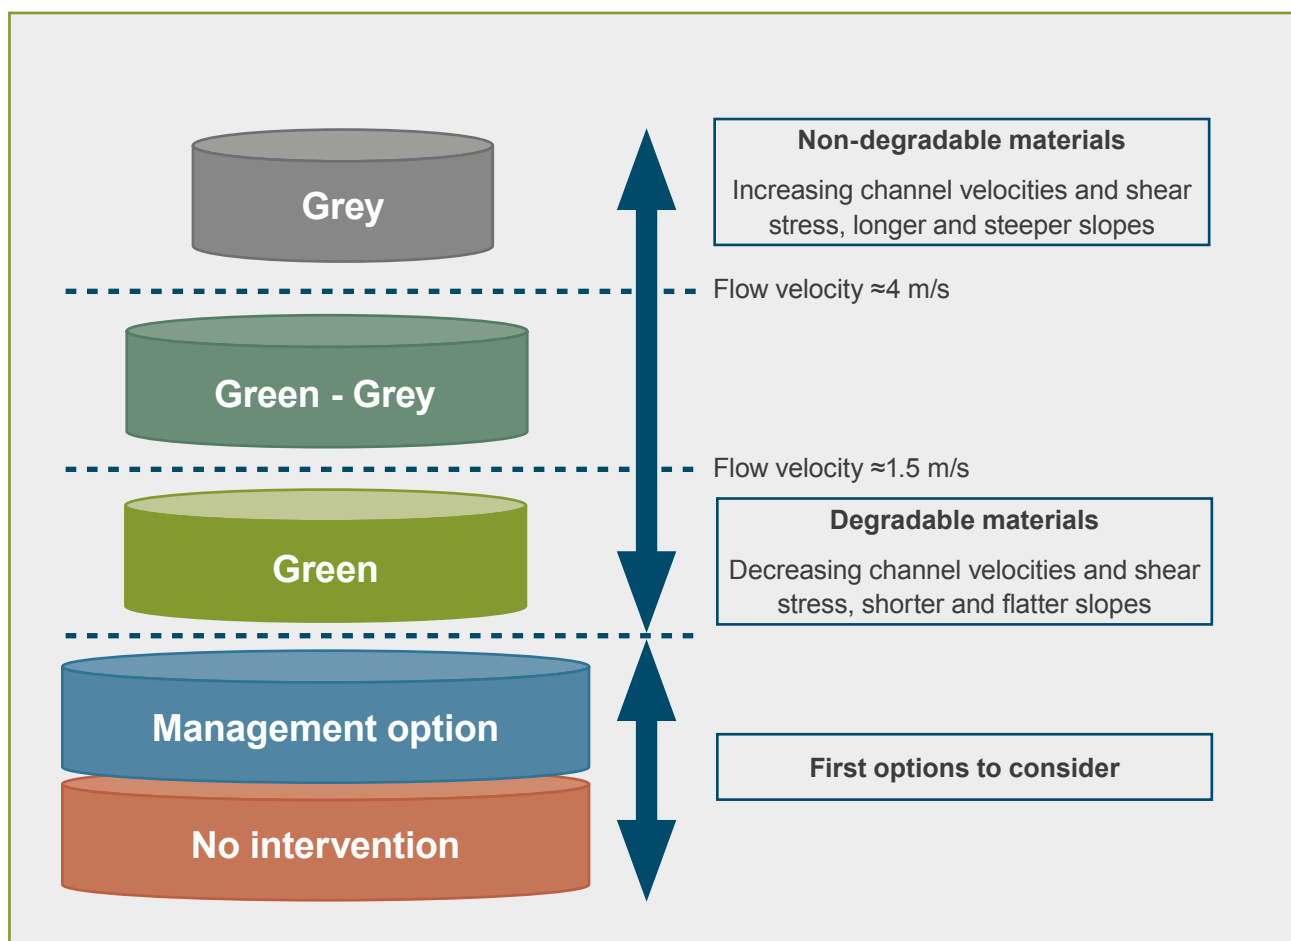
The following figure shows the likely applicability of the Green, Green-Grey and Grey options based on the river characteristics.

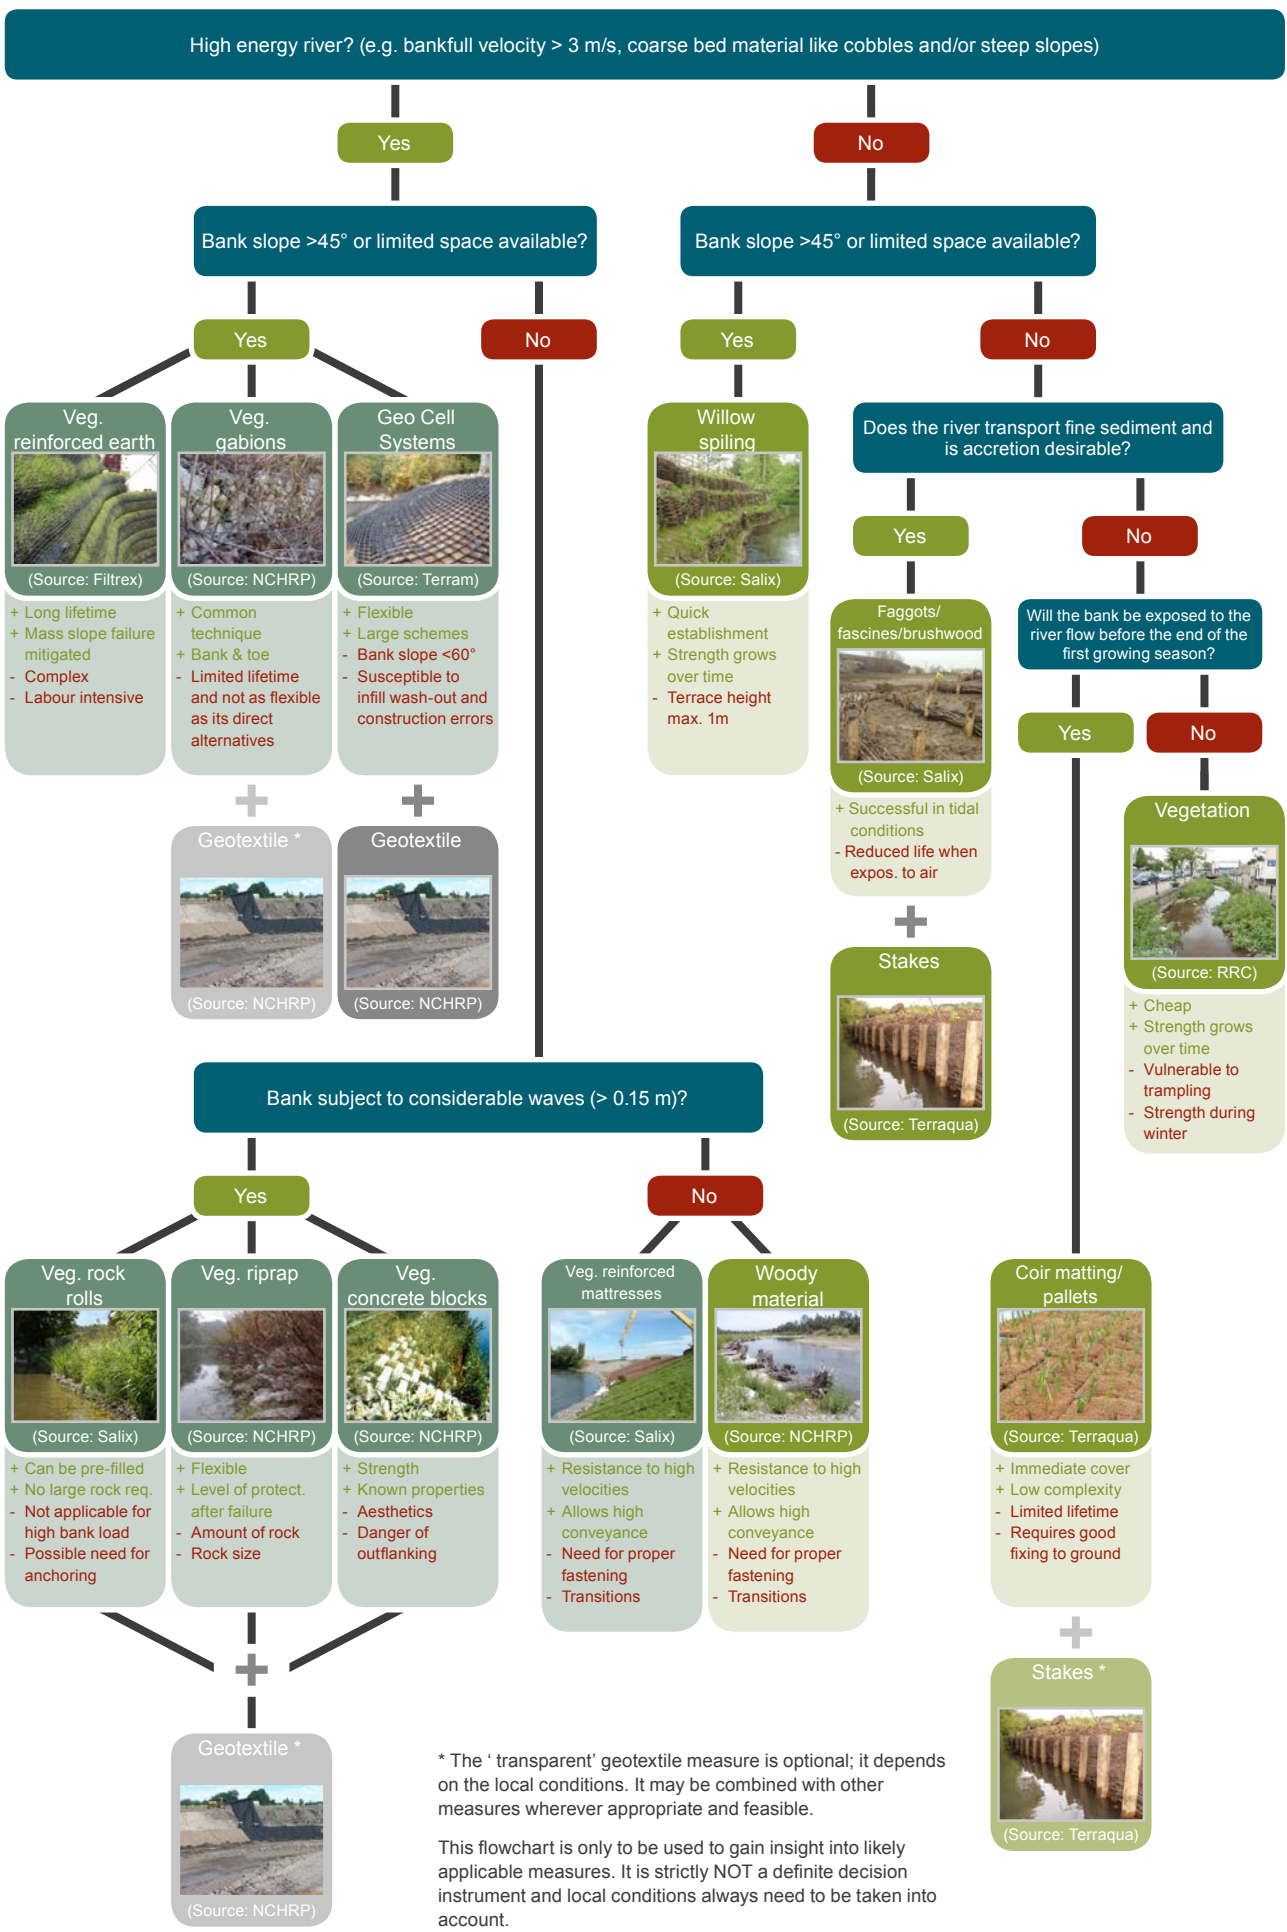
Bank protection

This flowchart is only to be used to gain insight in what are the likely application fields of the measures. It is strictly NOT a definite decision instrument and local conditions always need to be taken into account.

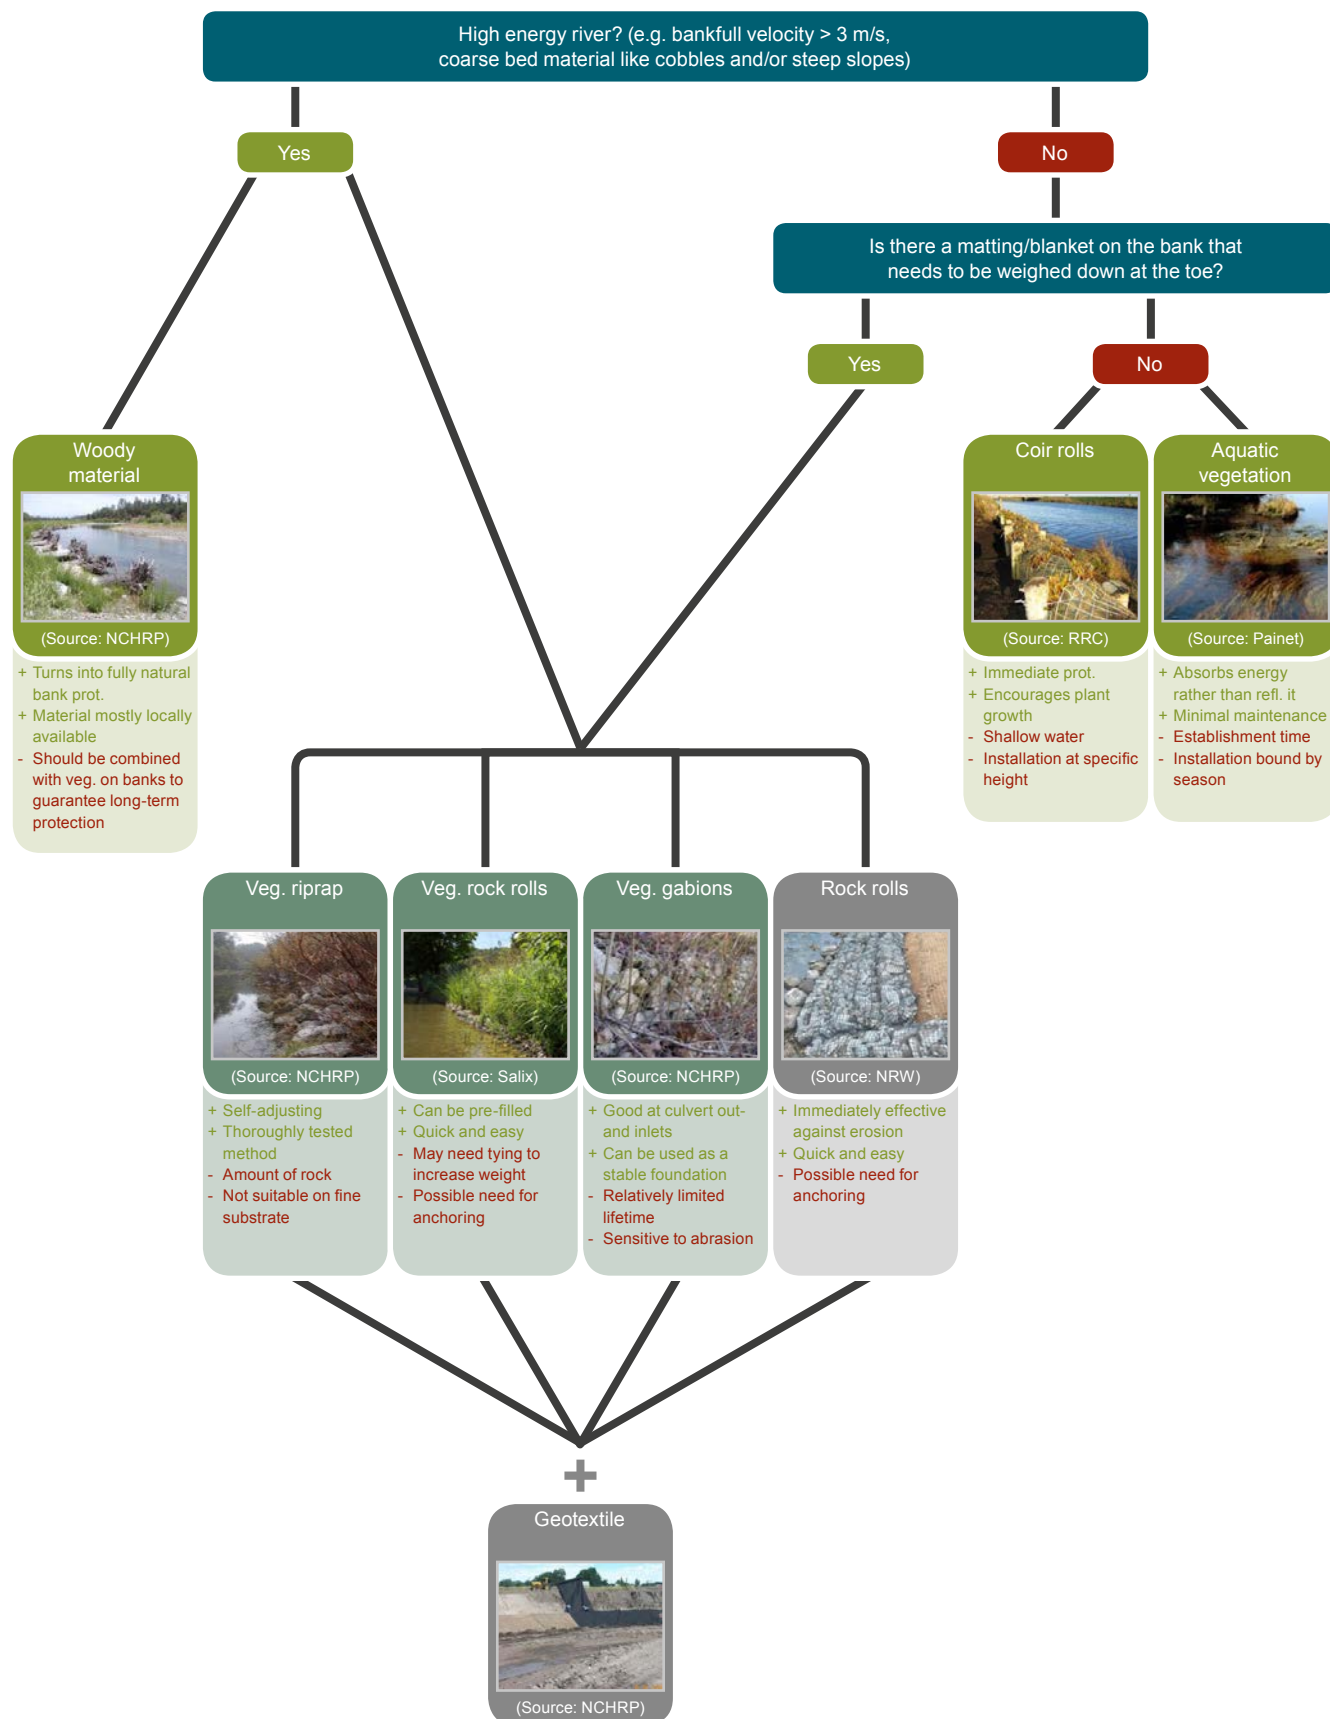
Toe protection

* The 'transparent' geotextile measure is optional; it depends on the local conditions. It may be combined with other measures wherever appropriate and feasible.

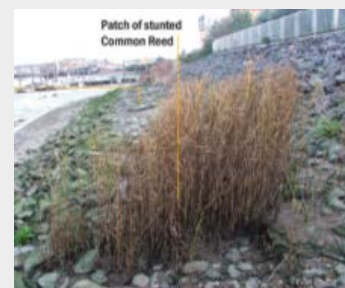
Examples: Lack of plant colonisation due to bed level below Mean High Water Neap tide level (Source: EA)

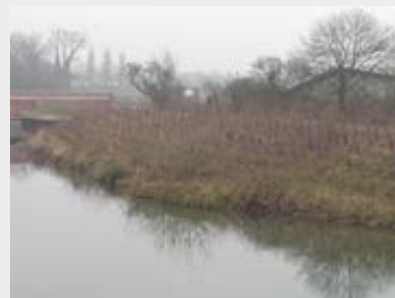
*Examples: Different types of vegetation planted up the bank profile
(Source: HR Wallingford)*

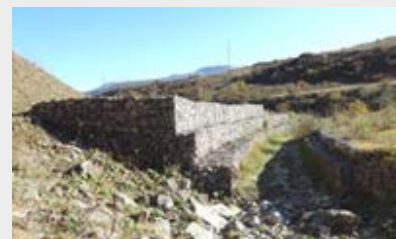
Examples: Upstream edge of gabions protection without transition (Source: HR Wallingford)

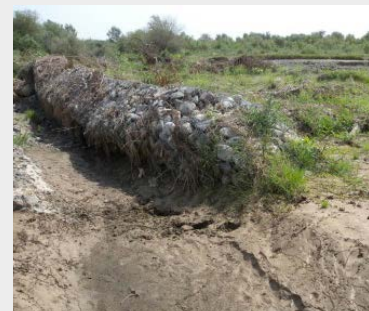
Examples: Failure of vegetated gabions due to development of scour and outflanking (Source: HR Wallingford)

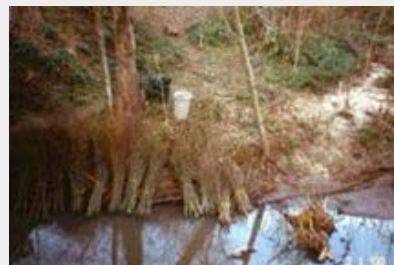
Examples: Cuttings soaking in the creek until installation (Source: Greenbank)

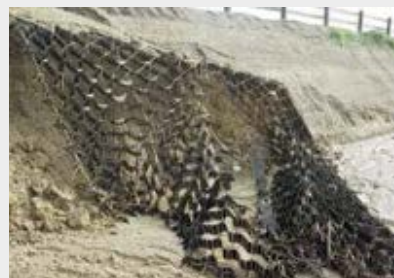
Examples: Failure of geo cell system due to inadequate connection and with improper infill (Source: Greenfix)

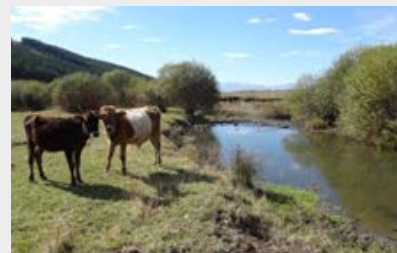
Examples: Cattle on a bank showing evidence of 'poaching' which is the combined impact of over-grazing and trampling (Source: HR Wallingford)

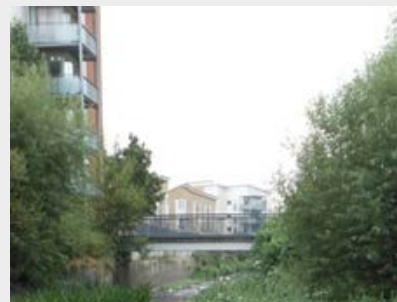
Examples: (Top) Example of planting failing to thrive. Dearth of plants on left concrete wall attributed to shading by high rise building (Source: HR Wallingford), (Bottom) Example of vegetation growth being curtailed by insufficient light despite efforts to include light in the culverted River Bollin (Manchester airport) (Source: RRC)

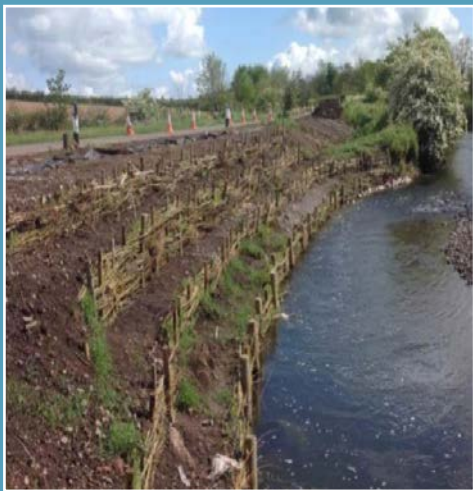
The scheme immediately after completion. Source: Phil Bradley

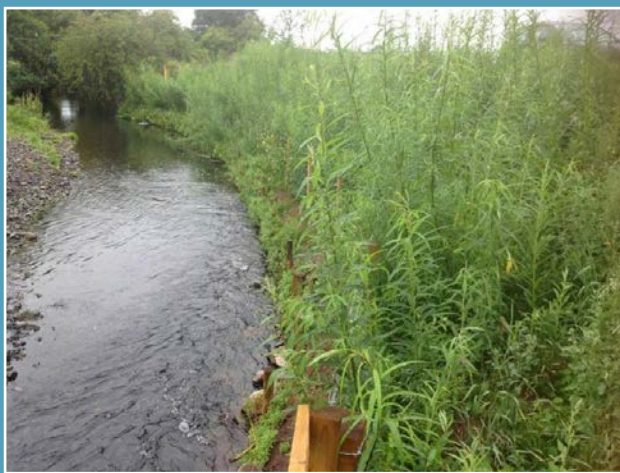
The scheme after one growing season. Source: Phil Bradley

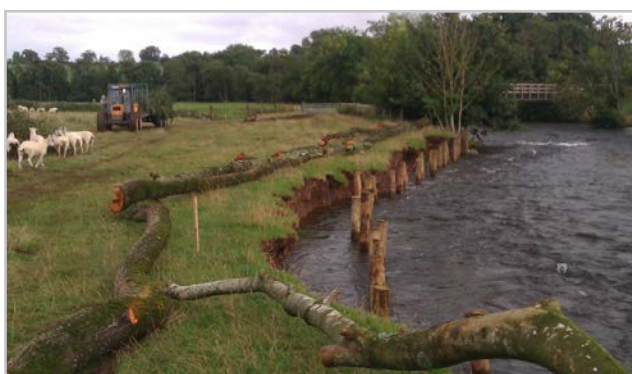
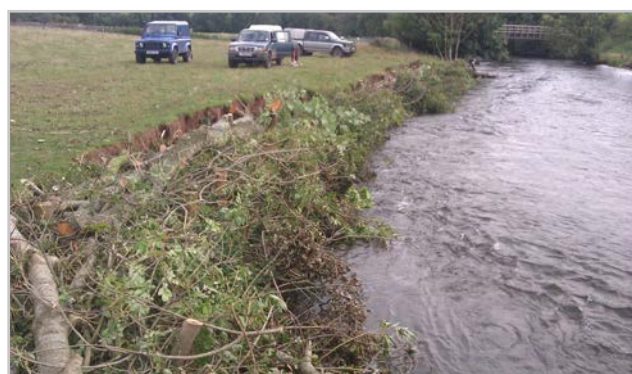
The eroded bank and footbridge downstream with strainers in place (left) and with completed protection (right).
Source: Tom Dawson, Northern Habitat, Countryside Contractors

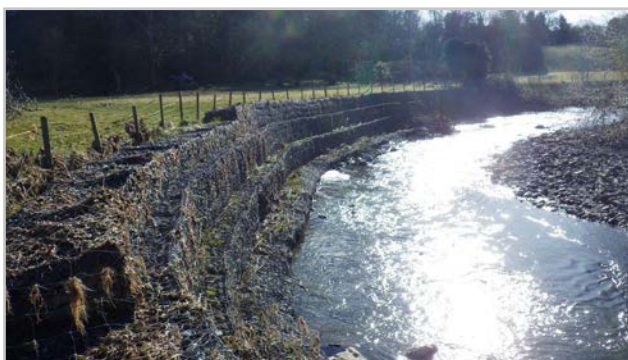
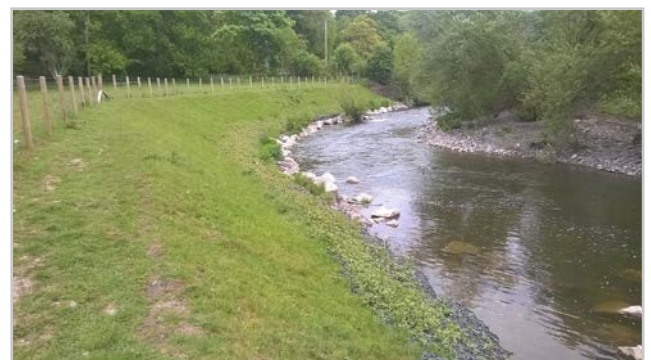
The old failing gabion baskets (left) and the new V-Max matting and (vegetated) rock rolls (right). Photo supplied by Salix Ltd

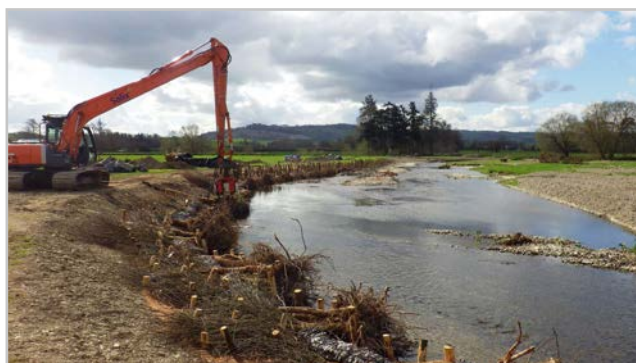
Stakes and faggot bundles. Photo supplied by Salix Ltd

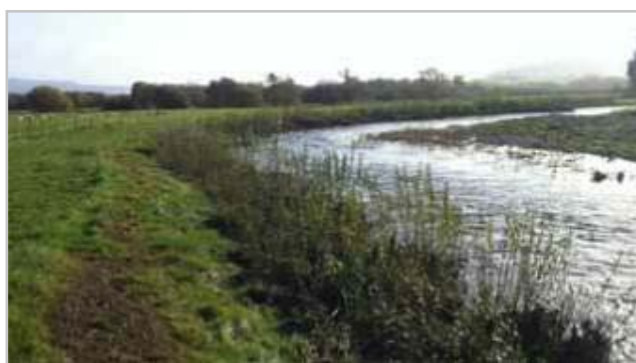
The root wad bank after 4 months. Photo supplied by Salix Ltd.

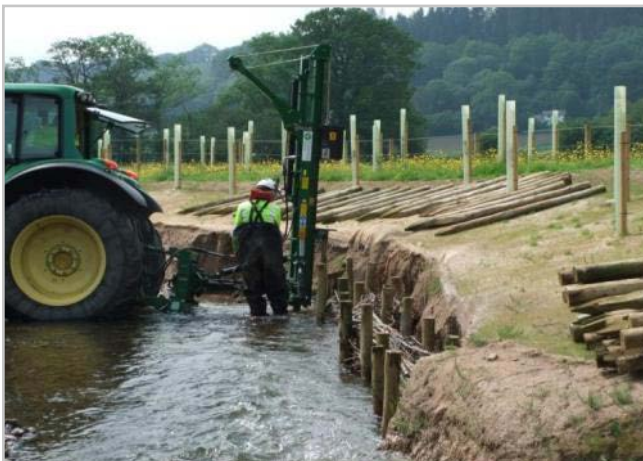
Post being driven into the bank to place the faggots.
Source: Environment Agency

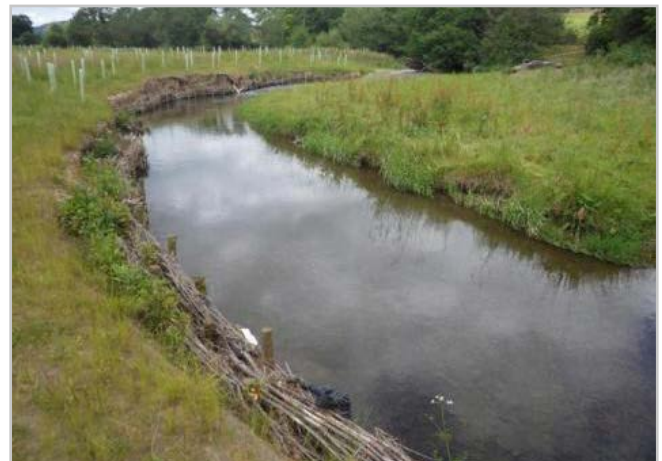
One year after implementation the bank is well vegetated.
Source: Environment Agency

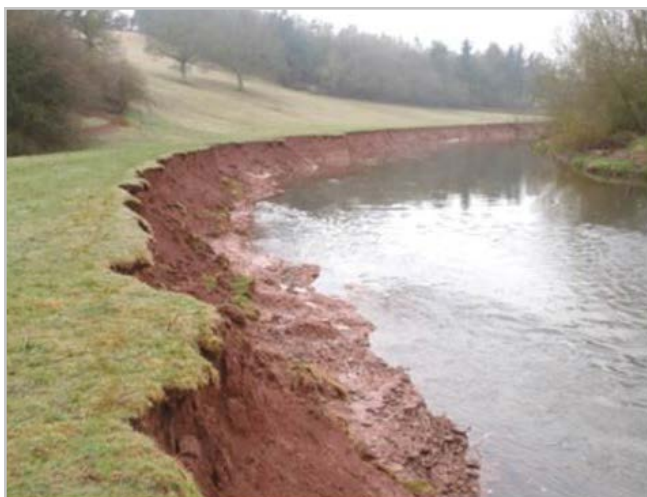
Bank erosion following the weir removal.
Source: Natural Resources Wales

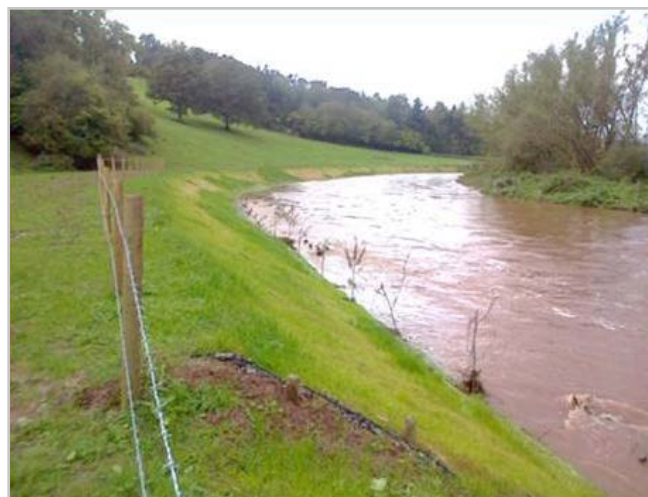
The protection works finalised
Source: Natural Resources Wales

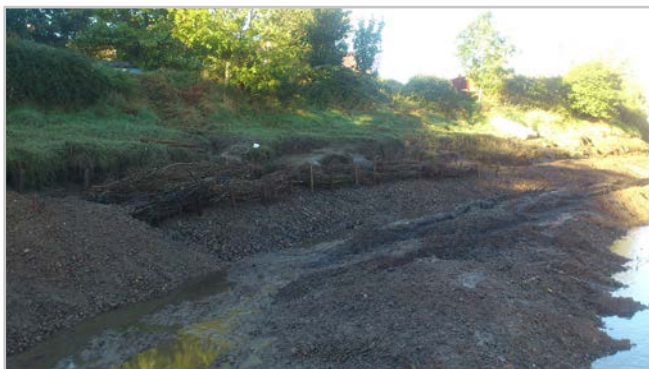
Faggots staked down above the rock roll mattresses.
Source: Natural Resources Wales, 2013

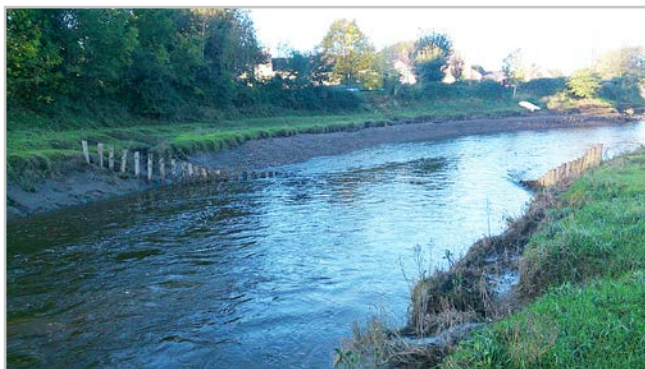
Wooden pile groynes diverting the flow away from the banks.
Source: Natural Resources Wales, 2013

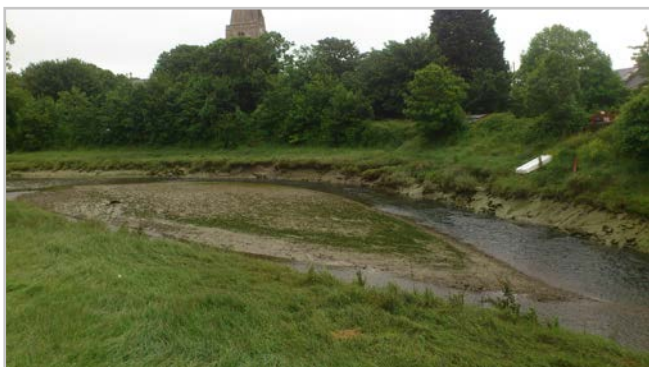
The shoal in 2013 before the intervention.
Source: Natural Resources Wales

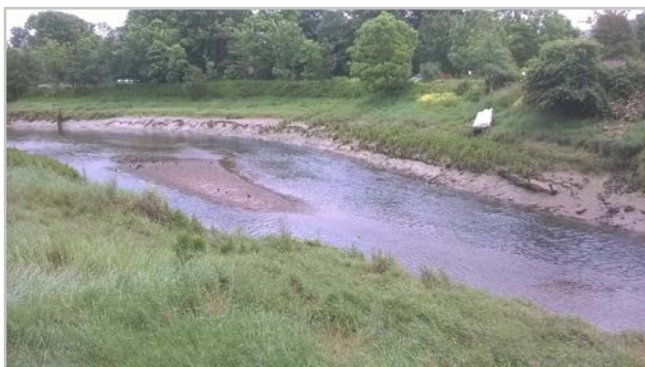
The smaller shoal in June 2016.
Source: Natural Resources Wales

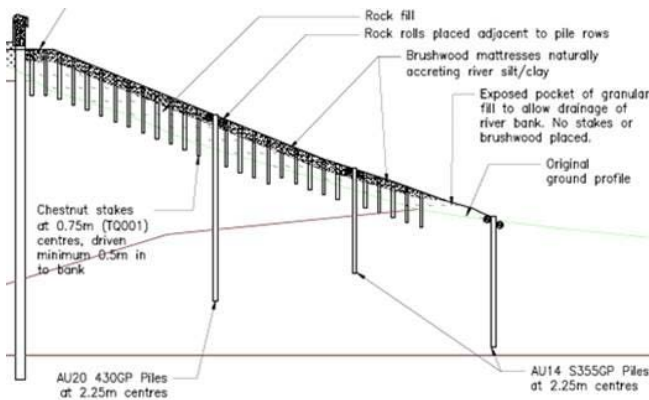
Schematization of the works carried out.
Source: Natural Resources Wales

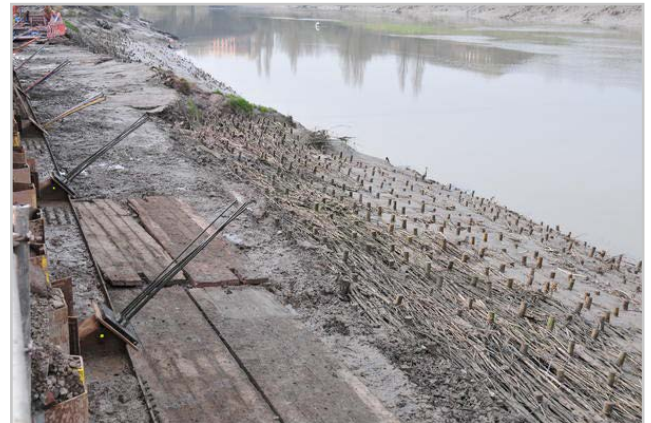
Scheme at the final stages of construction. The bottom part of the brushwood mattresses is already covered in silt.
Source: Natural Resources Wales

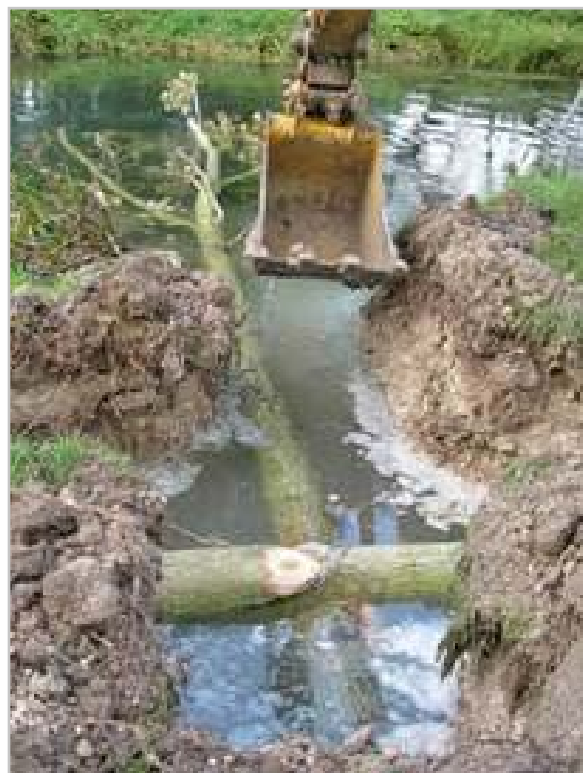
The 'crucifix' as it is placed in the trench before being backfilled. Source: Natural England

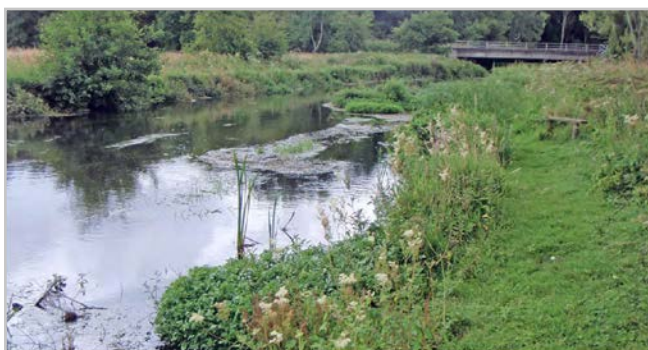
Channel narrowing caused by the wood deflectors.
Source: River Restoration Centre

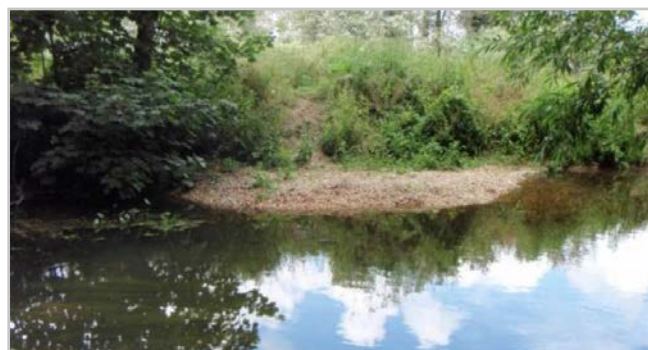
Gravel shoulder, Source: River Restoration Centre

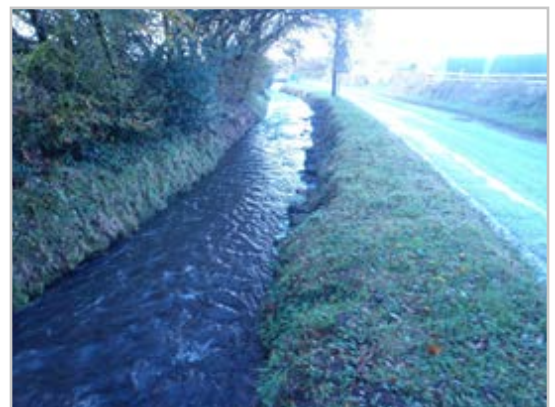
Flood embankment showing signs of erosion.
Source: Natural Resources Wales

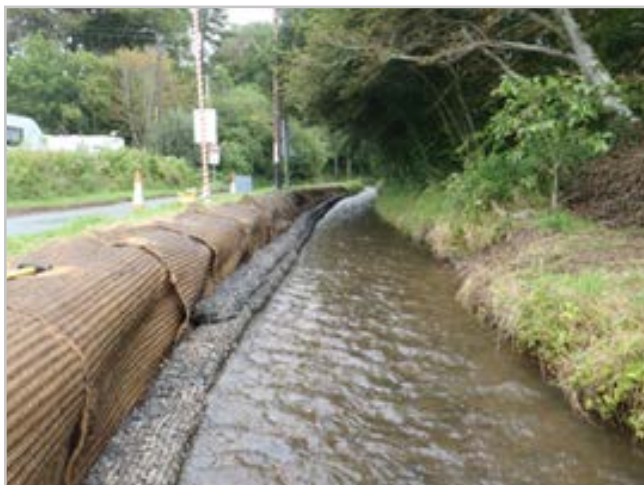
Repair work underway. Source: Natural Resources Wales

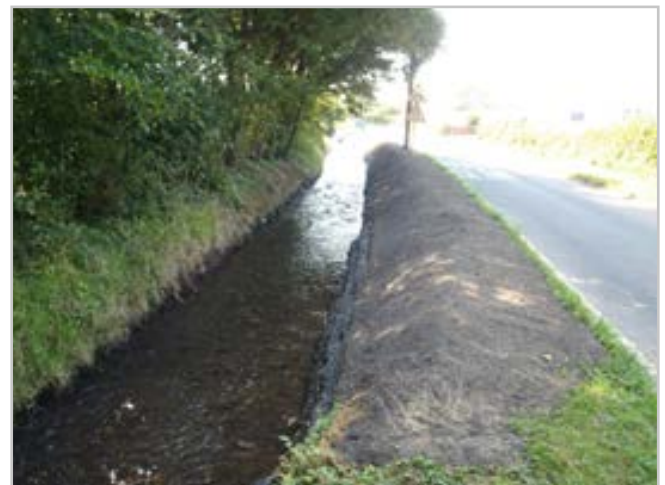
Completed works in September 2015. Source: Natural Resources Wales

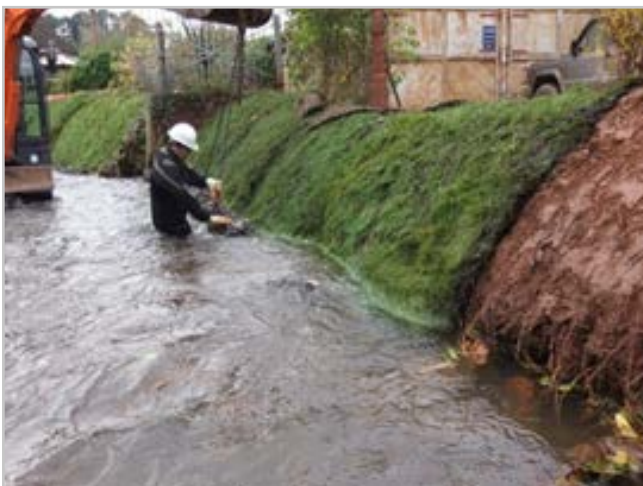
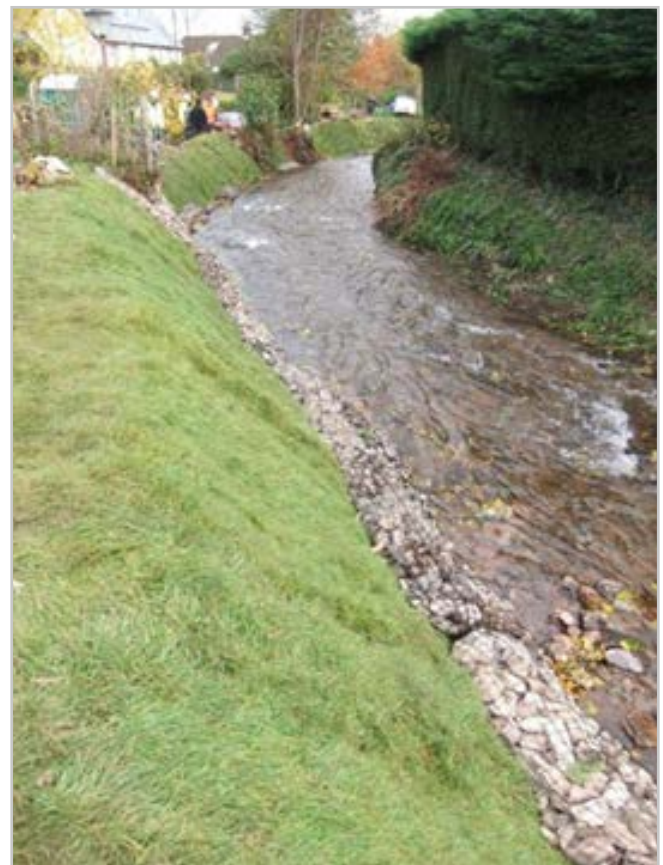
Left: Installation of toe protection (2013); Right: Completed works (2013). Source: Environment Agency
