Managing Legacy Infrastructure into the Future: The River Winster and Meathop Drain Flood Risk.

Abstract

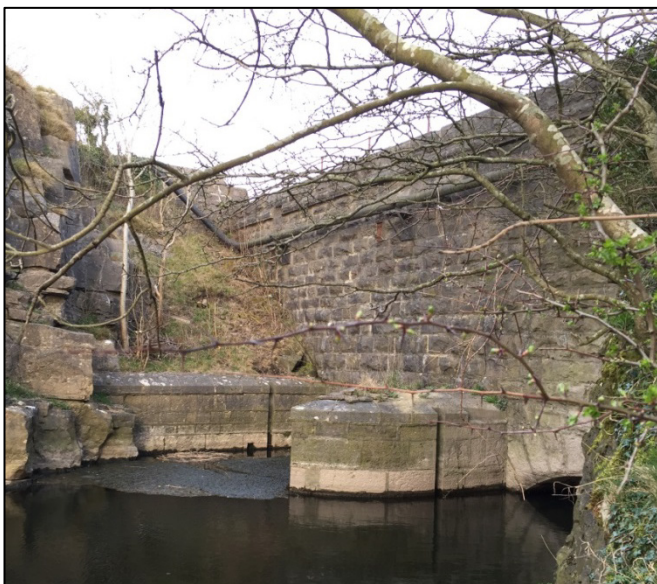
Figure 3. Photograph showing the upstream side of the tidal gates.

The River Winster (Figure 2) is the main water course passing through the tidal gates (Figure 3) with a small tributary called the Meathop Drain (Figure 4) running along the landward side of the embankment. The river is canalised for the reach immediately upstream of the tidal gate as it flows through relatively flat agricultural land (Figure 5). There are a small number of residential properties (Figure 6) and a nearby golf course.

To address the concerns that the tidal gates were frequently failing to operate the gates were inspected. The condition survey in July 2016 found that the gates were operating as expected. In October 2016 however there was a failure of one gate due to a hinge snapping and a restriction on the other gate's operation. As a result of this event one gate has been replaced and the other is scheduled for replacement in Network Rail's Asset Management Plan.

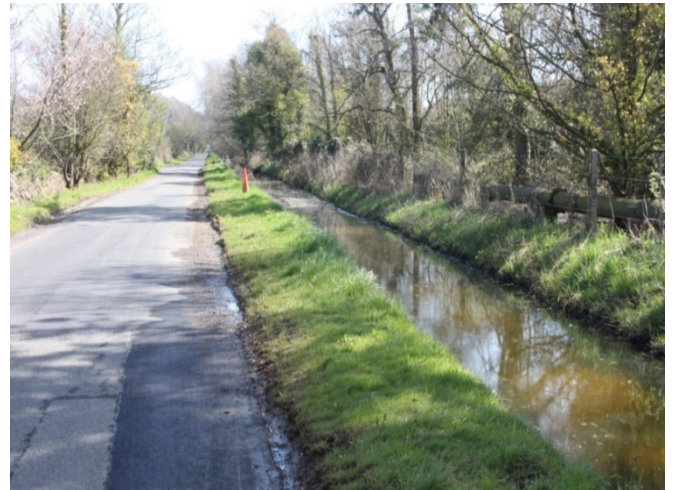
Figure 4. Photograph showing the Meathop Drain.

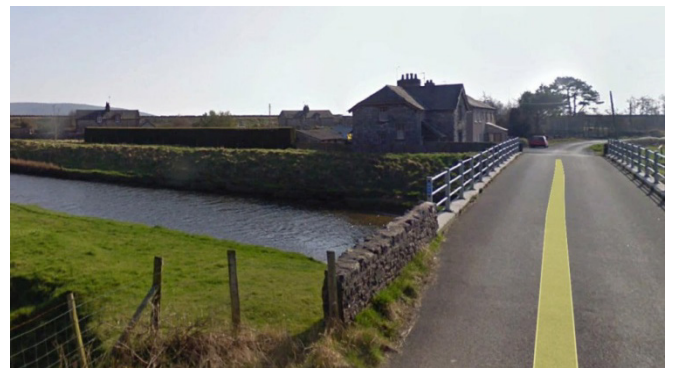
Figure 7. Photograph showing the rock training walls.

The sand within Morecambe Bay is extremely mobile causing the migration of drainage channels and has resulted in the construction of training walls for the two main discharges, the River Kent and River Winster, to enable efficient drainage into the bay. The River Winster is further controlled, as it flows under the embankment, by tidal gates that have been modified over the past 100 years. Since its construction the embankment has performed effectively as a coastal defence and still currently provides protection against significant coastal events. In recent times however the flood risk on the landward side of the embankment has increased from fluvial events and is anticipated to increase further due to climate change and other external factors. This paper will examine the possible causes of the increase and concludes that it is the natural processes of the estuary that have resulted in the increased flood risk. The implication for the future management of the embankment and river channels is also discussed.

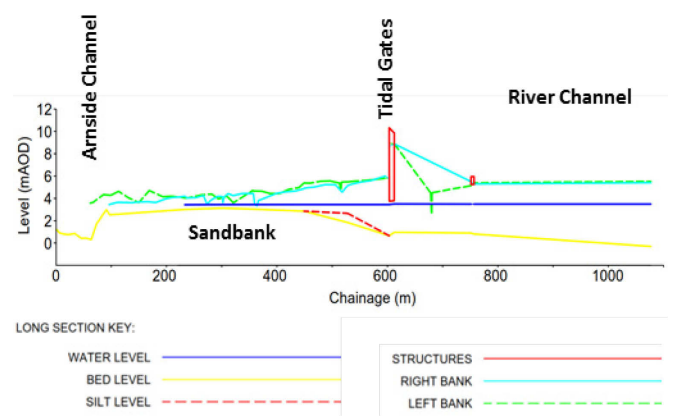
Figure 9. Long-section of the hydraulic model through the tidal gates
