Alde and Ore estuary, U.K. – levee overtopping performance – defence upgrade with 50 km of simultaneous overtopping

A.D. Hawes¹

¹ Hawes Associates, Aldeburgh, Suffolk

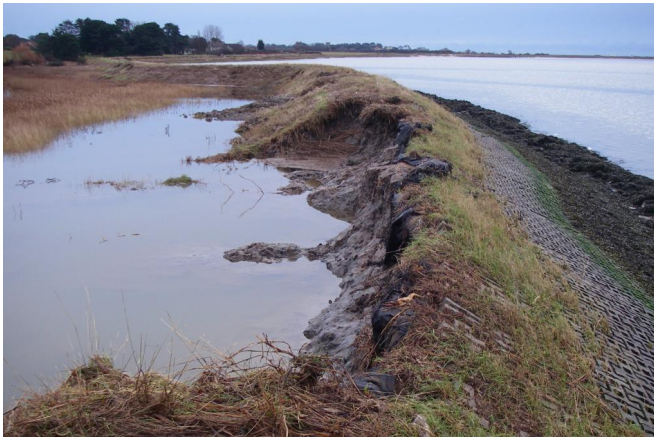
Photo 2 Typical overtopping damage, a shallow slip triggers rapid erosion. Here a full breach has been prevented by the Armourlok revetment.

The peak surge level of +3.1m O.D. in parts of the estuary caused significant over topping damage (photo 2 + 3) and a number of breaches (photo 4) together with flooding to around 30 houses.

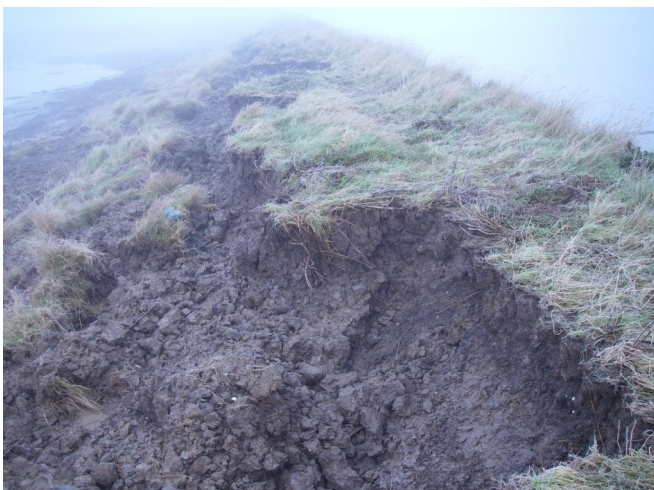
Photo 3 The “crumbly” nature of the exposed alluvial clay illustrates the extent of desiccation cracking.

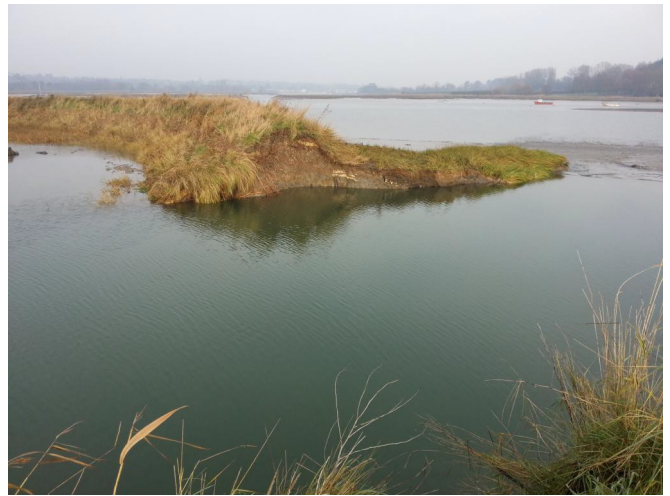
Photo 4 Hydraulic fracture can explain this particularly large breach. This wall had not been maintained and was heavily desiccated with cracking across its full width.

In extreme situations the cracking can result in hydraulic fracture, when the full hydraulic head of the flood surge is transferred through the cracking to the landward side of the levee, lifting blocks of material off the face. This situation soon develops into a breach of the river wall.

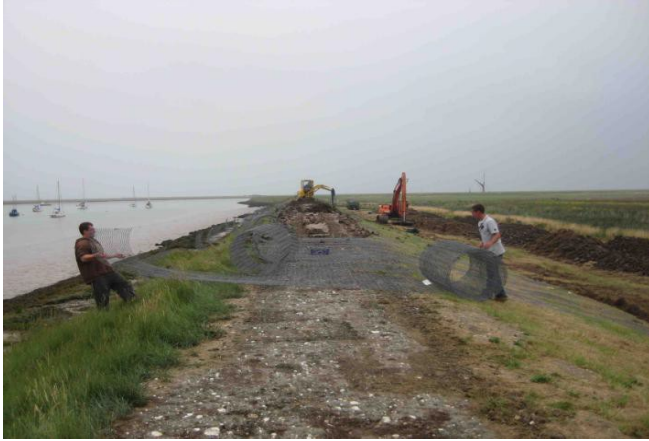
Photo 5

Pre cut 12.5m lengths of mesh are rolled across the levee (photo 5.) clay is then compacted and shaped along the crest and the mesh is pulled back tightly and fixed to itself and topsoil added (photo 6.).

Case history: 480m section of defence, south of Orford, raised by 0.4m to 0.7m using alluvial clay dug from behind the levee and compacted with a sheep's foot roller into a mesh (Double twist rock fall mesh, Galmac steel with UPVC cover, 40kN/m, joined with 316 stainless Spenax rings) encapsulated structure forming the new crest.

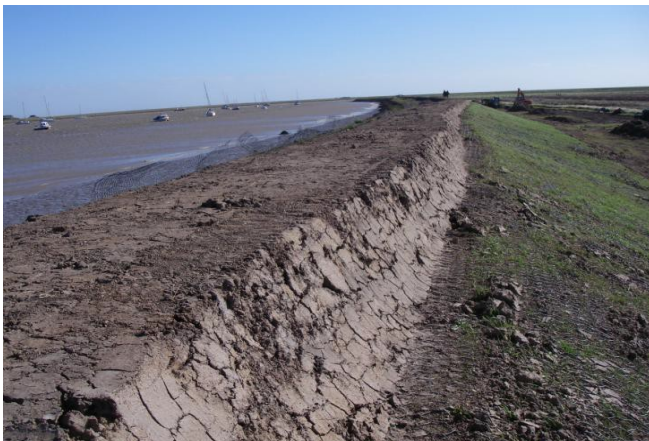
Photo 7

Compacted and shaped clay top (photo 7.) prior to mesh encapsulation, see 5m surplus on water side. Platipus stainless steel soil anchors are driven through the mesh for additional stability and mesh profiling (photo 8.).

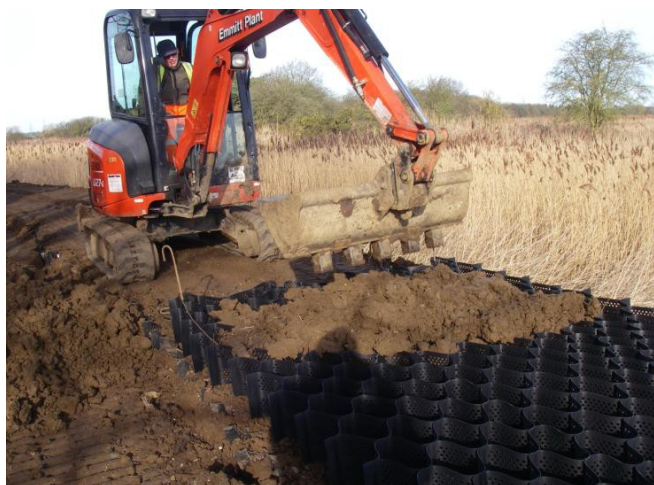
Photo 9

Clay compacted with adapted bucket with integral sheep's foot compactor into 5 horizons of cellular mattress (photo. 9) final finish with seeded topsoil and Ankalo pathway.

Case history: 80m section of defence, west of Snape Bridge, raised by 1.0m using clay washings from soil recycling plant compacted into a 20kN/m 200mm deep cellular confinement membrane. Five horizons of cells provide overtopping protection on the landward face. Ankalo revetment has been used to reinforce the pathway.

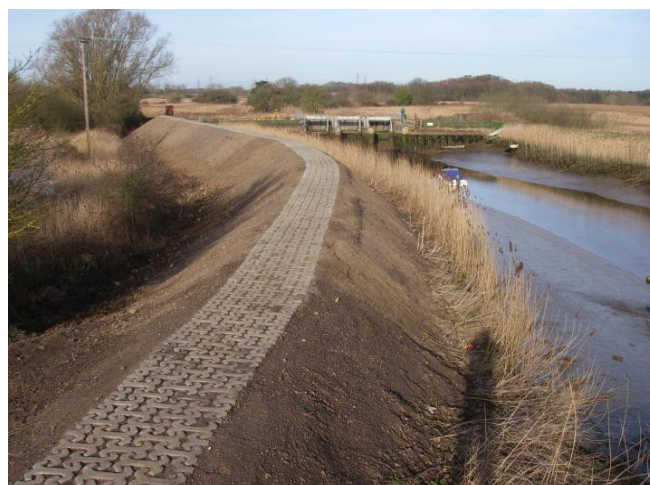
Photo 10

iv) Lowering and re profiling sections of a defence and, if overtopping time and velocity dictates, armouring them to create a spillway to allow full or partial inundation of the flood cell during the design event.

One of the three spillways constructed to date was at Havergate Island owned by the Royal Society for the Protection of Birds (RSPB). Here the small size of the flood cell is such that full inundation can take place rapidly during a North Sea storm surge.

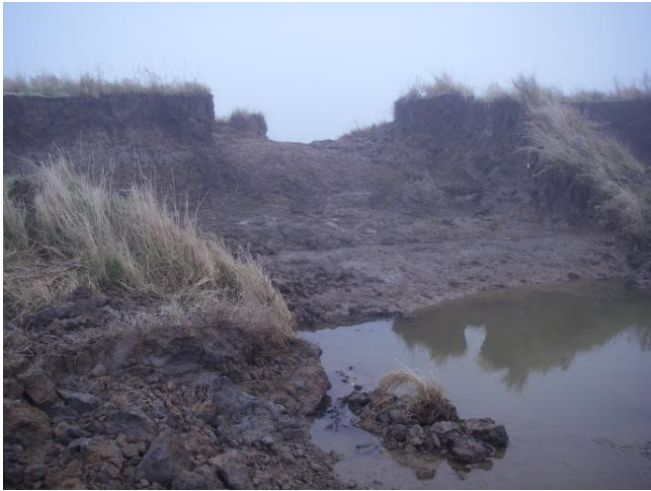
Photo 11

Condition after 2013 tidal surge (photo 11.). Completed and functioning spillway (photo 12.) grass needs to establish, further seeding required. Four overtopping events to date with no erosion due to rapid inundation time.

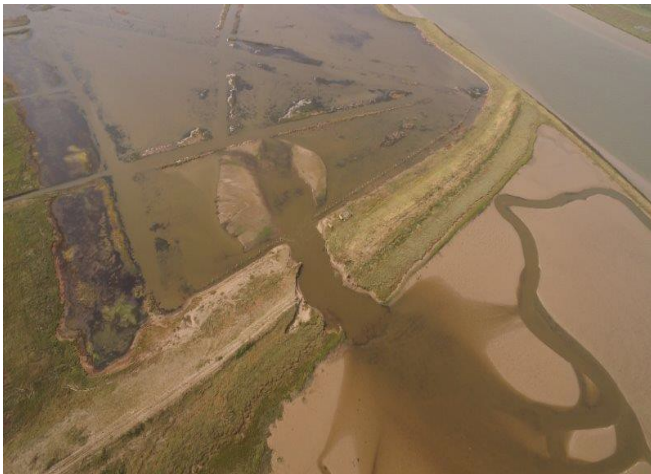
Photo 13

Breach from the air (photo 13.). Long reach machine to enable alluvial clay to be borrowed (photo 14.)

Case history: Repair of 30m wide breach on Orfordness. Alluvial clay used to build levee founded on a 40 kN geogrid. High performance geotextile (HPS 6 by Geofabrics) laid over 11o (1:5) spillway as foundation for 150mm deep gravel infilled cellular mattress.

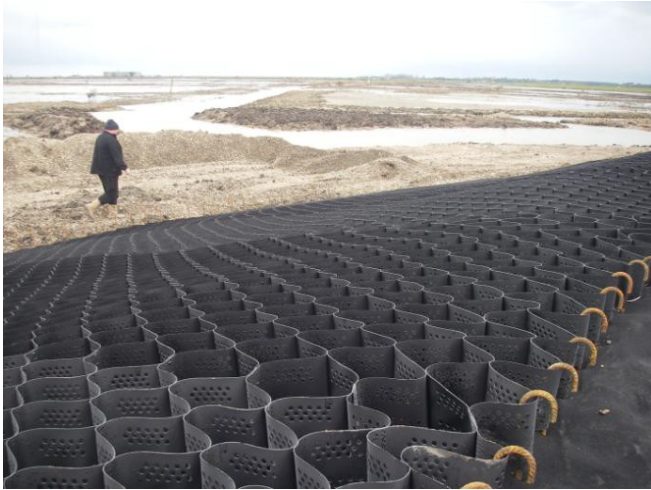
Photo 15 Cellular mattress prior to gravel filling

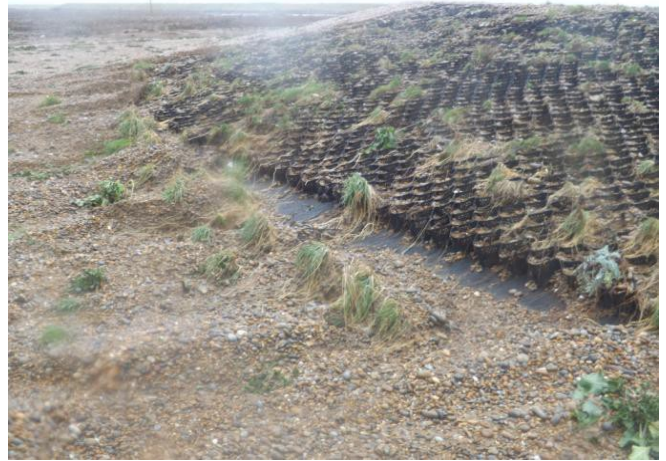
Photo 16 No damage from overtopping

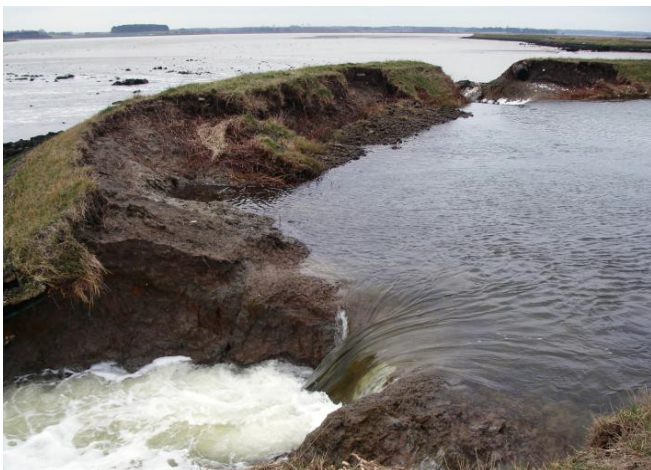
Photo 17

Multiple breaches in foreground with debris field visible beyond (photo 17.) Construction of new defence behind temporary tidal barrier of marsh clay (photo 18.).

Case history: Loss of 120 Ha. of grazing marsh to multiple breaches along a 1000m length of levee. Retreated defence in the form of a 400m long levee spillway. Alluvial clay used to build levee founded on a 40 kN geogrid with 11o spill slope (1:5).

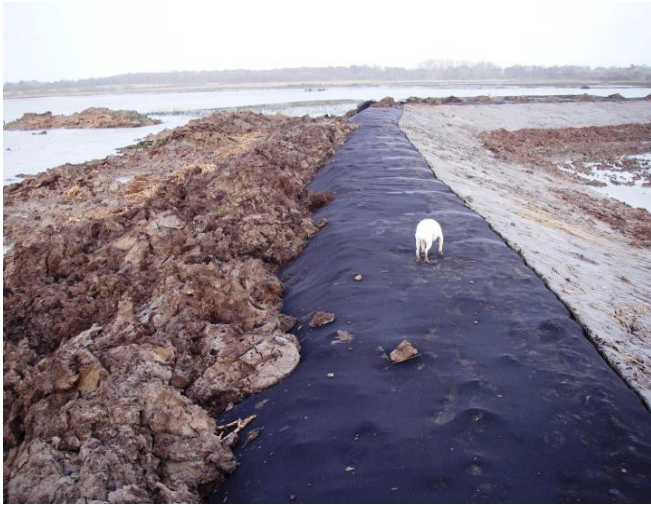
Photo 19

Introduction of high performance geotextile as erosion protection (photo 19.). First overtopping event resulted in full flood cell inundation and no damage to defence, sluice drainage in 48 hours (photo 20.).

High performance geotextile (HPS 8 by Geofabrics) to provide front face erosion protection. Hydro seeding to
