Hydraulics Research
Wallingford

A MACRO-REVIEW OF THE COASTLINE OF
ENGLAND AND WALES

2 The East Coast. The Tees to the Wash

Report No SR 107
November 1986

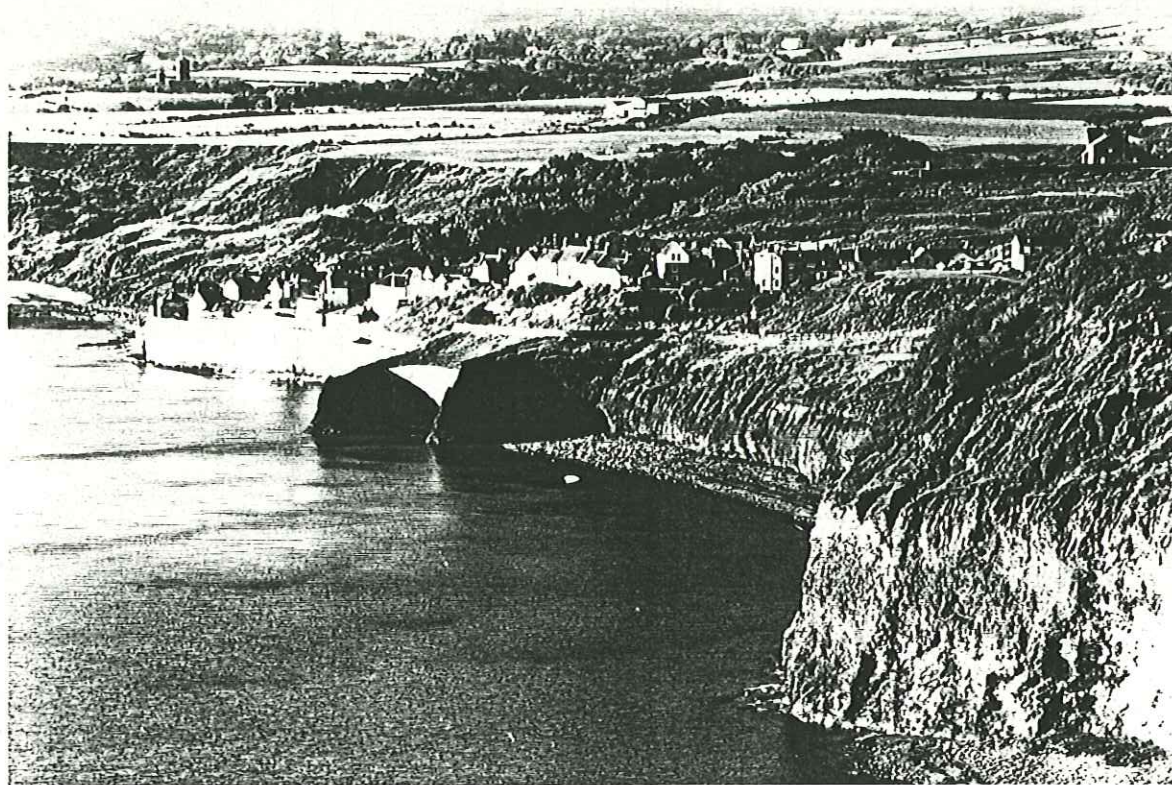
Plate 3 Robin Hood's Bay

rocks at the north end of the bay is evident in Plate 3 taken from near Ness Point. The village is in fact perched on steep, unstable slopes with a massive concrete sea wall at the toe of the cliffs. (Erosion caused several houses to fall into the sea and in 1974 a new massive 12 metre high concrete sea wall was constructed at the north end of the village.) The strength of the rocks towards Ness Point is variable and weak sections of cliff between more resistant outcrops north of the sea wall have also been faced with concrete (Plate 3). The beach within the bay is sandy and is reddish in colour, being derived from cliff erosion. There is a narrow upper beach of pebbles and boulders also from local erosion. In the centre of the bay aerial weathering has led to the formation of spectacular clay "stacks". The sand beach rests on a wave cut platform extending as much as $\frac{1}{2}$ km seawards at low water. Despite the obviously rapid erosion of the boulder clay cliffs in the centre of the bay the beach is relatively narrow and thin. The present sea wall appears to be adequate from the point of view of sea defence, though it remains to be seen whether it has sufficient mass to prevent slumping of the cliff slopes above it. There is severe "terminal erosion" at the junction between the south end of the sea defences and the unprotected clay cliffs beyond. However, there appears to be no cliff top development at risk in this area. Remnants of old concrete walls at the south end of the village suggest that the sea wall may have extended further south once. Clearly erosion at the southern end of the wall will continue to be a problem in future years. Due to the high reflectivity of the massive sea walls protecting the village it is likely that beach scour will also become a problem in the future.

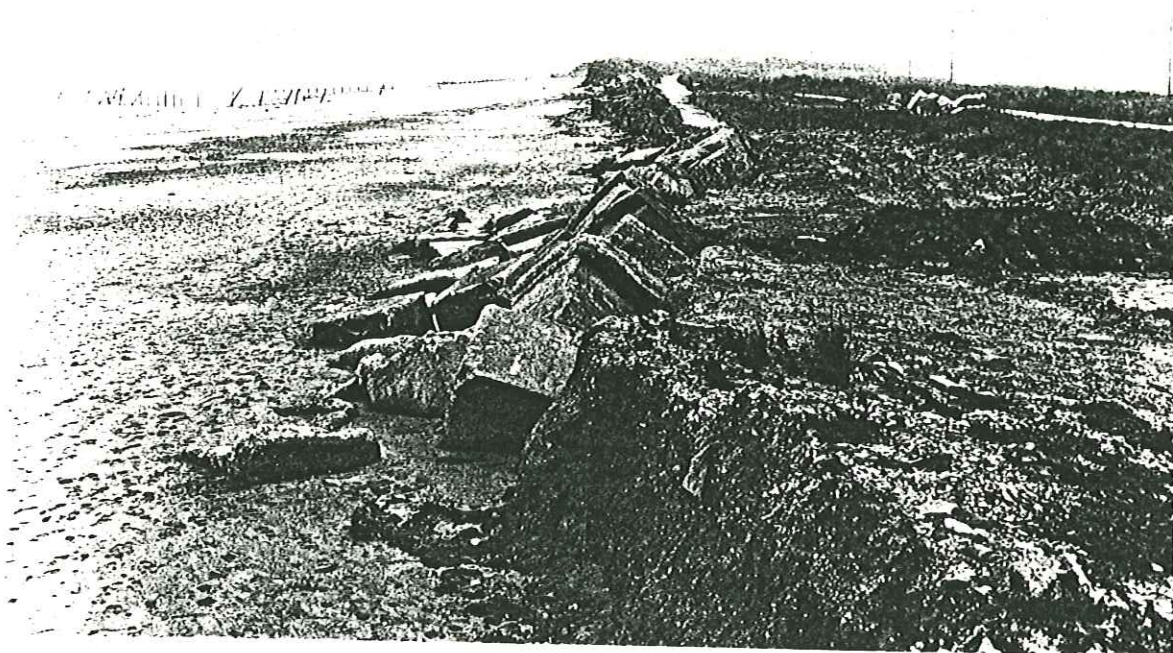
Plate 8 The neck of Spurn Peninsula

The threat of breaching is ever present at the narrowest point south of Kilnsea Warren. The artificial defences have tried to fix the position of the coastline but have failed to accumulate sand. At the same time, these have increased its vulnerability to destructive wave action by making the spit unable to 'roll back' and maintain an equilibrium plan shape with the Holderness cliffs.

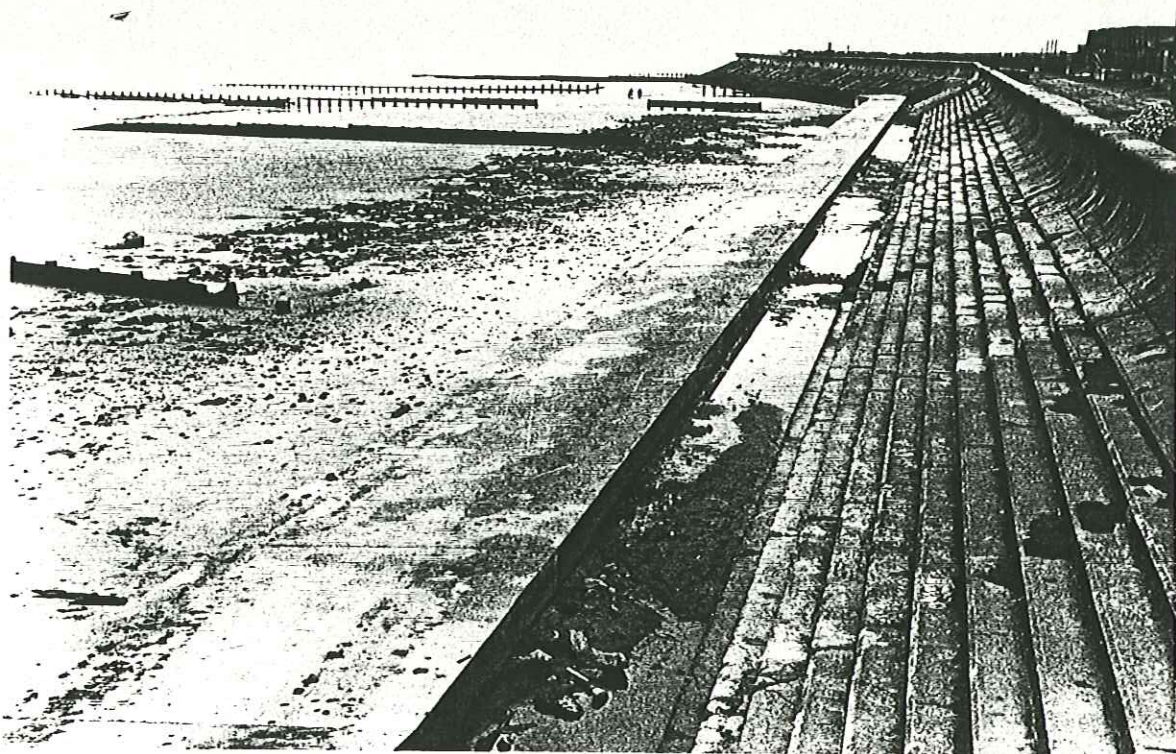
Plate 9 Sea wall at Convalescence Home, Mablethorpe

At Mablethorpe the concrete sea walls have been in place for many years and the promenade now projects seawards of the general line of the coast due to some recession adjacently. The sand beach is still quite wide but is not very thick over the boulder clay. Certainly it is insufficient to give protection against wave attack during storms, when the material is eroded down to the clay base. Onshore/offshore sand movement is particularly marked in this area and the groynes are insufficiently long to trap much of the net southward drift. The groynes were maintained until the 1970's but repair costs have now become prohibitive. Plate 9 shows the very poor condition of the groynes and low beach levels opposite the Convalescent Home, Mablethorpe. The town is situated on low lying land and is protected against flooding by the sea wall. This wall extends southwards to Huttoft. Certain key stretches of coast have not been allowed to recede and the sea wall forms small promontories, eg at the south end of the town frontage. At these points beach levels are particularly low. The sea wall at the south end of

Mablethorpe is being reconstructed, with the addition of massive concrete footings. The defences south to Trusthorpe are in poor condition and the wall shows signs of being overtopped, even in relatively calm weather.

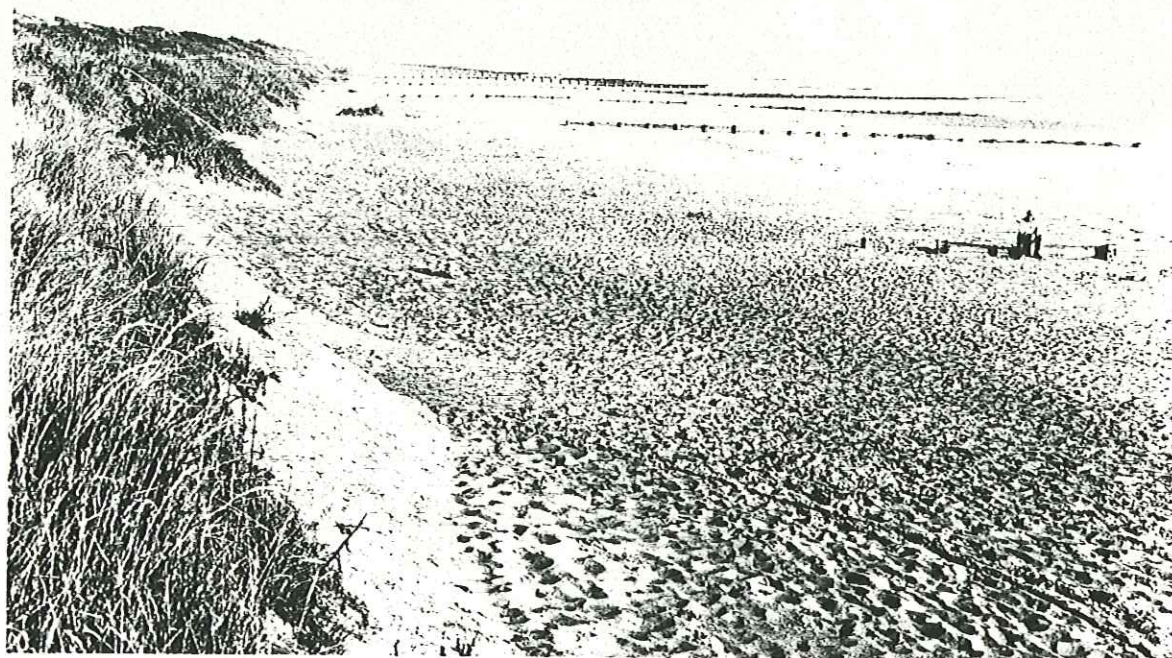
Plate 11 Wide sand beach - Anderby

almost buried in sand. The embankment is almost completely vegetated and the beach is healthy (Plate 11). As with the stretch of coast further northward it is difficult to discern the magnitude of littoral drift.
