**BANK PROTECTION USING EMERGENT PLANTS AGAINST
BOAT WASH IN RIVERS AND CANALS**

A J Bonham

Report No. IT 206
December 1980
Crown Copyright

**Hydraulics Research Station
Wallingford
Oxon OX10 8BA
Telephone 0491 35381**

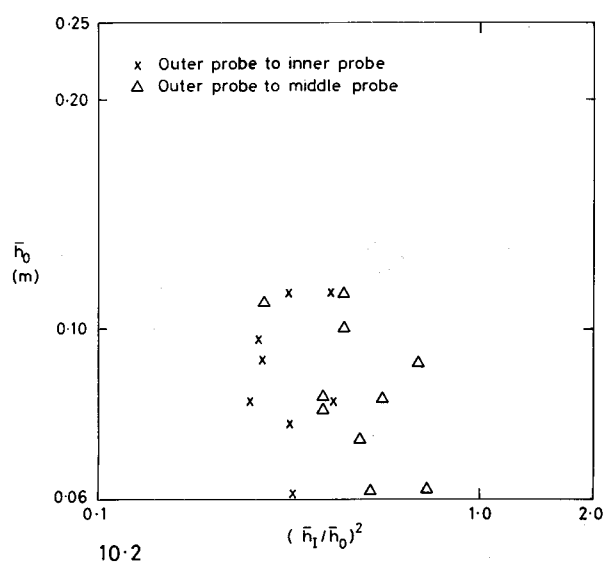
- 10-1 *Phragmites australis* (syn. *P. communis*)
common or Norfolk reed
- 10-2 *Schoenoplectus lacustris* (syn. *Scirpus l.*)
common clubrush, greater rush or bulrush
- 10-3 *Typha angustifolia*,
lesser or narrow leaved reed mace
- 10-4 *Acorus calamus*, sweet flag (reed)
- 10-5 Control beach, without vegetation

Energy reduction, mean of five highest ship waves

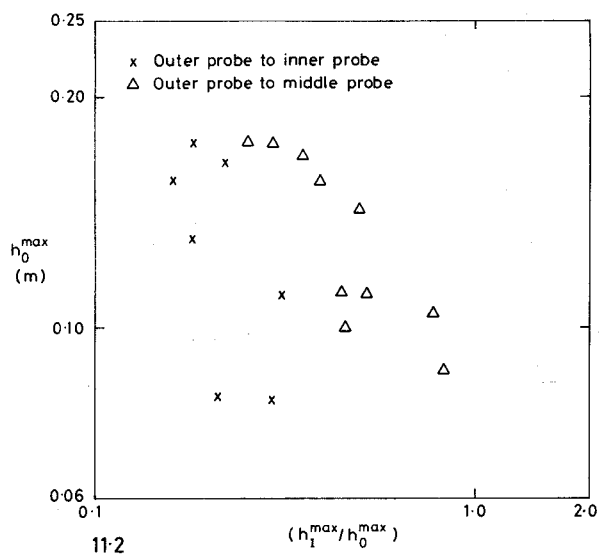
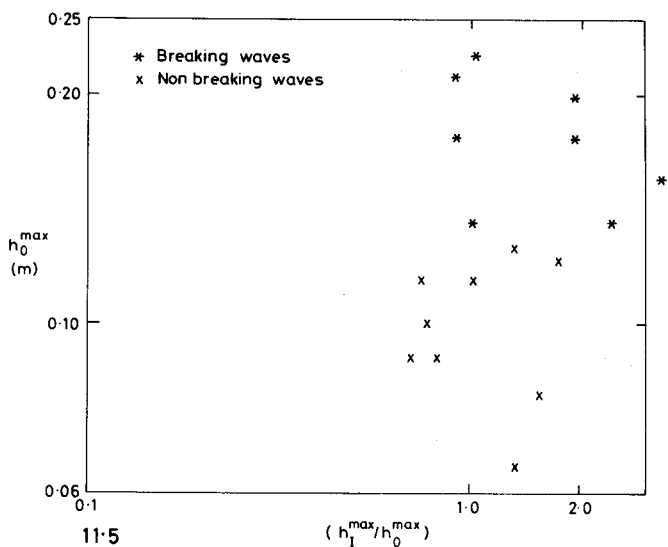
- 11.1 *Phragmites australis* (syn. *P. communis*)
common or Norfolk reed
- 11.2 *Schoenoplectus lacustris* (syn. *Scirpus l.*)
common clubrush, greater rush or bulrush
- 11.3 *Typha angustifolia*,
lesser or narrow leaved reed mace
- 11.4 *Acorus calamus*, sweet flag (reed)
- 11.5 Control beach, without vegetation

Energy reduction, maximum height of ship waves

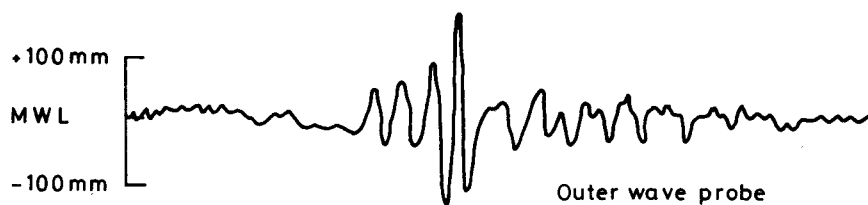
B. Boat wash at C.S.1.

For a modern multichine hull form
 Phragmites australis, common or Norfolk reed

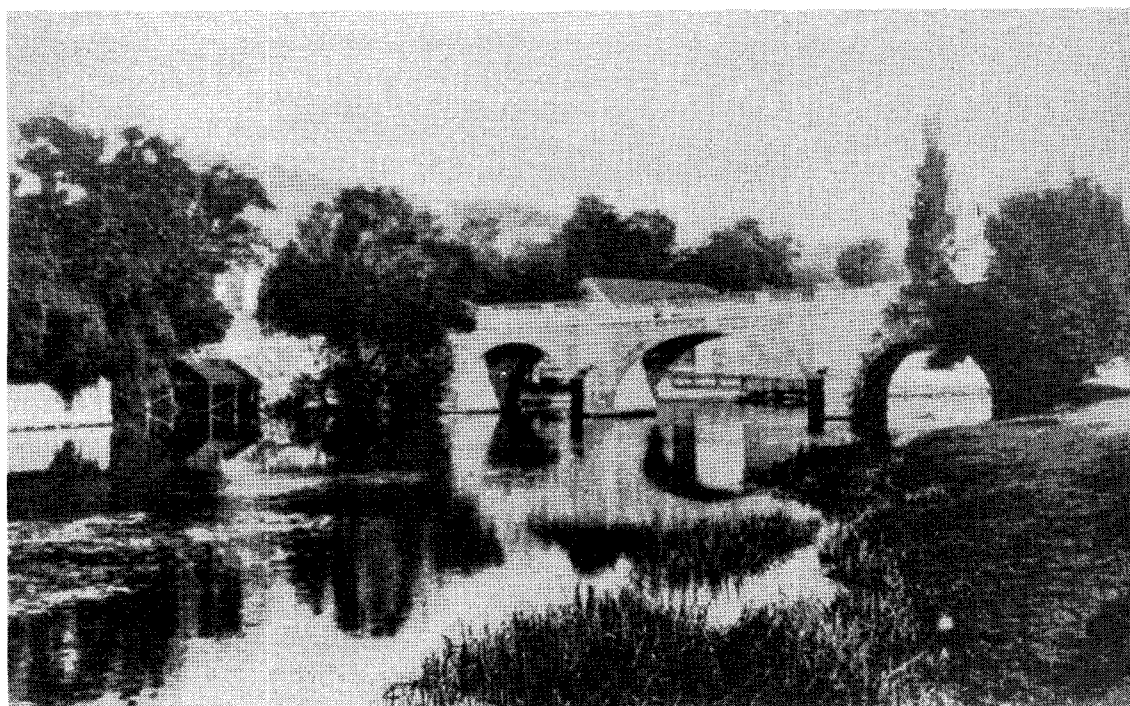
PLATE 1 Right bank below Wallingford Bridge in 1910, showing emergent and floating leaved rooted river plants

The Norfolk Broadland rivers and particularly the Rivers Bure, Thurne and Ant near Horning were selected for study. The numerous old photographs⁽⁷⁾ available show that before the onset of heavy holiday motor cruiser traffic the rivers were much narrower, were flanked by continuous thick stands of emergent river plants and contained extensive areas of floating leaved rooted plants. See Plates 1 to 4.

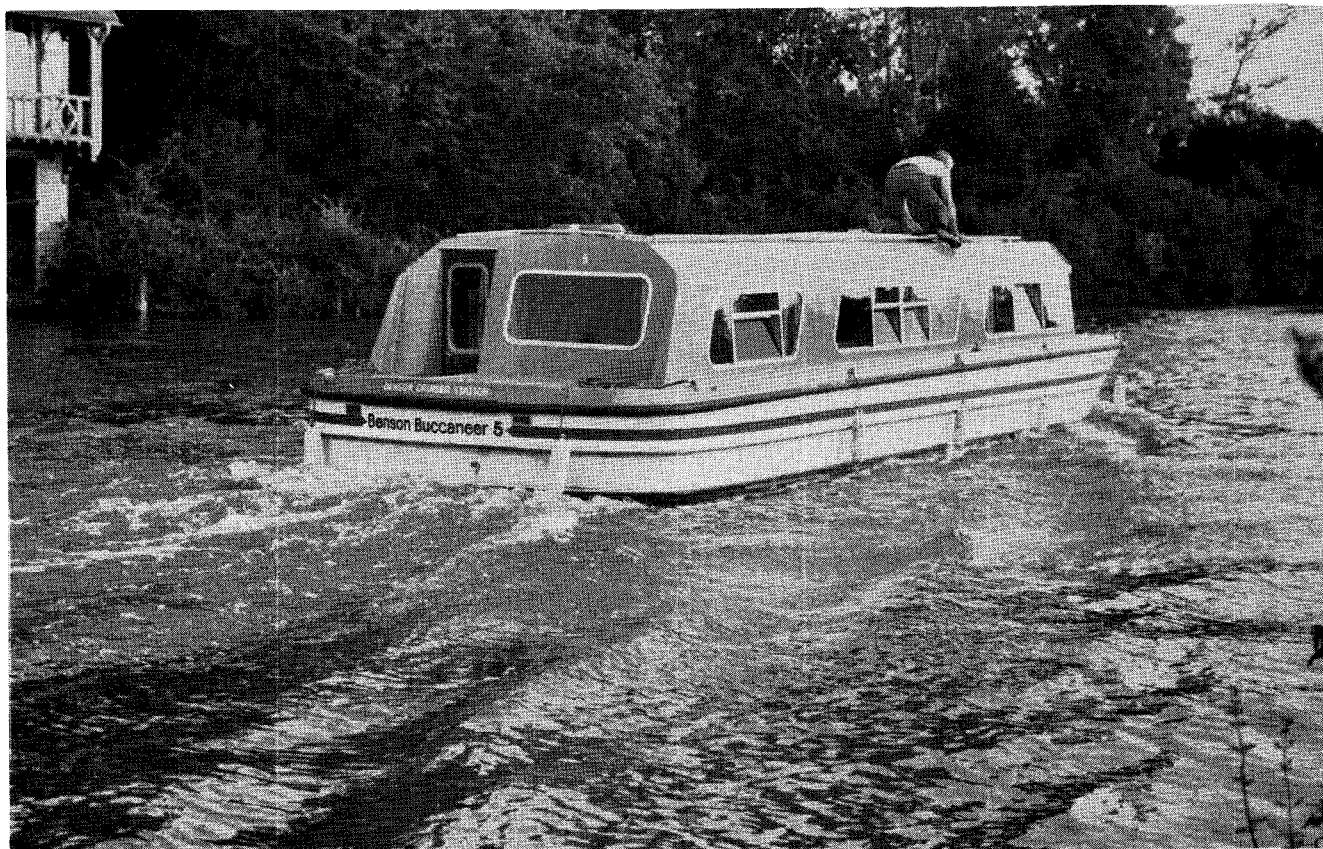
PLATE 5 'Wide' recreational motor boat on the River Thames passing the Hydraulics Research Station wave recorder

Five distinct categories of boat hull form were recognised (Plates 5, 6 and 7) as follows:
