**PROCEEDINGS
WORKSHOP ON
CANAL LINING AND SEEPAGE**

18-21 October, 1993
Lahore - Pakistan

Publication No.120

**PROCEEDINGS OF THE
INTERNATIONAL WORKSHOP
ON
CANAL LINING AND SEEPAGE**

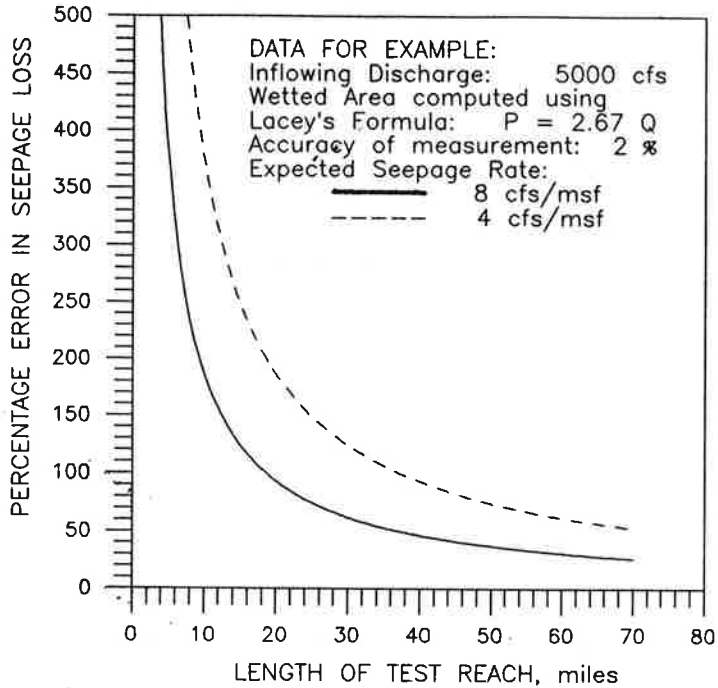
- (vi) errors in discharge measurement are independent and random in both sign and magnitude. It can also be noticed that where seepage loss rate is low, test reach should be even longer.

Figure 4. Plot of error in seepage loss vs. length of test reach.

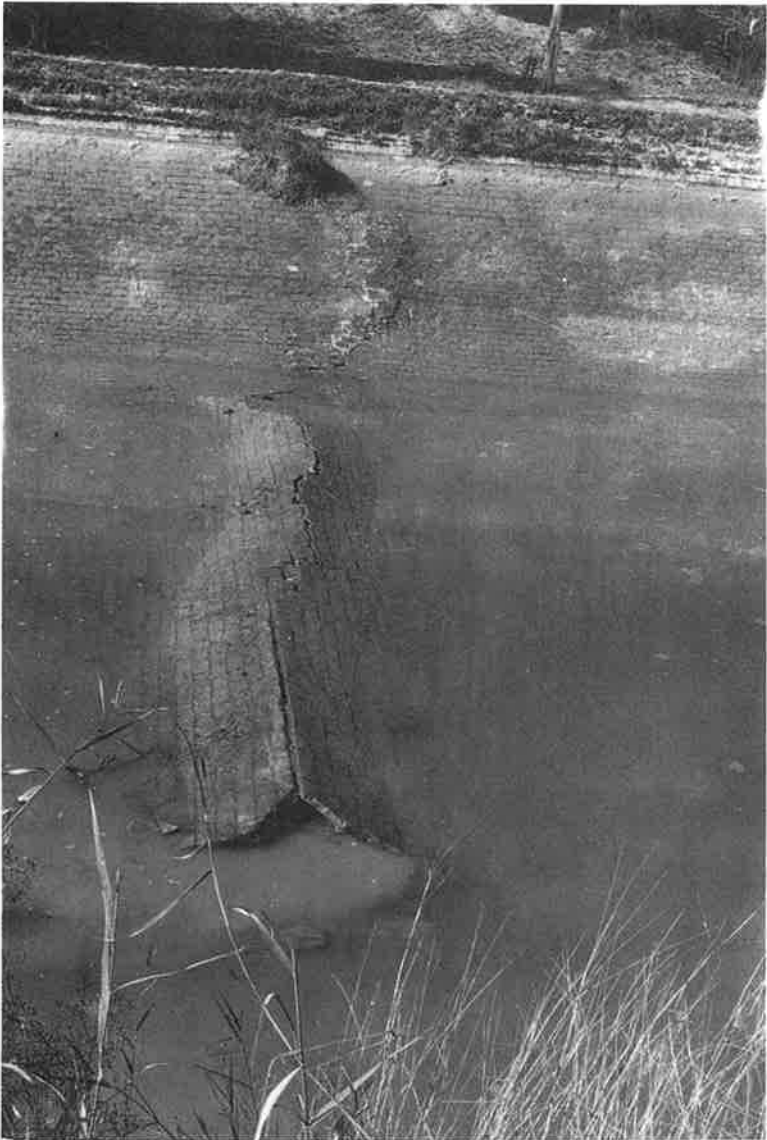
Figure 4A. Lined Bed of Haveli Canal Lift-up by Water Pressure.

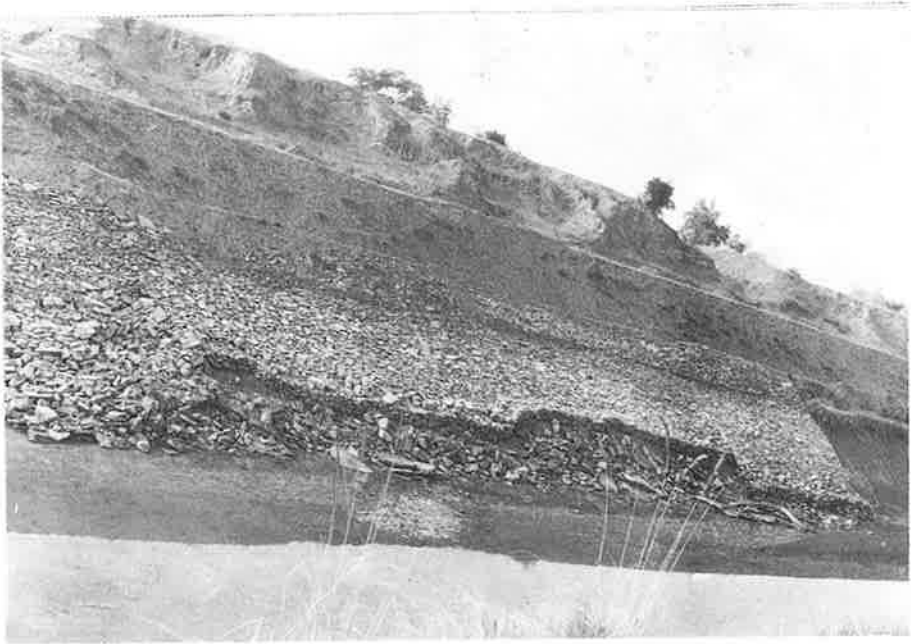
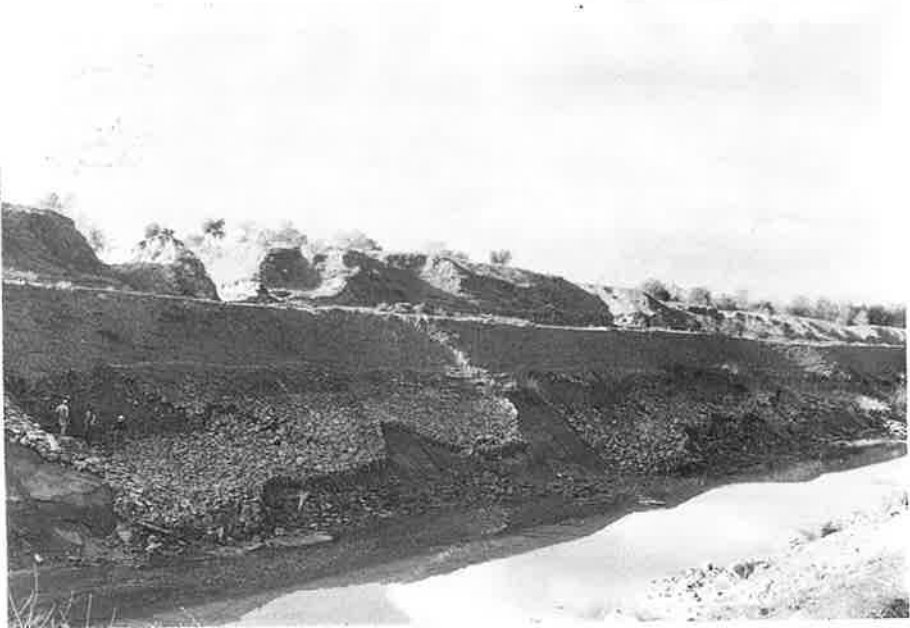
Figure 4B. Specimen of Damaged Lining of Thal Main Line Upper.

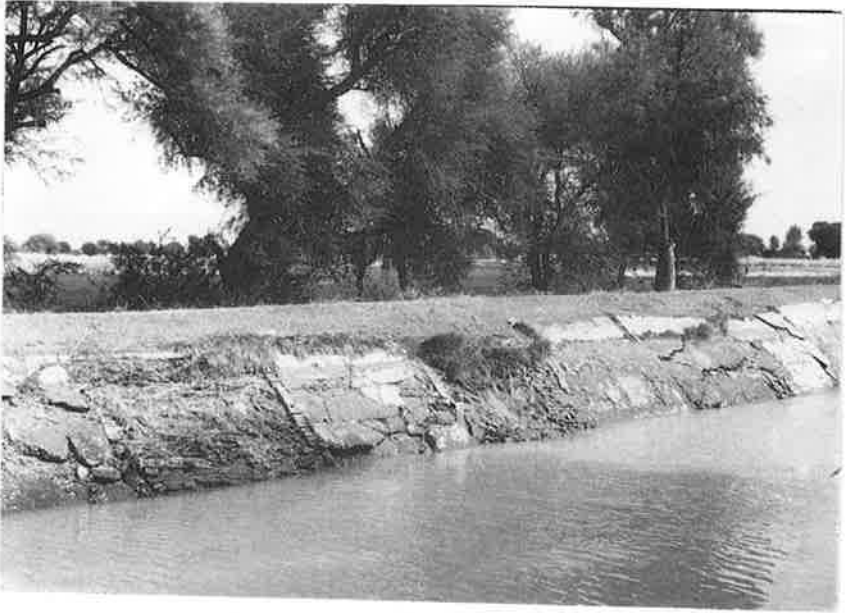
Figure 4C. Damaged Lining of Mohajar Branch.

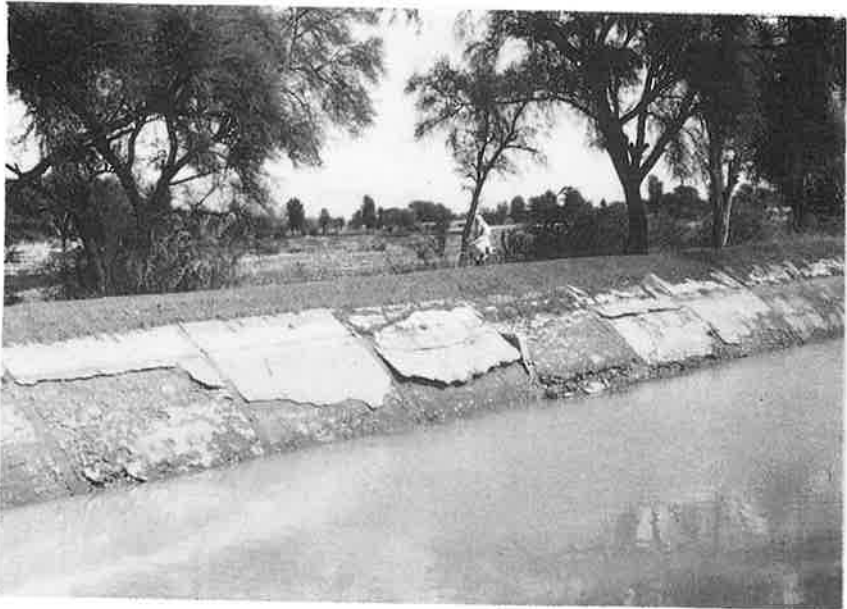
Figure 4D. Damage to Plaster Used to Repair Lining Mohajar Branch.

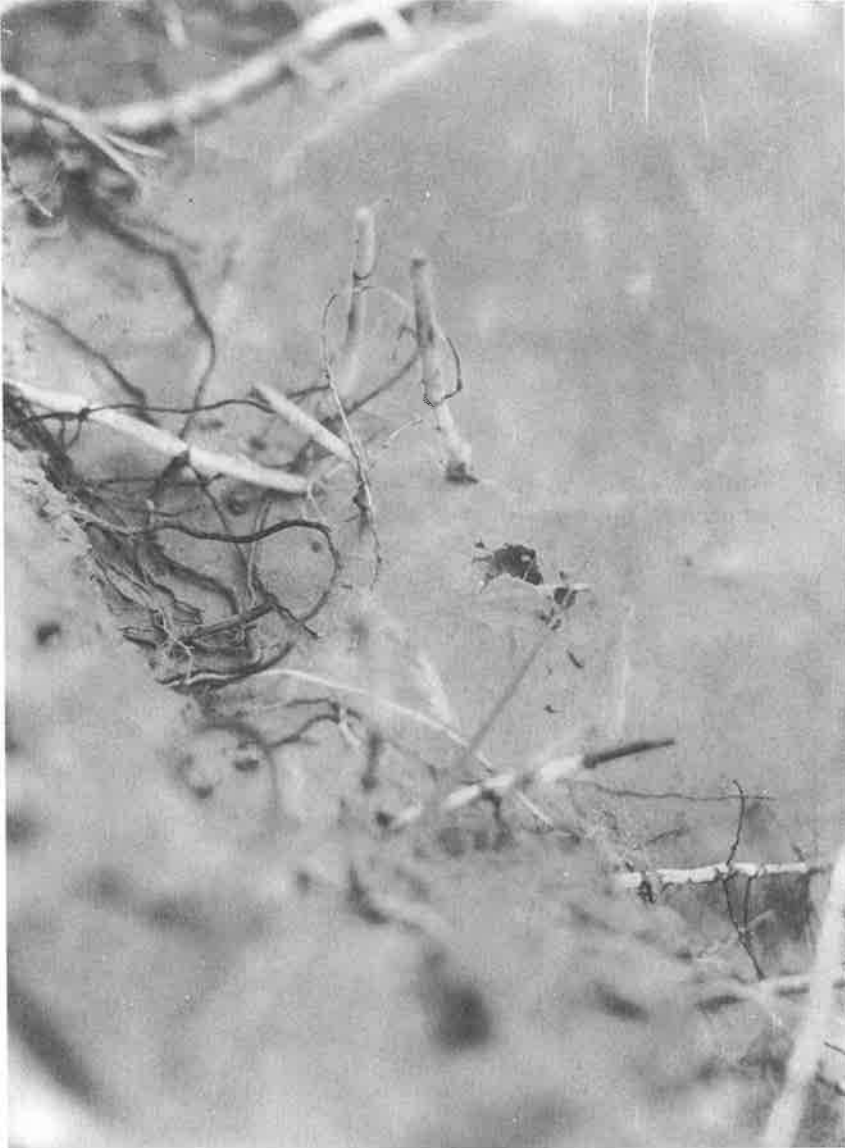
Photo 1. Weed roots puncturing the polyethylene sheet, observed after removing the soil cover (Field study).

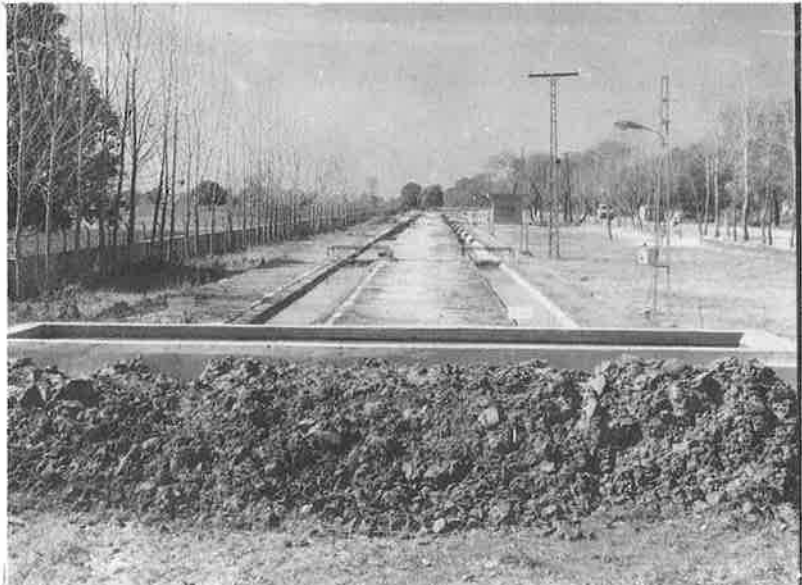
Photo 3. Permanent experimental set up of water channels for testing various lining materials at Niaz Beg Research Station, Lahore.

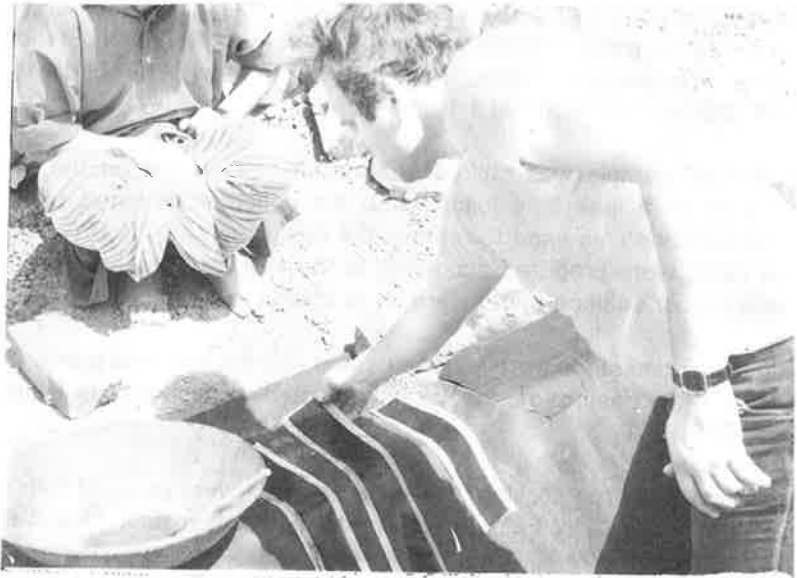
Photo 4. Butyl adhesive strips prepared prior to joining the Taurus rubber sheet with pillars Niaz Beg Research Station, Lahore.

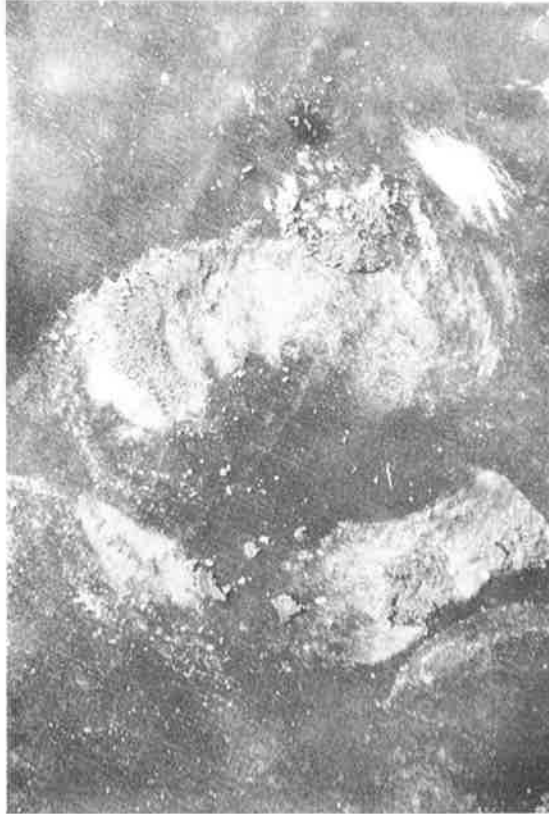
Photo 9. A view of the buffalo hoof print - indicating no damage to Mizu rubber sheet at Nandipur Research Station, Gujranwala.

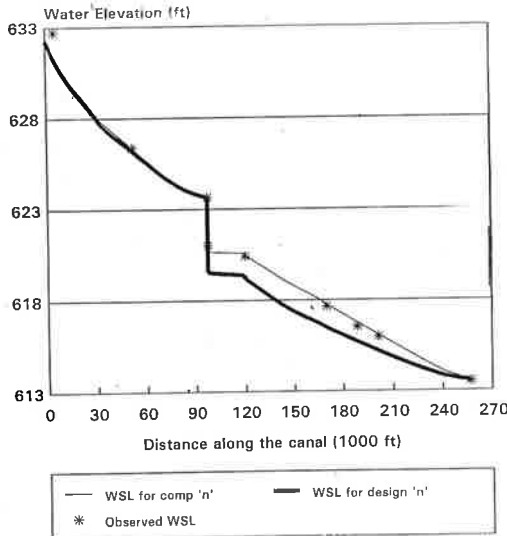
Figure 2. Water profile at 2800 cfs inflow comparison of design and computed 'n'.
