Examples of recent floods in Europe

Donald Knight and Paul Samuels

Reproduced from a paper published in
Journal of Disaster Research
Volume 2, No 3, 2007

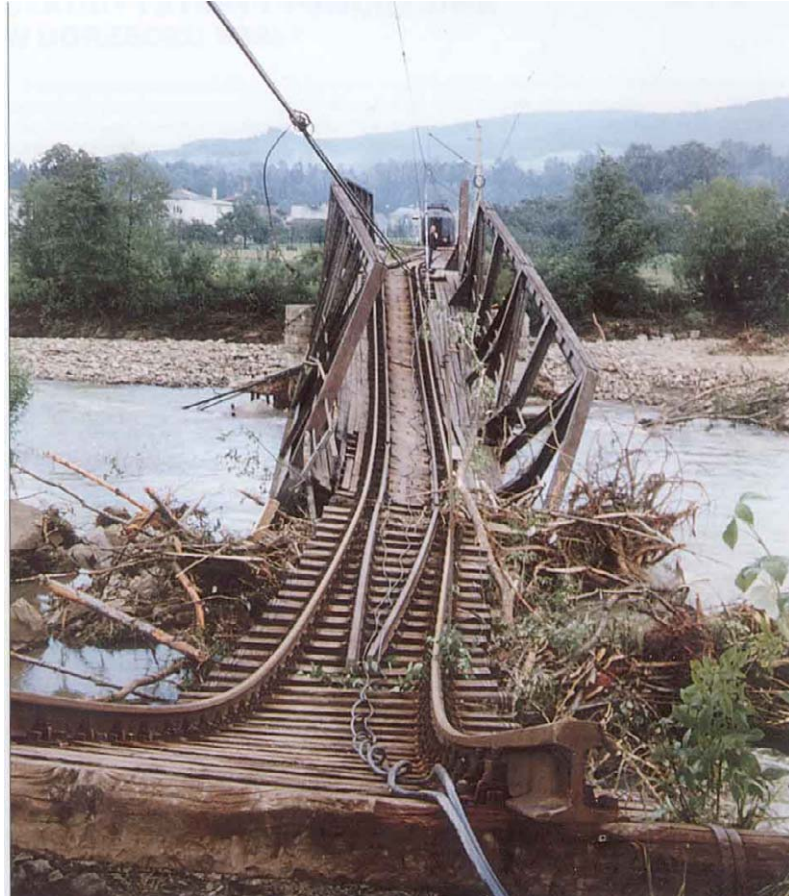
Figure 1 Flood damage in the Oder River basin, July 1997 (Courtesy IHR)

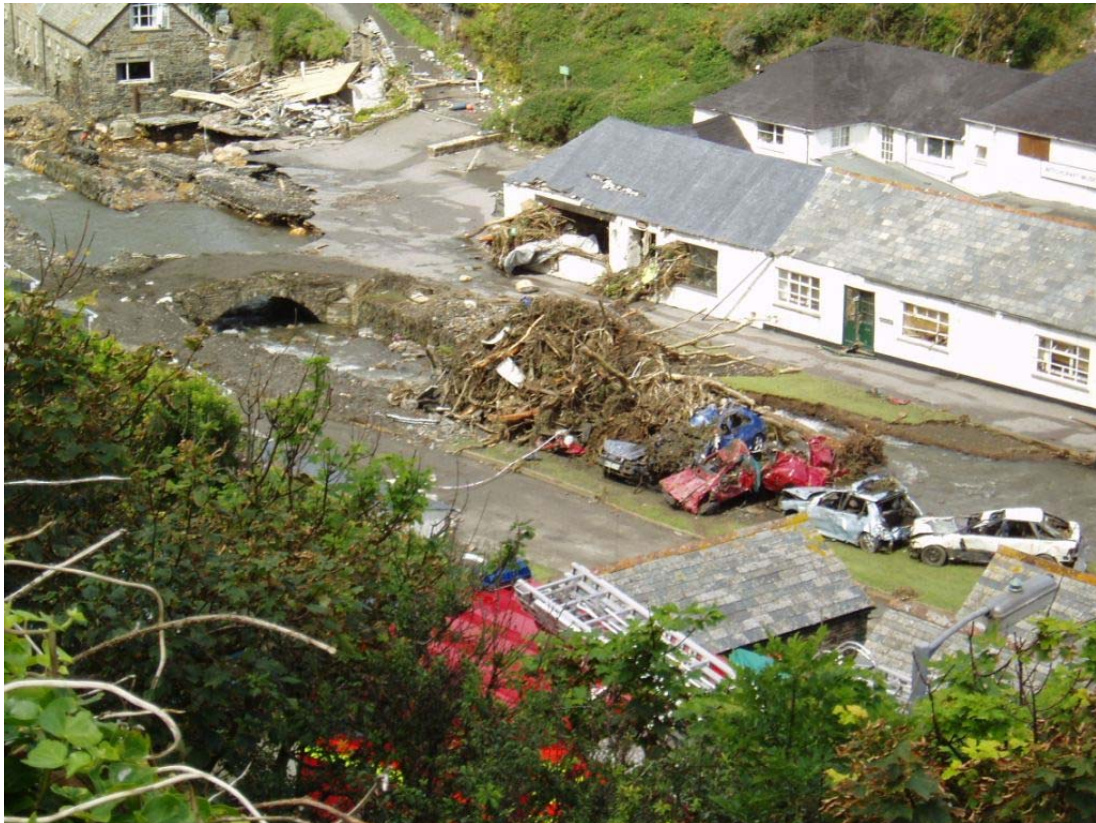
Figure 2 Flood damage in Boscastle, UK, August 2004 (Courtesy HR Wallingford)

topography of the steep-sided valley inevitably accentuated the run-off, causing a surge of water, reported by eye-witnesses to be some 3 to 4 m high, to travel down the valley and through Boscastle at an estimated speed of 65 km/h, causing serious damage and distress (see Fig 2).

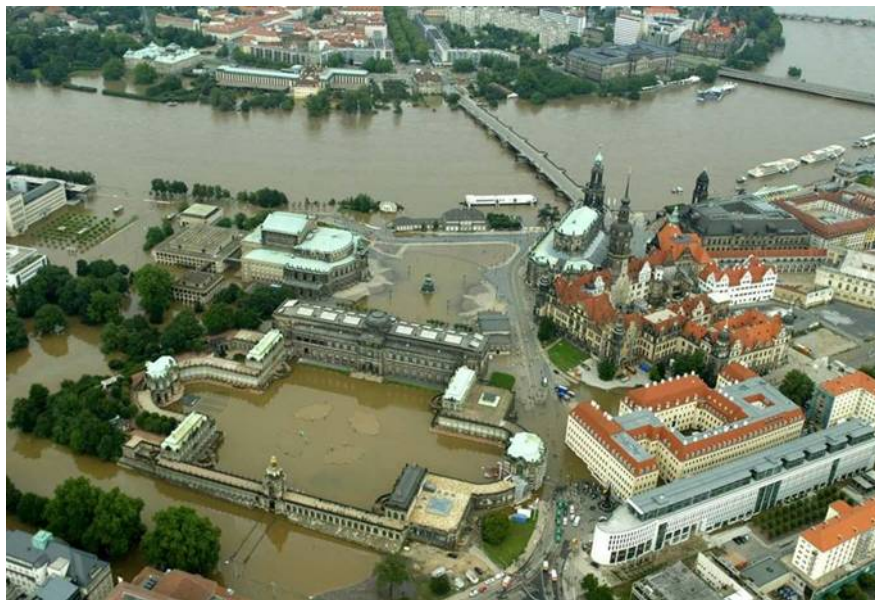
Figure 3 Flooding of the Elbe River at Dresden, August 2002 (Courtesy IOER, Dresden)

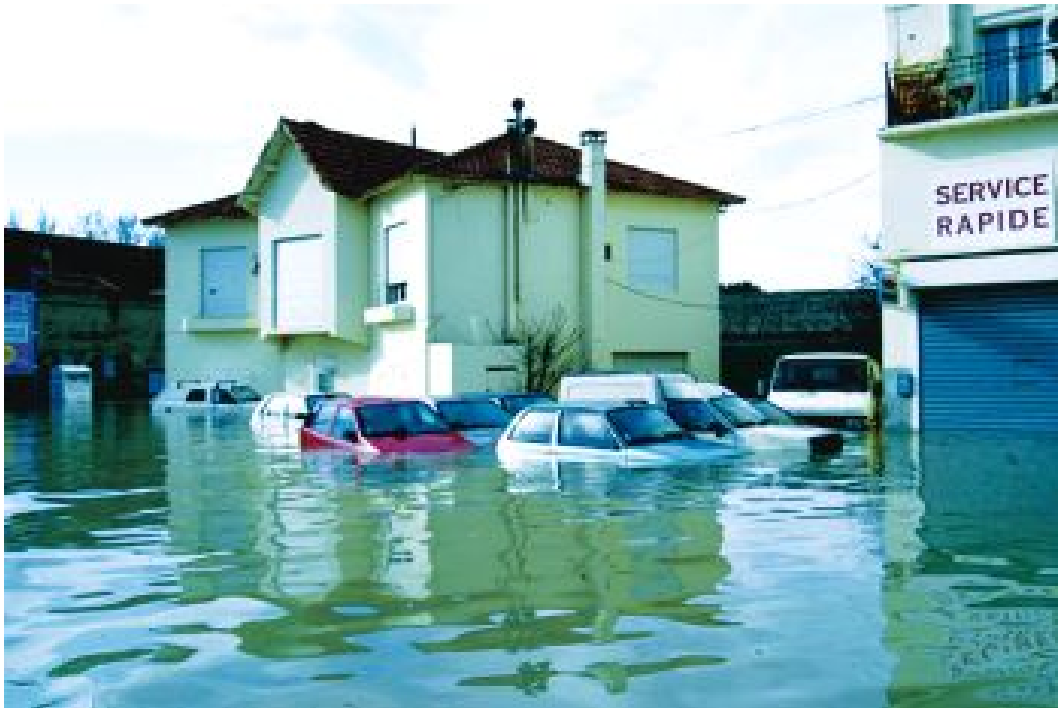
Figure 4 Flooded street in the Rhône flood of December 2003

Following near constant rain in October 2003, river levels rose throughout the Autumn and between Dec 1-3 powerful storms hit the Rhône valley and Marseilles area with 200 mm of rain. In nearby Montpellier half of its average annual rainfall fell in a single night. As a result, the river reached its highest ever recorded level for 100 years (6.42 m at Marseilles). In Avignon, the river was 2.8 m above its normal warning level, and at Pont-Saint-Esprit it reached an unprecedented 4 m above the warning level. The flood inundated some 80,000 km², thousands of buildings, and caused 27,000 people to be evacuated, including 193 prisoners who had to be transferred from ground floor cells to upper floors. In the village of Aramon, where 5 people died from floods in 2002, the rebuilt dykes were in danger of over-topping. In Bollene, 80 elderly people had to be evacuated from their home into temporary shelters. The water depths reached up to 1 m in many parts and over 2 m in some industrial areas, causing severe disruption to both road and rail links (see Fig. 4). The number of deaths was estimated to be 15.

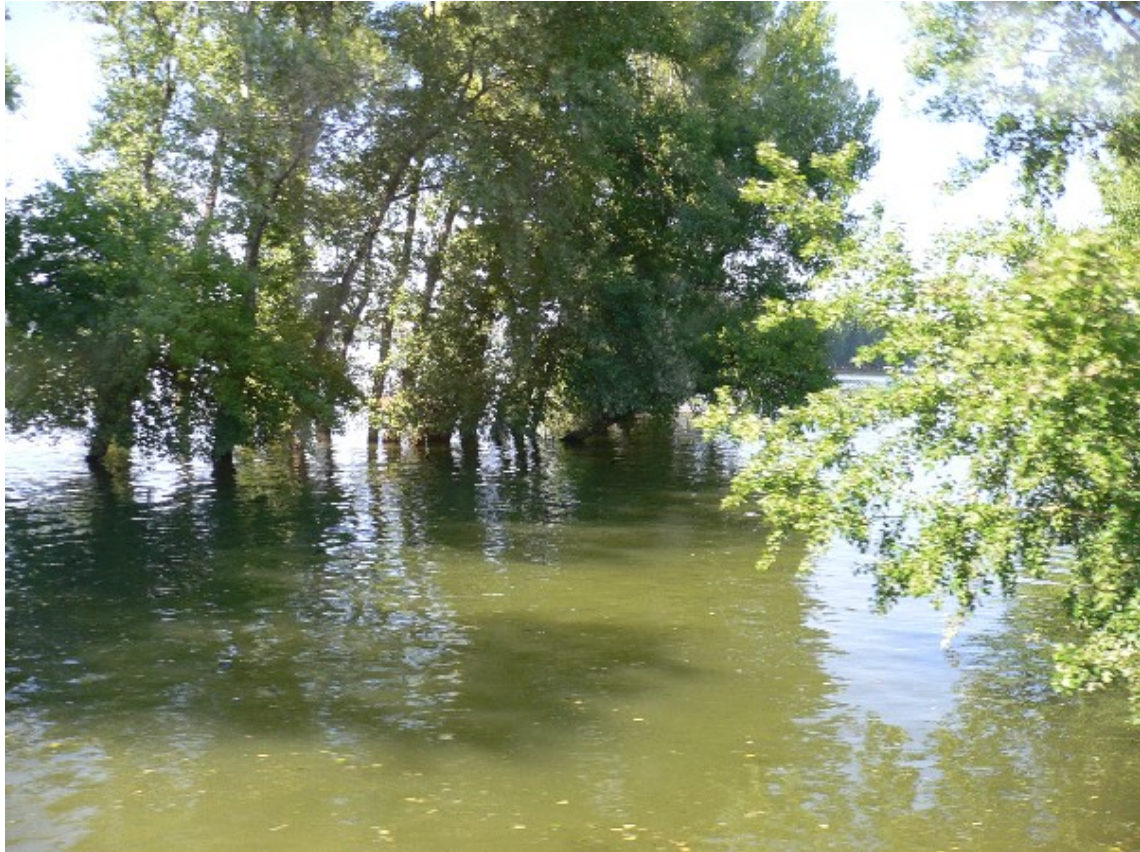
Figure 5 Danube flood retention in the natural floodplain near Galati

According to World Wildlife Fund (WWF), the ongoing flooding of the Danube in Romania is the result of bad land use planning and mismanagement along the entire length of the river. As a result of man-made changes, including channelling and construction of dykes and dams for navigation and traditional flood management, the Danube River has lost 15,000–20,000 km² of floodplains since the 19th century, with less than 19 per cent of the former floodplains remaining. When natural retention zones are lost on the upper reaches of the river, the problem simply gets transferred further downstream, with increased impacts and damage. The view of the WWF is that an integrated and internationally coordinated approach to flood management that works with nature, not against it, is needed for flood security along the entire length of the river. The new EU Floods Directive could provide the kind of integrated approach to flood management that is needed for flood security in future, but it will depend on the way that the legislation is implemented. The aim must be to ensure that economic activities in flood risk areas bear the costs of flood defence measures and that other EU member states should also promote other flood mitigating measures, such as maintaining and restoring floodplain areas, which can store water and thus limit the impact of floodwaters. An example of a restored floodplain area is shown in Fig. 5.

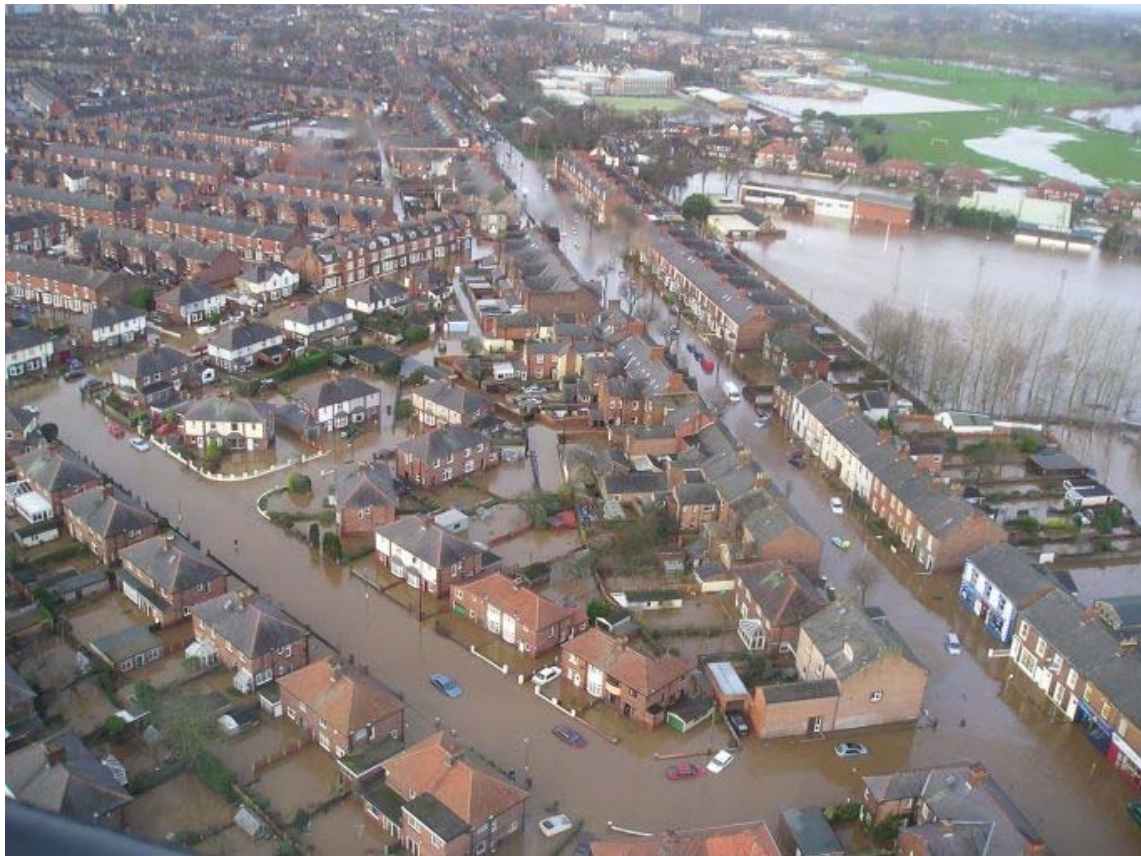
Figure 6 **Flooding in Carlisle, January 2005 (Courtesy Environment Agency UK)**

The worst floods for over a century hit Carlisle in January 2005. Over 1 month's rain fell in 24 hours, forcing 6,000 residents to be evacuated from their homes and to be placed in emergency accommodation overnight. The river level rose to over 1 m above its previous highest recorded level on Eden Bridge in 1822. At one point some 3,500 properties and 350 business premises were seriously affected and 70,000 homes were without power. See Fig. 6.
