HRPP 399

A laboratory Study of Overtopping and Breaching of Shingle Barrier Beaches

Charlotte Obhrai, Keith Powell & Andrew Bradbury

Reproduced from a paper presented at:
International Conference on Coastal Engineering 2008
Hamburg, Germany
31 Aug - 5 Sept 2008

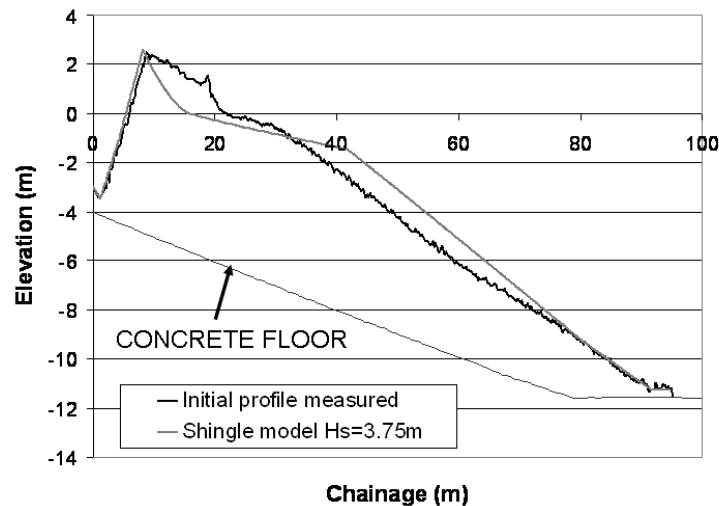
Figure 3 Shingle model prediction for test 2, bay 2 (D50=16mm).

particularly for the finer sediment. Figure 3 gives an example where the SHINGLE model predicted the correct threshold for failure of the barrier beach. The original hydraulic tests used to derive the SHINGLE model were based on sediment of a similar size to the finer material that was used ($D_{50}=16\text{mm}$). However SHINGLE was not calibrated to work with much coarser sediment similar to that used in Bay 4 ($D_{50}=57\text{mm}$). It is therefore not surprising that it did not work so well for the coarser sediment used. Figure 4 shows the same test as the previous figure but shows the results for the coarser sediment. SHINGLE predicted the initial profile reasonably well but the position of the crest for the failed profile is beyond the back of the barrier. This implies that SHINGLE would have predicted failure too soon. Unfortunately SHINGLE did not perform well for the swell wave conditions but it is also important to note that the original tests from which the model was derived did not include many swell wave conditions. In general SHINGLE predicted a much higher crest elevation than was actually measured for the swell wave conditions.

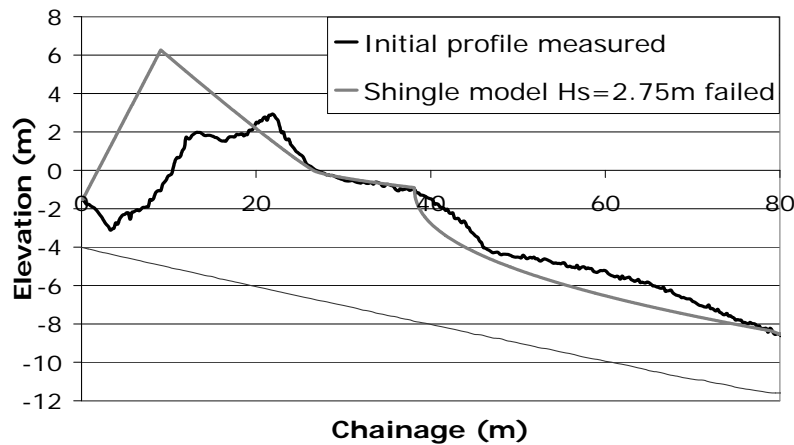
Figure 4 Shingle model prediction for test 5, bay 2 (D50=16mm).

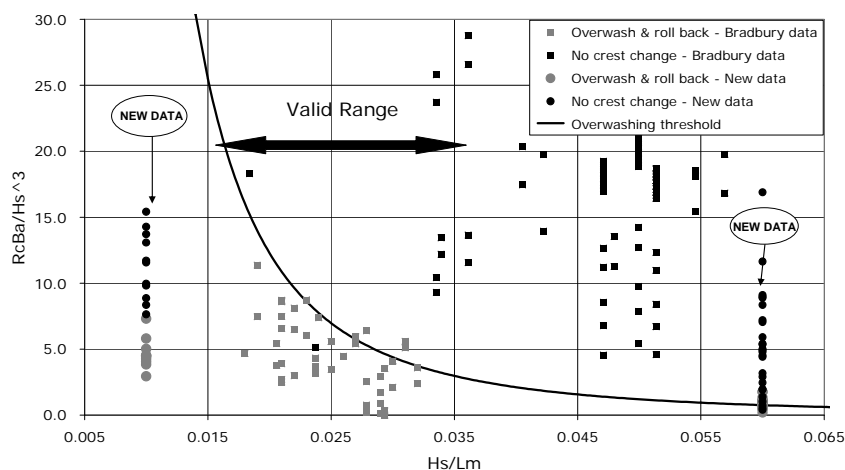
Figure 5: A comparison between the empirical approach of Bradbury (2000) and the combined field and model data.

Figure 4 shows a comparison between the threshold curve (2) and the field and model data used to derive the curve combined with new physical model data. Being below the curve implies that breaching will occur. It is clear from the new physical model data that extrapolation of the empirical model is not valid and that the predictive curve needs to be modified. This empirical model only includes the effects of wave steepness and barrier cross-sectional area. Results from the physical model tests indicate that the sediment size and the barrier geometry

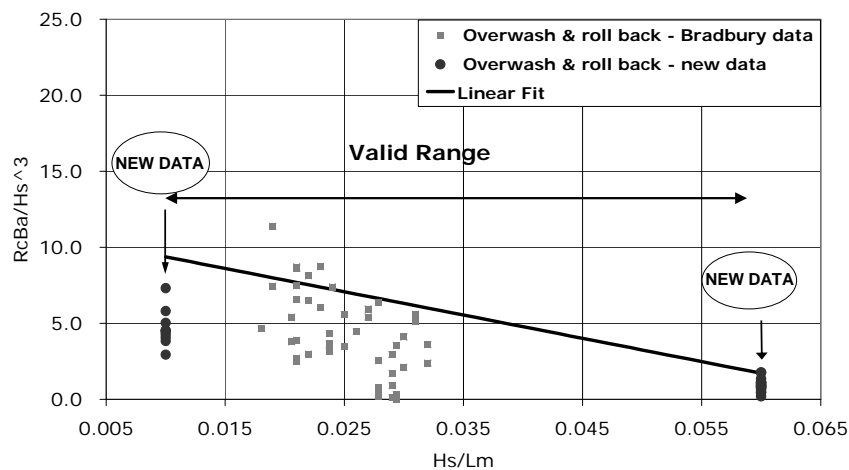
Figure 6: A comparison between the modified empirical curve and the combined field and model data.

The Bradbury model over predicts the threshold for breaching for swell waves and under predicts the threshold for steeper storm waves. By combining the previous field and model data with the new physical model tests a new more widely applicable model to estimate the threshold for the breaching of shingle barrier beaches can be developed. Figure 6 shows the combined field and laboratory data set with the new empirical curve to describe the upper limit for the threshold of failure of a shingle barrier beach. Three different types of regressions were investigated (Linear, Exponential and Logarithmic) and the results showed that all three were a significant improvement on the Bradbury threshold in view of the new data. However the simple linear fit provided the best description of the upper limit for the threshold for breaching and can be described as follows:

$$\frac{R_C B_A}{H_s^3} < -153.1 \frac{H_s}{L_M} + 10.9 \quad (3)$$
