HRPP 425

## Historical experience of vertical breakwaters in the United Kingdom

Reproduced from a paper presented at:  
Coasts, Marine Structures and Breakwaters 2009 Conference  
EICC, Scotland  
16-18 September 2009

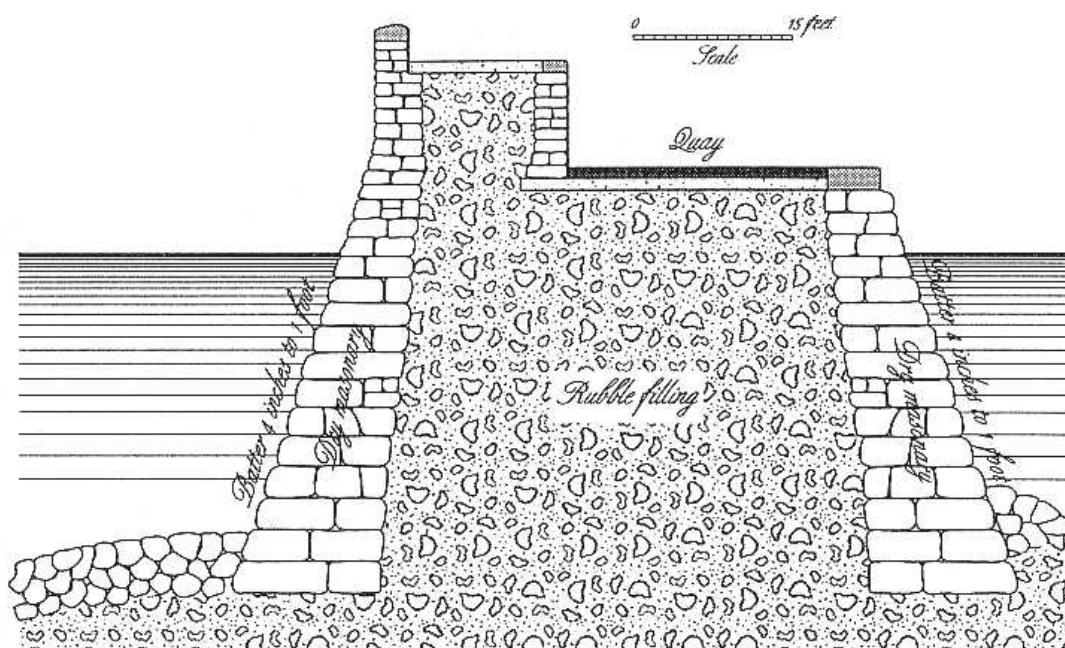
An example breakwater section in Figure 1 from St Catherine's harbour on Jersey (see Bray & Tatham, 1992, Hold, 2009), constructed at about 1855-60 shows the dry masonry walls, the rubble filling between the walls, and the rubble mound on which the walls are founded. The figure does not show low water, which is slightly above the wall foundation level shown, see also Figure 3. For all of these breakwaters, the depth at which foundation blocks could be placed was set almost entirely by diving capabilities at the time. Rubble material placed below lowest tide level was trimmed by divers to accept the foundation stones. Divers also guided placement of the foundation blocks. In greater water depths, the rubble mound foundation became a significant proportion of the overall structure height. Thus many of the deep water breakwaters around the UK have been vertically-composite with substantial mounds. Advances in diving technologies over the period 1850-1880 significantly increased those depths, reducing the proportional height of the rubble mound, so that the mound represents a smaller proportion of the overall structure height.

**Figure 1** St Catherine's breakwater, 1856 (after Bray & Tatham)

The sections of St Catherine and Alderney Breakwaters in Figures 1 and 2 are relatively typical of the larger breakwaters constructed between 1850 and 1880. Of these, Alderney is exposed to substantially more severe wave conditions, has suffered significant damage, provides us with more information on failure modes and responses, and is therefore given more attention later.

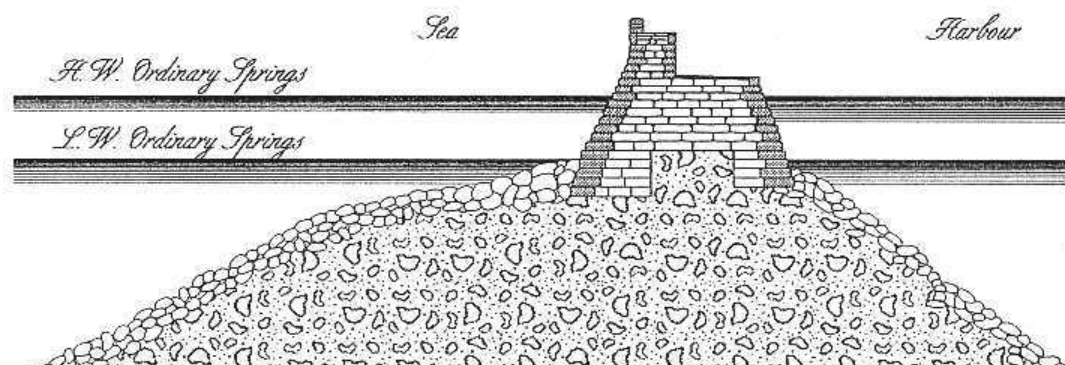
**Figure 2 Alderney breakwater, 1851-64, (after Bray & Tatham)**

At Alderney, the lowest intended level of foundation for the wall along the outer sections of the breakwater was 7.3m (24ft) below low water on spring tides, but settlement or consolidation of the rubble mound caused this to increase to 9.1m (30ft) towards the seaward end. Towards the landward end, the foundation was set no more than 3.5m below low water. Large blocks of stone (later of concrete) were laid on the rubble after it had been allowed to settle for about 6 months. The batter of the wall of 2V:1H at the inner end is shallower than for many other contemporary breakwaters, and was revised to steeper slopes for the outer sections at Alderney. The wall at St Catherine's was battered at 3:1, and at Aberdeen at 8:1. The discussion by Marth et al (2004) on the effect of batter in providing restraining forces on the lower blocks is again instructive.

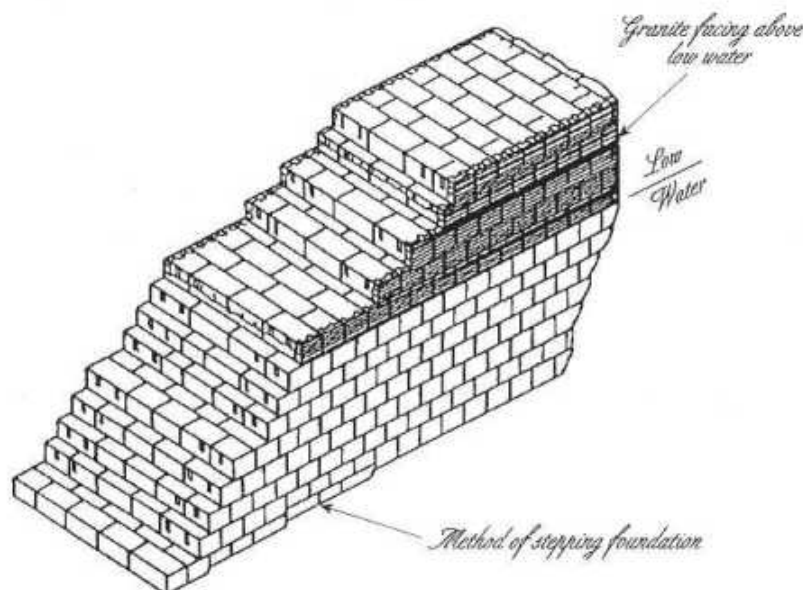
**Figure 3 Blockwork construction at Dover, 1898-1909,**

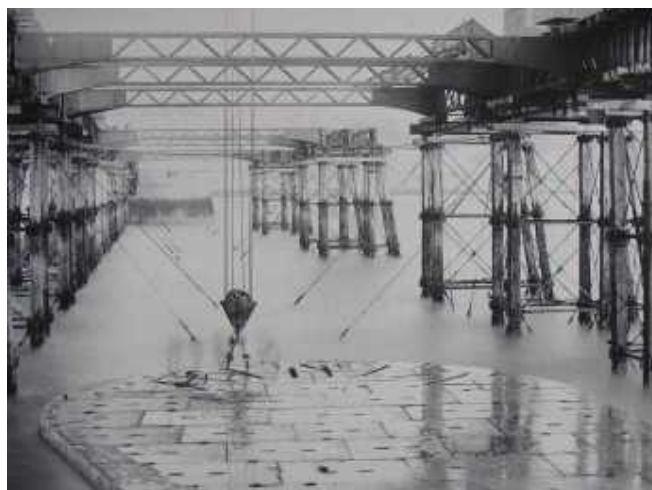
**Figure 4** Blockwork construction at Dover, 1898-1909,  
(photo from Dover Harbour Board)

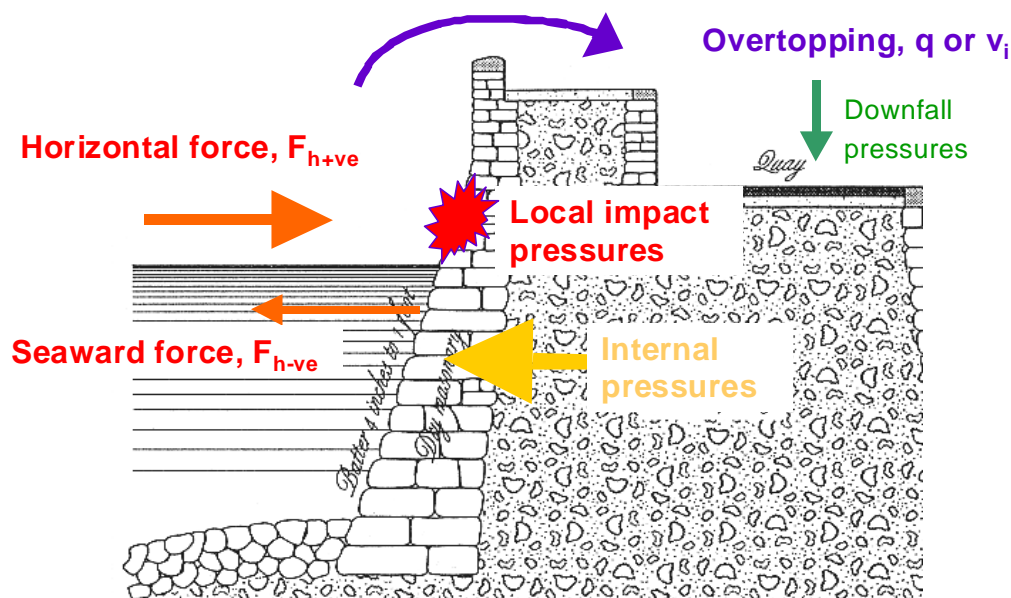
**Figure 6 Summary of wave-driven loadings on blockwork breakwaters**

The main forces acting on these walls arise from wave momentum and impact pressures, which in turn induce up-lift and internal water pressures. Overtopping may induce down-fall pressures. Geotechnical forces from backing materials; seismic; vessel and equipment loads; may also act. Breakwater walls resist wave action and geotechnical forces by their own weight, and by friction with underlying materials. Interlock or bonding between elements is essential to retain continuity and avoid loss of blocks and/or fill, as the constitutive elements are easily moved by wave forces if not acting together. A useful discussion on load transfer within a simple blockwork wall is given by Marth et al (2004) who demonstrate that the “spreading” angle for loads can be remarkably narrow, thus favouring very steep batters.

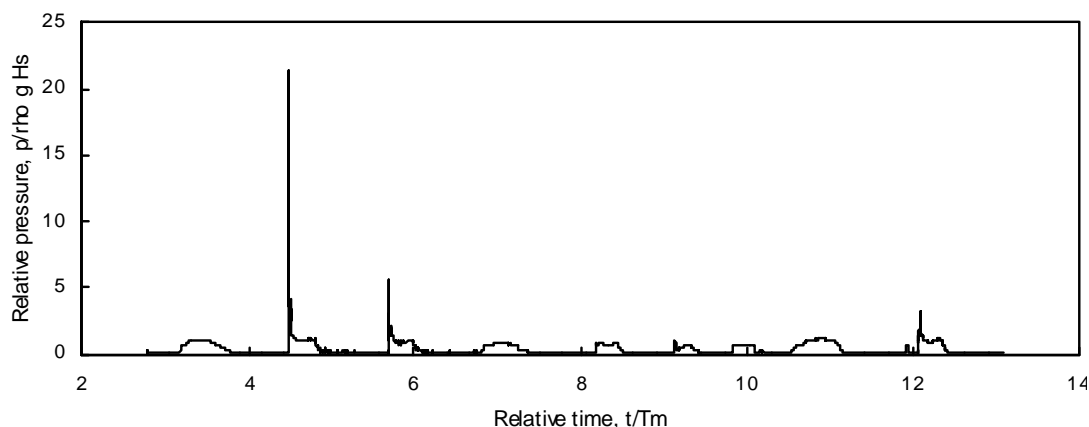
**Figure 7 Example impulsive wave pressures (dimensionless) on vertical wall with small toe mound, from Allsop et al (1996), McKenna (1997)**

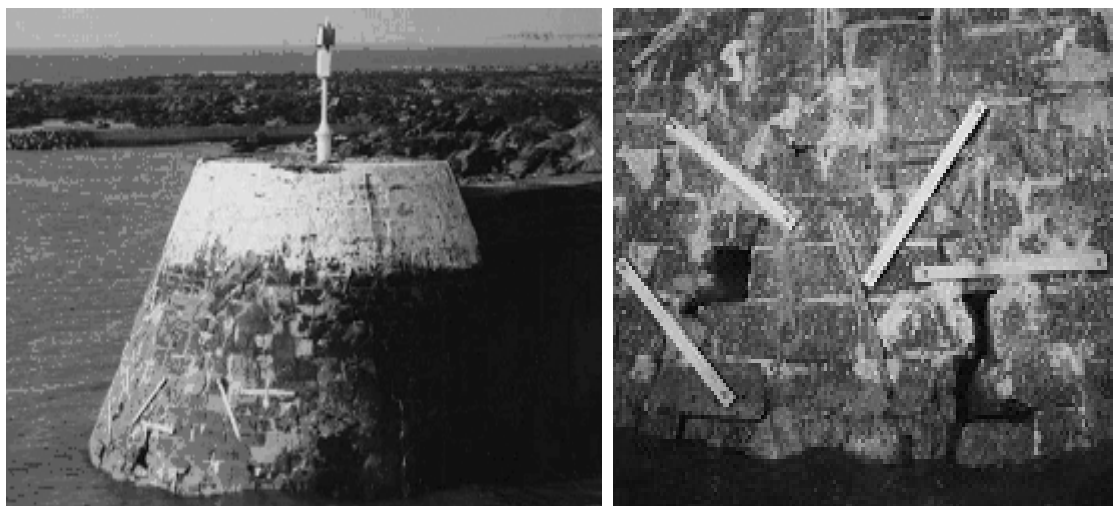
**Figure 8 Outer end of Arbroath West Breakwater, and detail of damaged / missing blockwork**

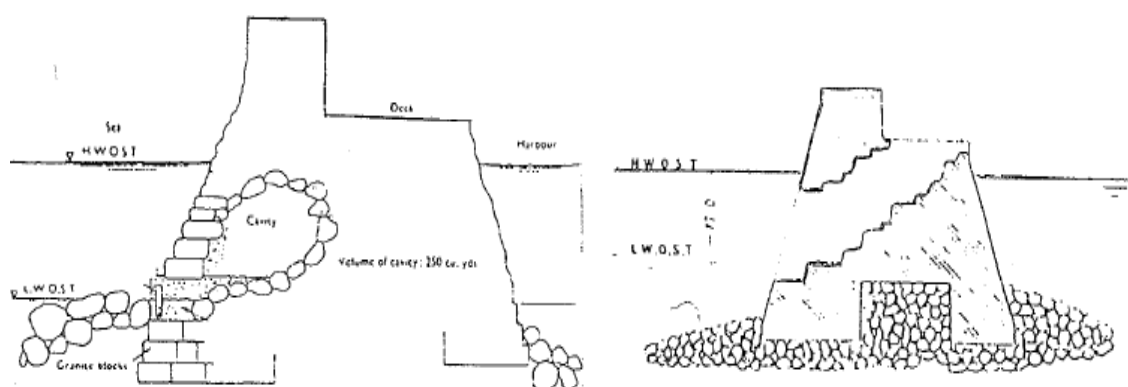
**Figure 10 Example breaches to Alderney breakwater upper wall**

The main failure mode of the wall is by removal of individual blocks, followed by erosion of finer material from behind the blockwork. The integrity of the blockwork depends upon the exclusion of wave pressures, and on frictional resistance between blocks. Where the foundation support offered by the mound is locally insufficient, or the mortar joint between blocks deteriorates, blocks are relatively easily extracted. Experience shows that local failures spread very rapidly, and are often followed by failure of the deck slabs and/or harbour wall. The damage caused in January and February 1990 was therefore quite typical.
