Hydraulics Research  
Wallingford

MORPHOLOGICAL EFFECT OF RIVER WORKS

A review of current practice

Report No SR 116  
May 1987

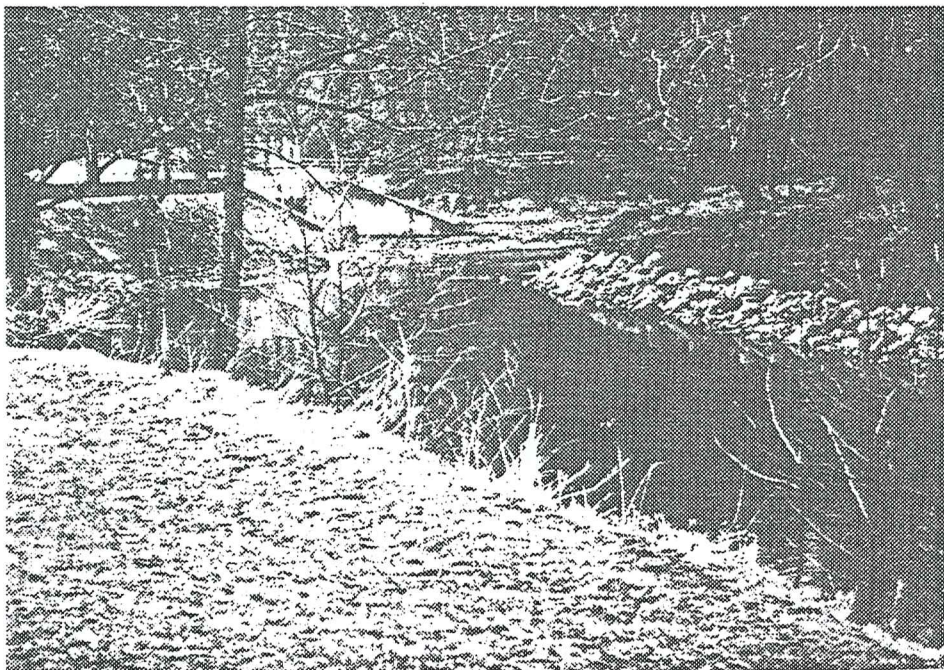
PLATE 8

to local residents. Minor erosion problems are often countered by stone revetments (see Plate 8). In areas where natural stone is not available building waste is sometimes used to construct these. The Wessex Water Authority have planted willows to counter erosion that occurred as a result of the Thornford scheme. (see Plate 9). Stone gabions have been used to protect part of the River Exe in Exeter. (see Plate 10). Grass has been allowed to grow through these gabions to form what appears to be a natural grass covered bank.
