**Hydraulics Research**  
Wallingford

**A Review of Novel Shore Protection Methods**

**Vol 6 - Final Report**

**Report No SR 106**  
**May 1987**

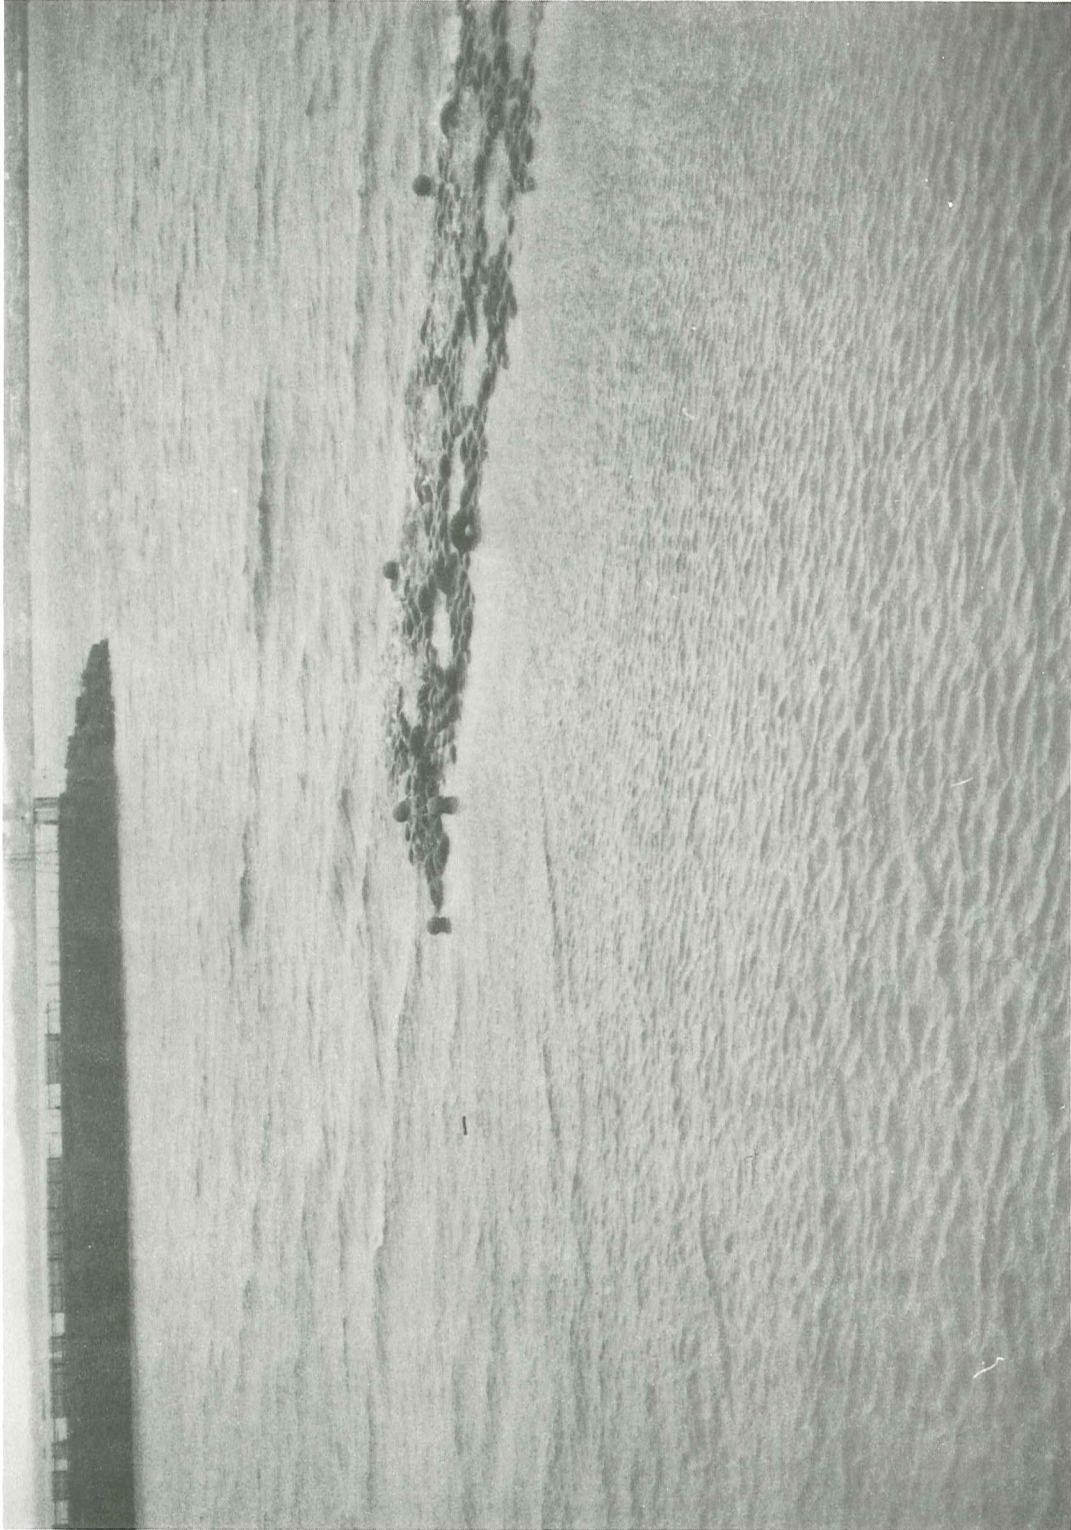
1. Kowalski type floating breakwater - Port Edgar, Lothian

Few floating tyre breakwaters are to be seen in the UK and only then in very sheltered conditions. One such structure was built inside a harbour at Port Edgar in Scotland (Plate 1). Completed in 1980 at a total cost of £29,000, this "Kowalski" type breakwater has so far been successful in attenuating waves of up to 3 second periods. One drawback is the high cost of maintenance of which 50% may be for anti fouling measures (removal of silt, seaweed, barnacles, etc.). However, the low capital outlay needed for these schemes and the rapid installation gives them positive advantage in comparison with more conventional works.

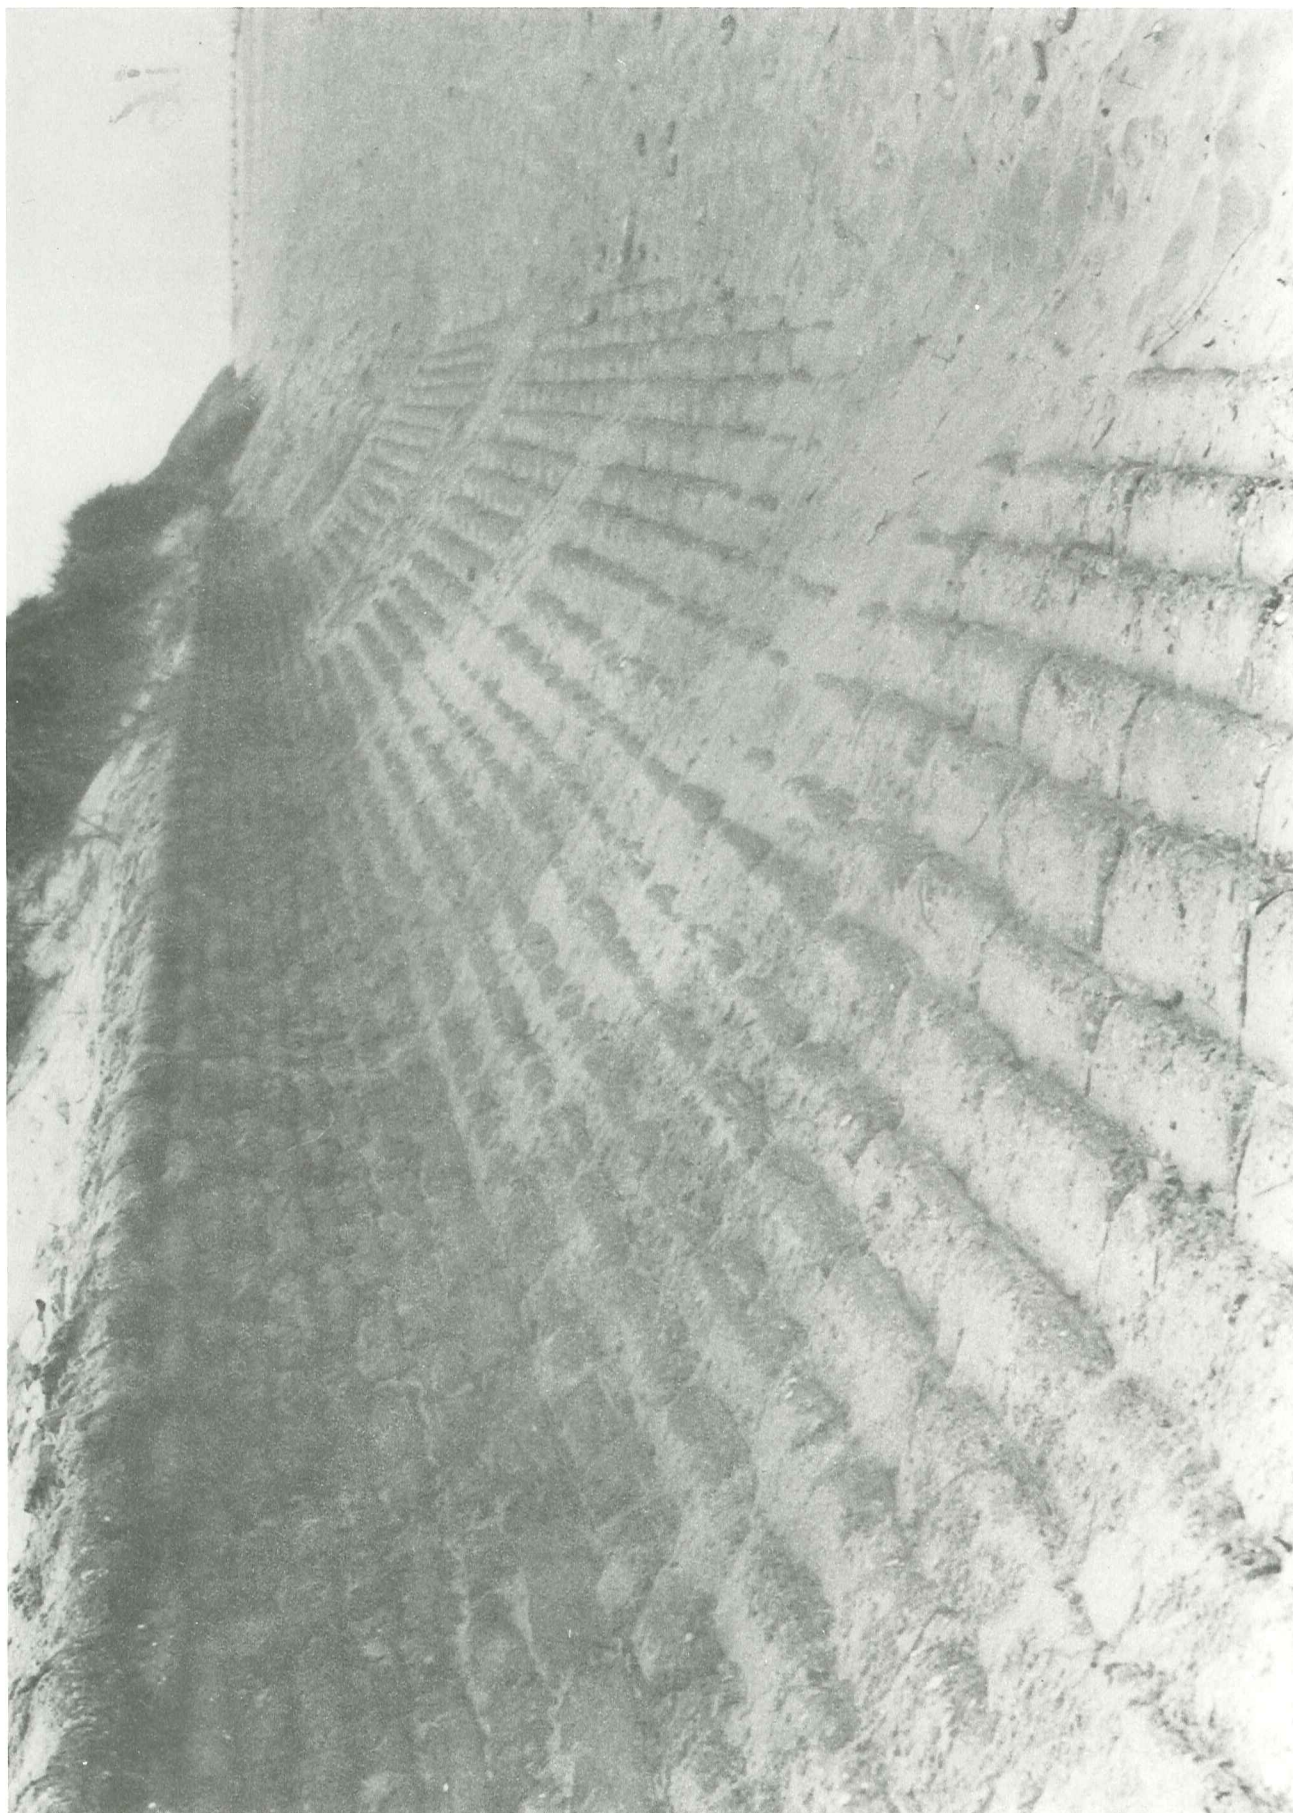
2. Sand/cement filled bag revetment - Eccles, Norfolk

Revetments made of mortar-filled containers have been used with success in this country as well as abroad. Mortar-filled bags can develop a certain degree of cohesion. Normally this is insufficient to prevent failure if toe scour or settlement of the backfill takes place on more than a very local scale. They are not used widely now because of the labour intensive nature of construction. For example, the sand dunes at Eccles on the East Anglian coastline were until quite recently protected by a sea wall consisting of mortar-filled hessian bags which had been in place for many years (see Plate 2). They are now being replaced by a conventional concrete wall, since the original was damaged due to undermining during a period of lowered beach levels.

Although the revetment at Eccles has had a long design life, adverse conditions can lead to rapid failure. For example, at Alameda a sand-cement bag revetment was constructed at a slope of  $60^{\circ}$  to the horizontal, with the toe taken down to 0.6 metres below beach level. In March 1979, only three months or so after construction, the embankment had slumped badly and there appears to have been very little left in the way of bonding between adjacent bags. The failure of this project highlights the fact that such structures, if lacking in tensile strength, are all too easily destroyed when there is movement of the bedding layer.

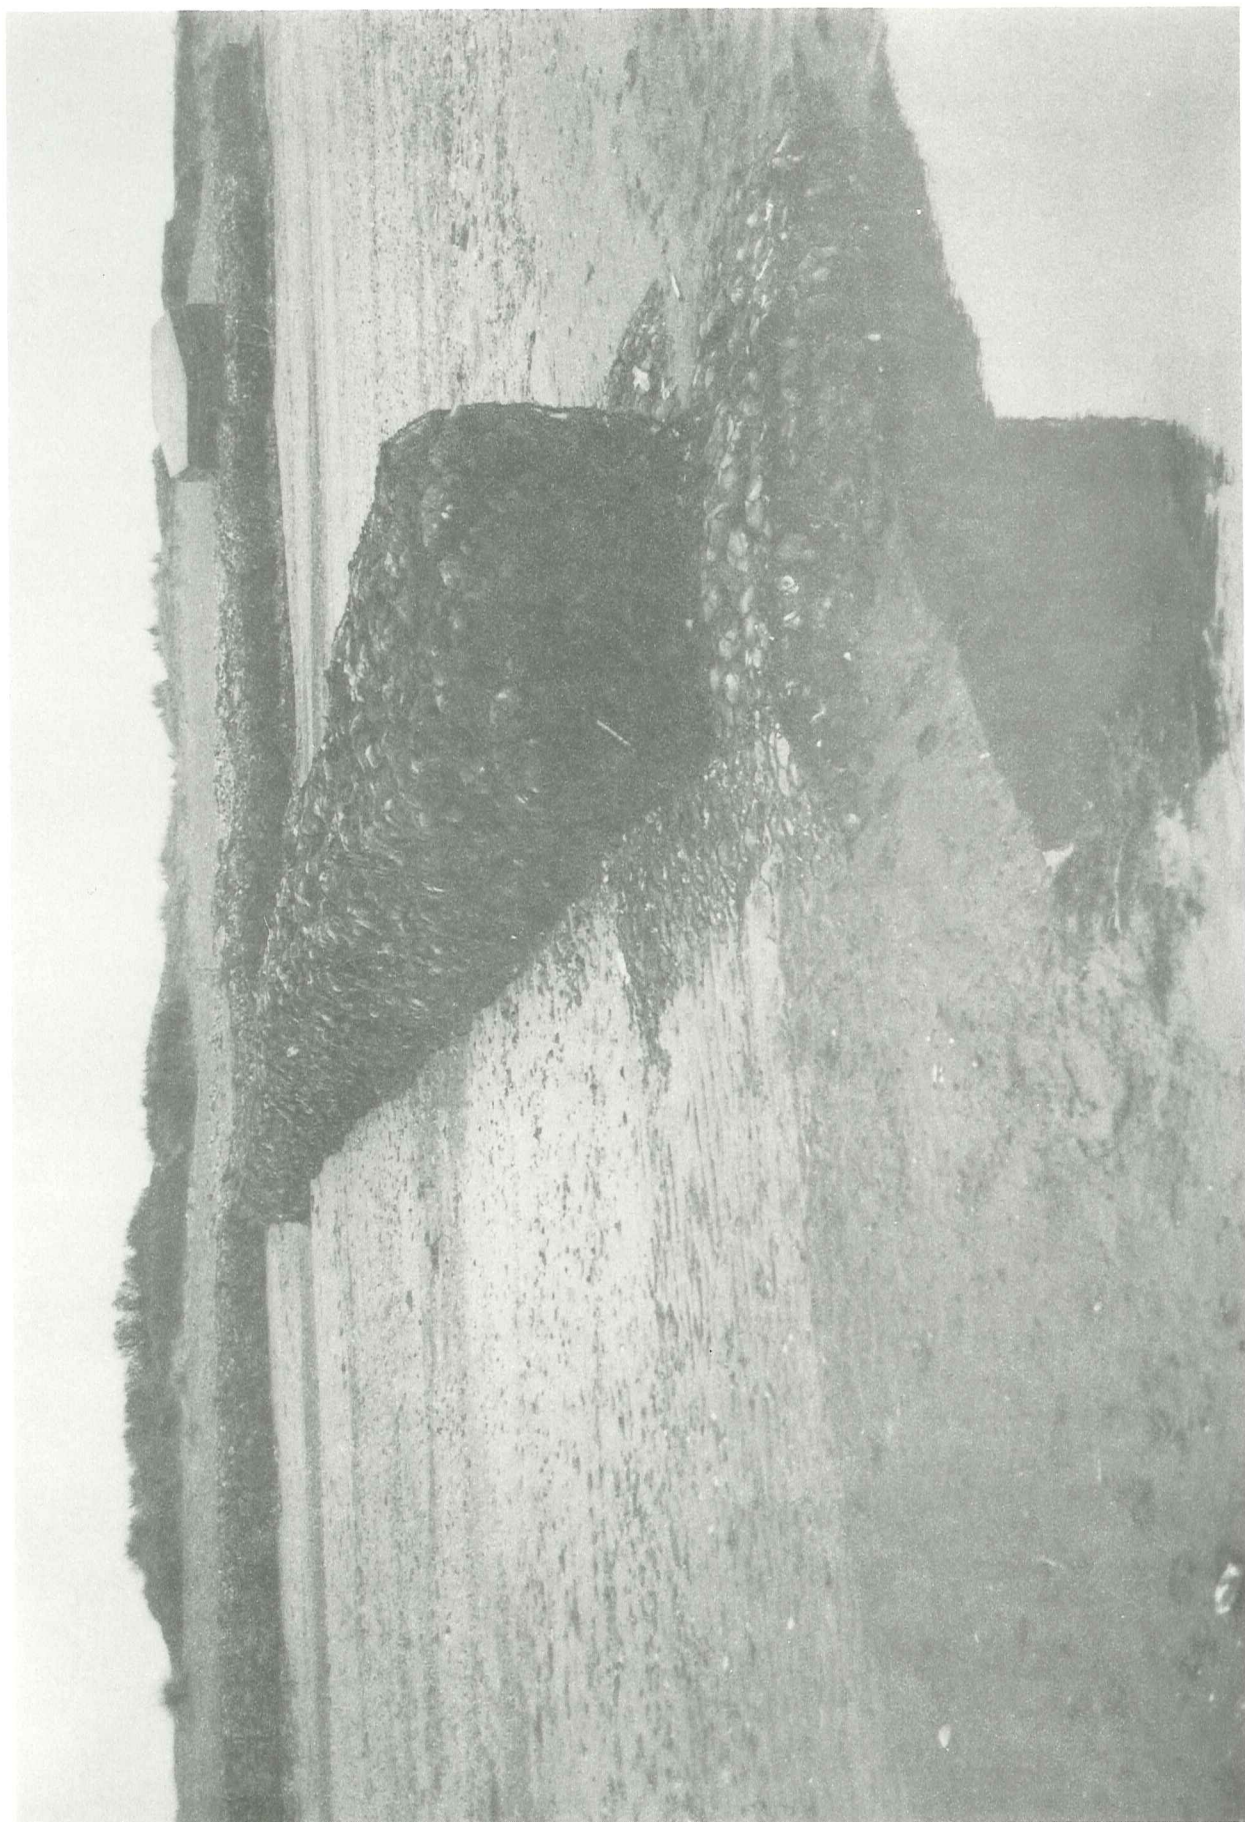
3. 'Maccaferri' gabion groynes - Old Hunstanton, Norfolk

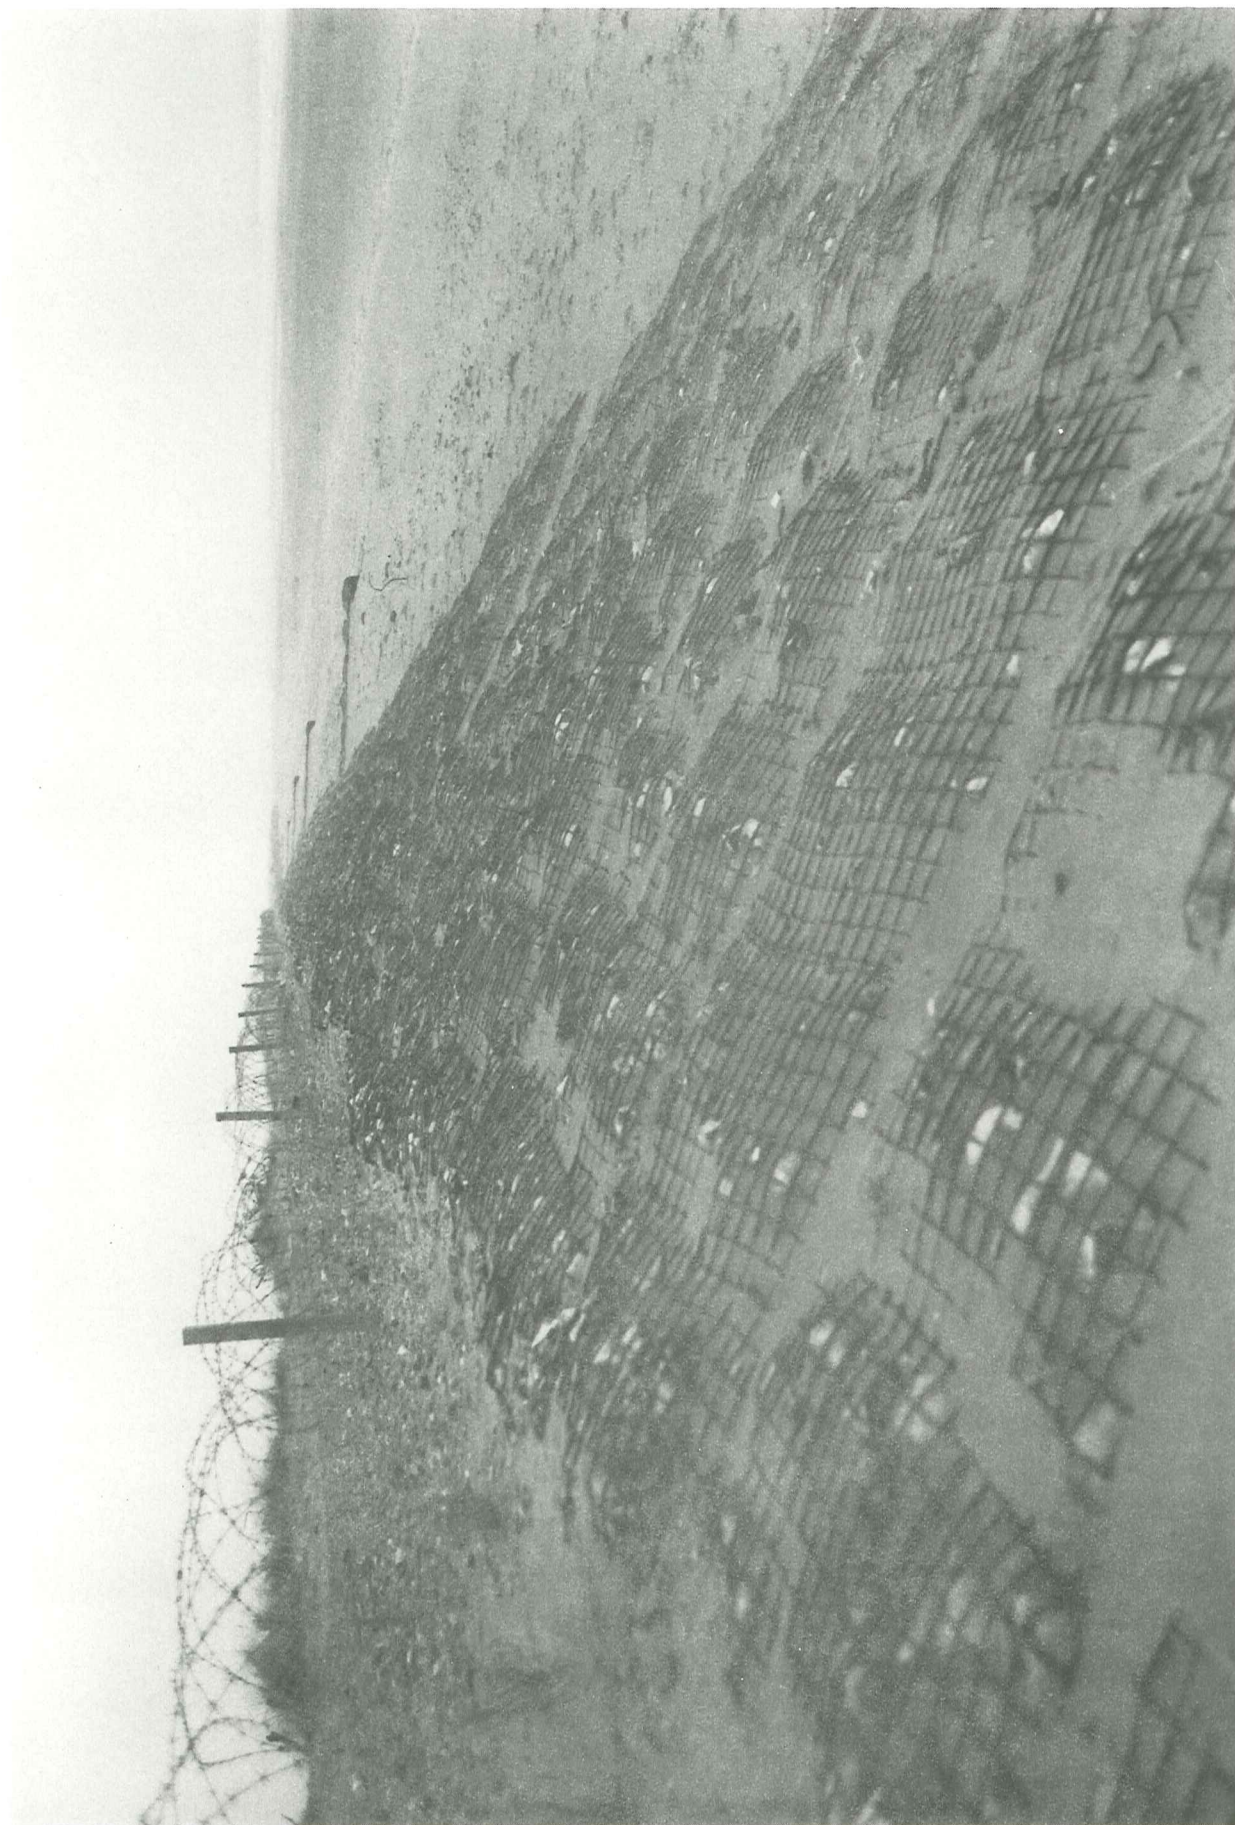
5. 'Netlon' gabion revetment - Brancaster, Norfolk

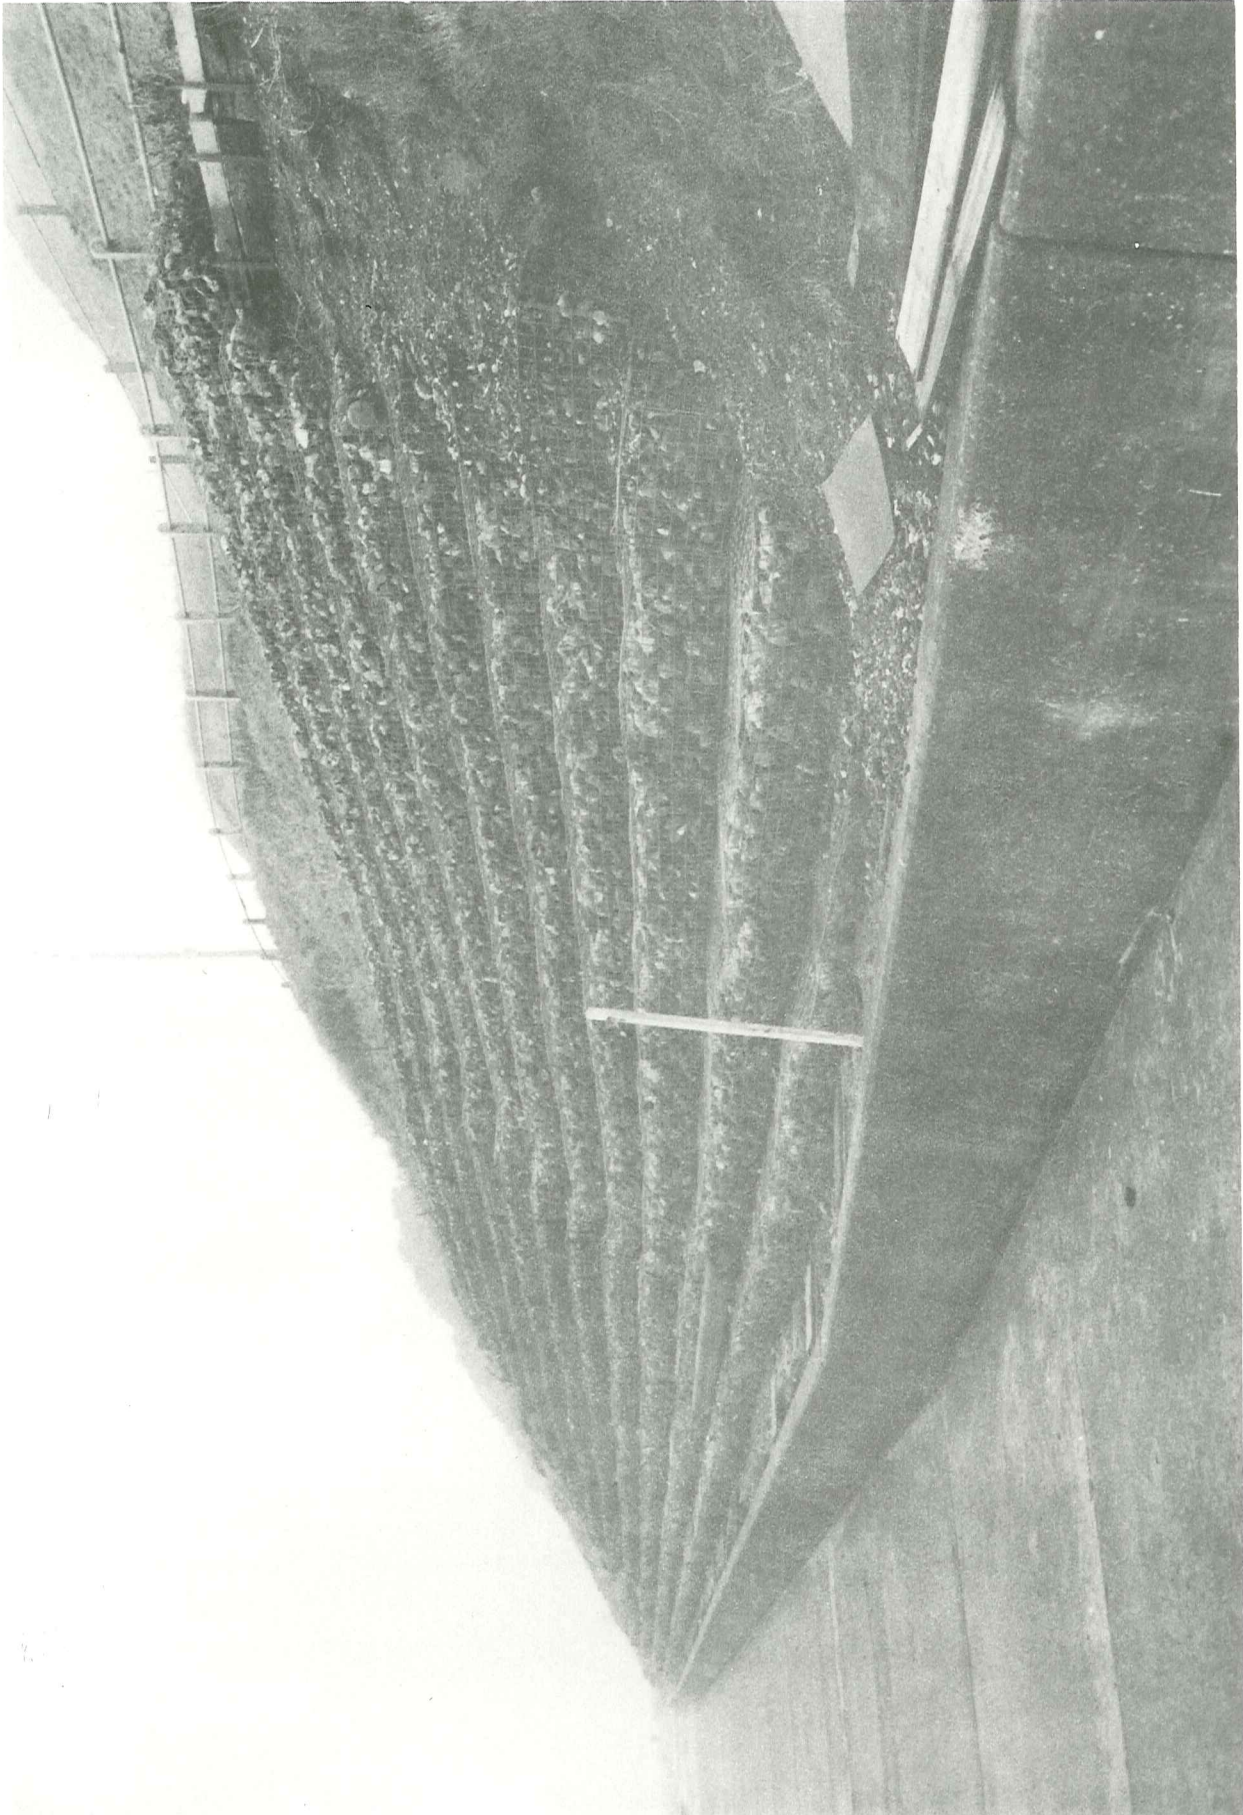
6. 'Weldmesh' gabion retaining wall - Overstrand, Norfolk

Both the flexible "Maccaferri" type PVC coated gabion and the rigid "Weldmesh" or "Gridweld" type can be built with sloping, vertical or stepped faces. Since these structures are permeable, problems with water run off for example are considerably reduced. At Overstrand in Norfolk for example, "Weldmesh" gabions (see Plate 6), were used to stabilise a cliff slip and regrade its seaward face. The cliff face was protected with 12 rows of gabions laid at an angle of 45 degrees. Built in 1966, the 245 gabion wall continues to be effective. An inspection in 1983 showed only minor corrosion had taken place and the baskets were generally in good condition although one or two were half empty, possibly the result of the rockfill splitting into smaller pieces and being washed out by run off.

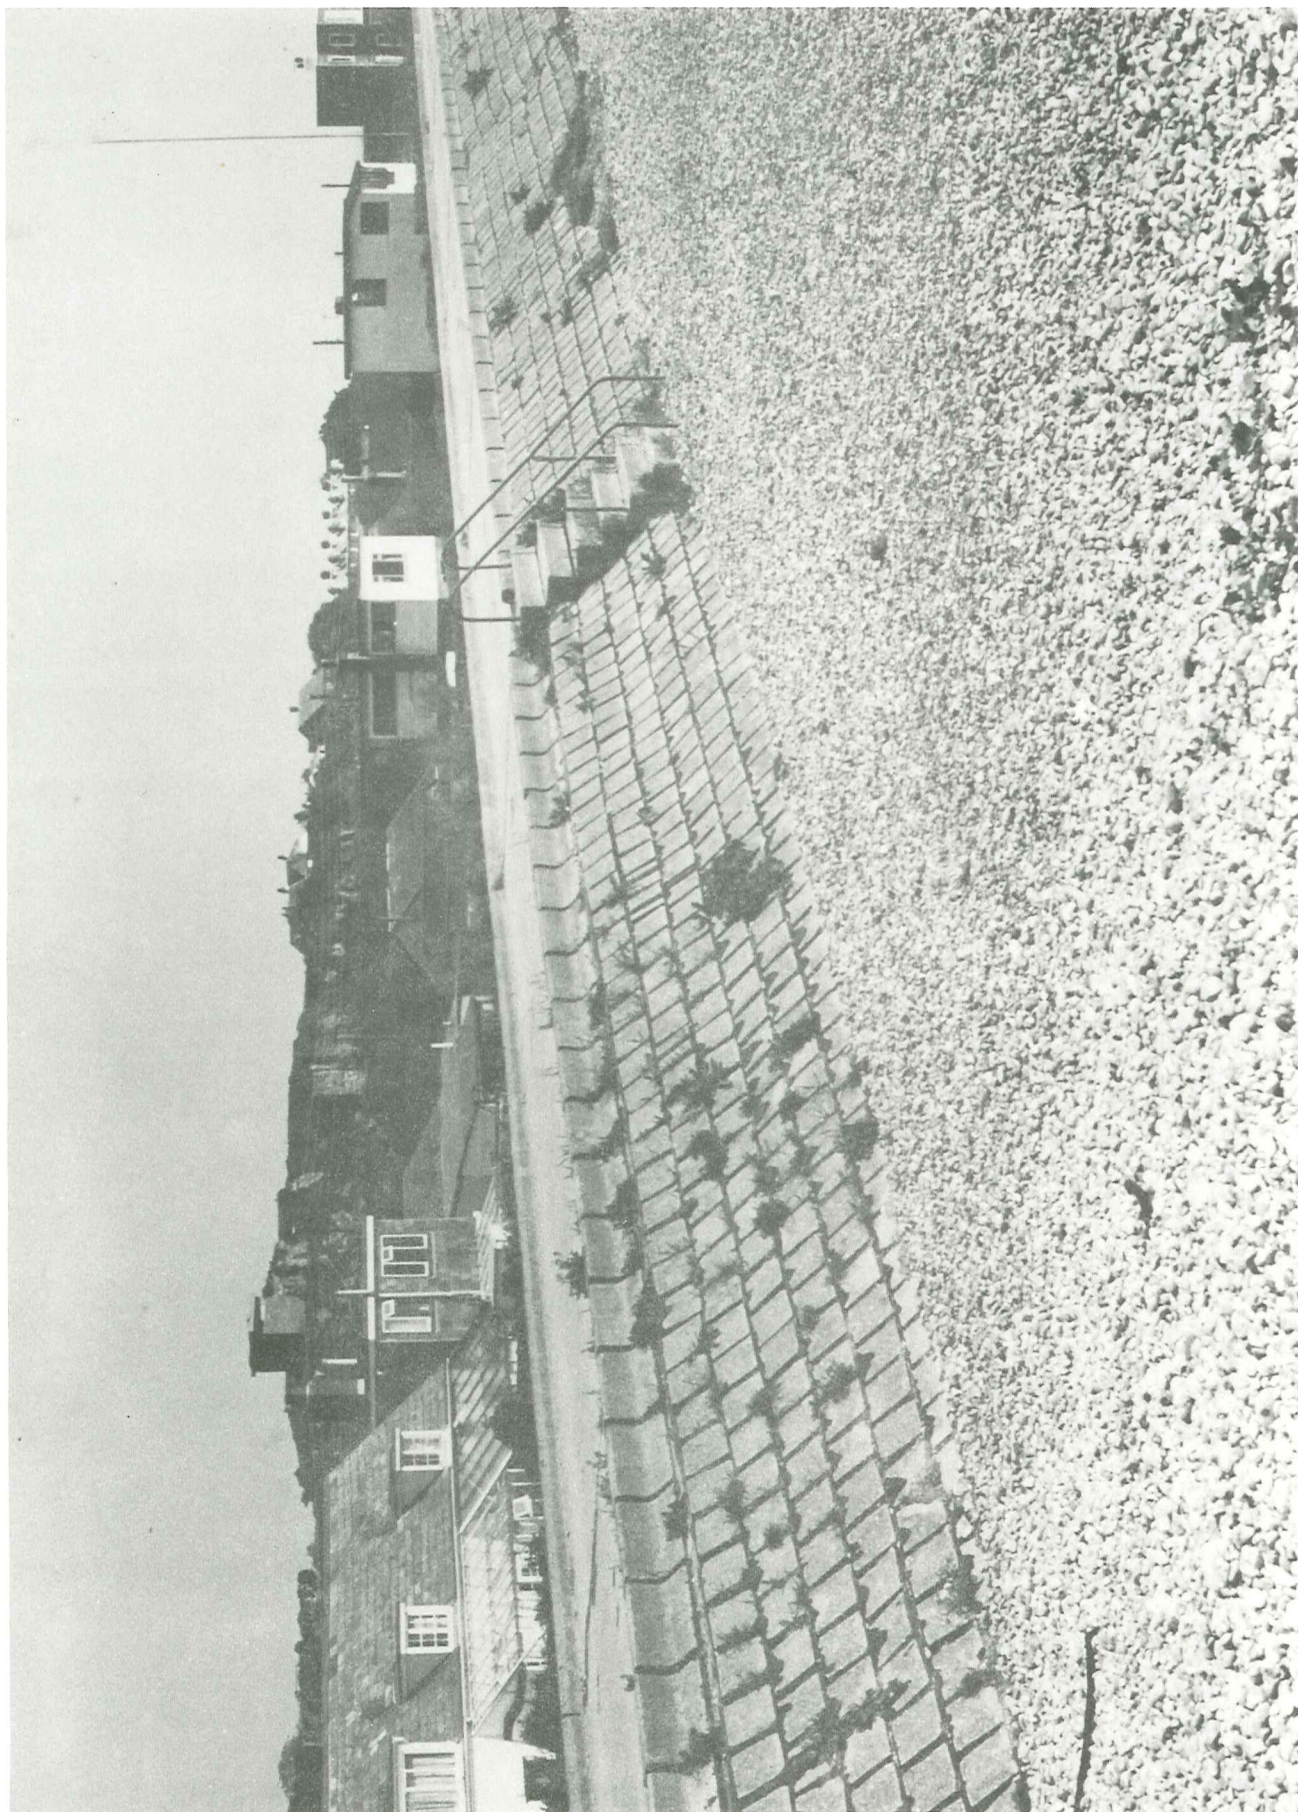
10. Revetment - shiplap blocks - Pett, Sussex

Tongue and groove blocks usually have connections on opposite sides. With some designs the short sides interlock while the long sides just butt against each other. Because the blocks are normally laid in strips from the revetment toe upwards, differential movement between adjoining strips can cause stresses on the underlying filter which may then result in loss of fill. This type of blockwork also tends to bridge cavities or holes and makes the armour surface appear more rigid than it is. Thus damage to the sublayer is not always evident by inspection of the revetment face. Tongue and groove Shiplap type blocks are effective in low to moderate wave energy conditions.

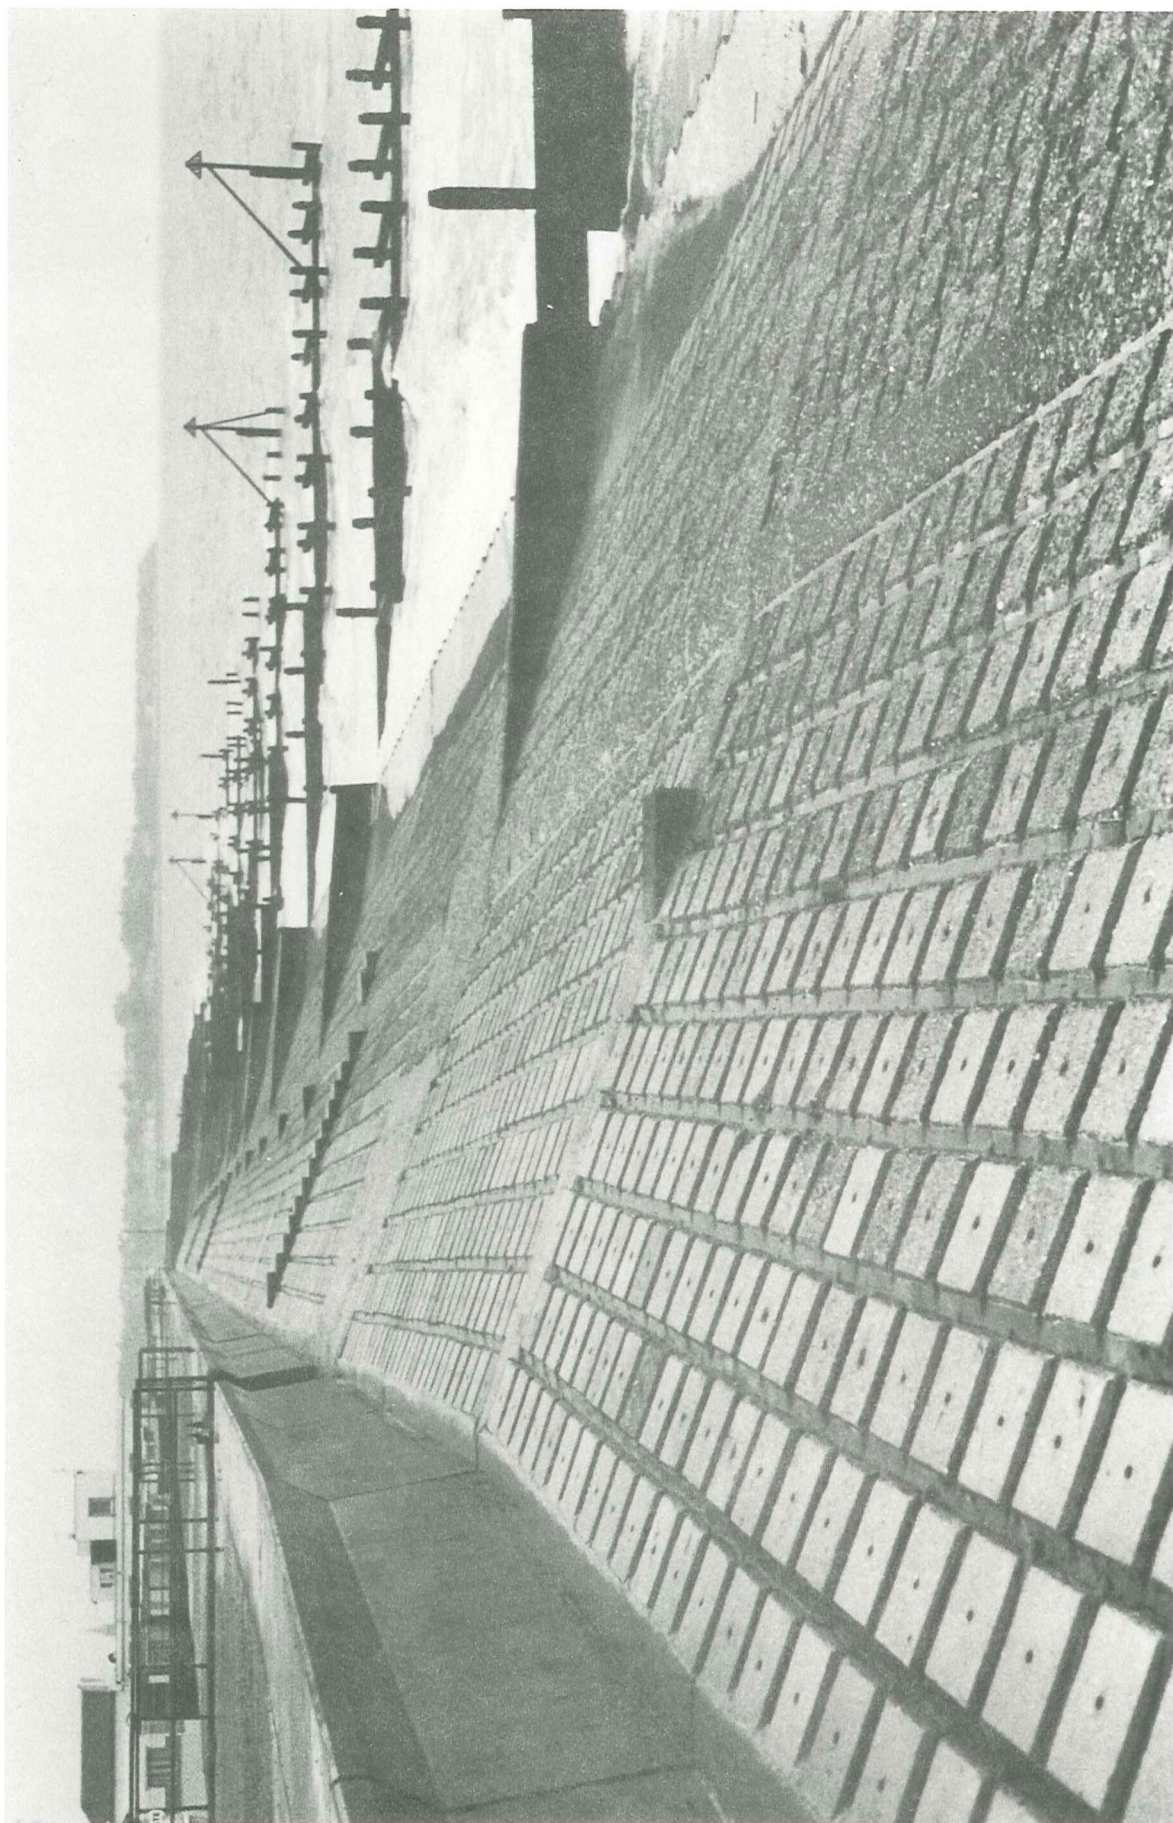
12. Revetment - asphalt grouted blocks - Felixstowe, Suffolk

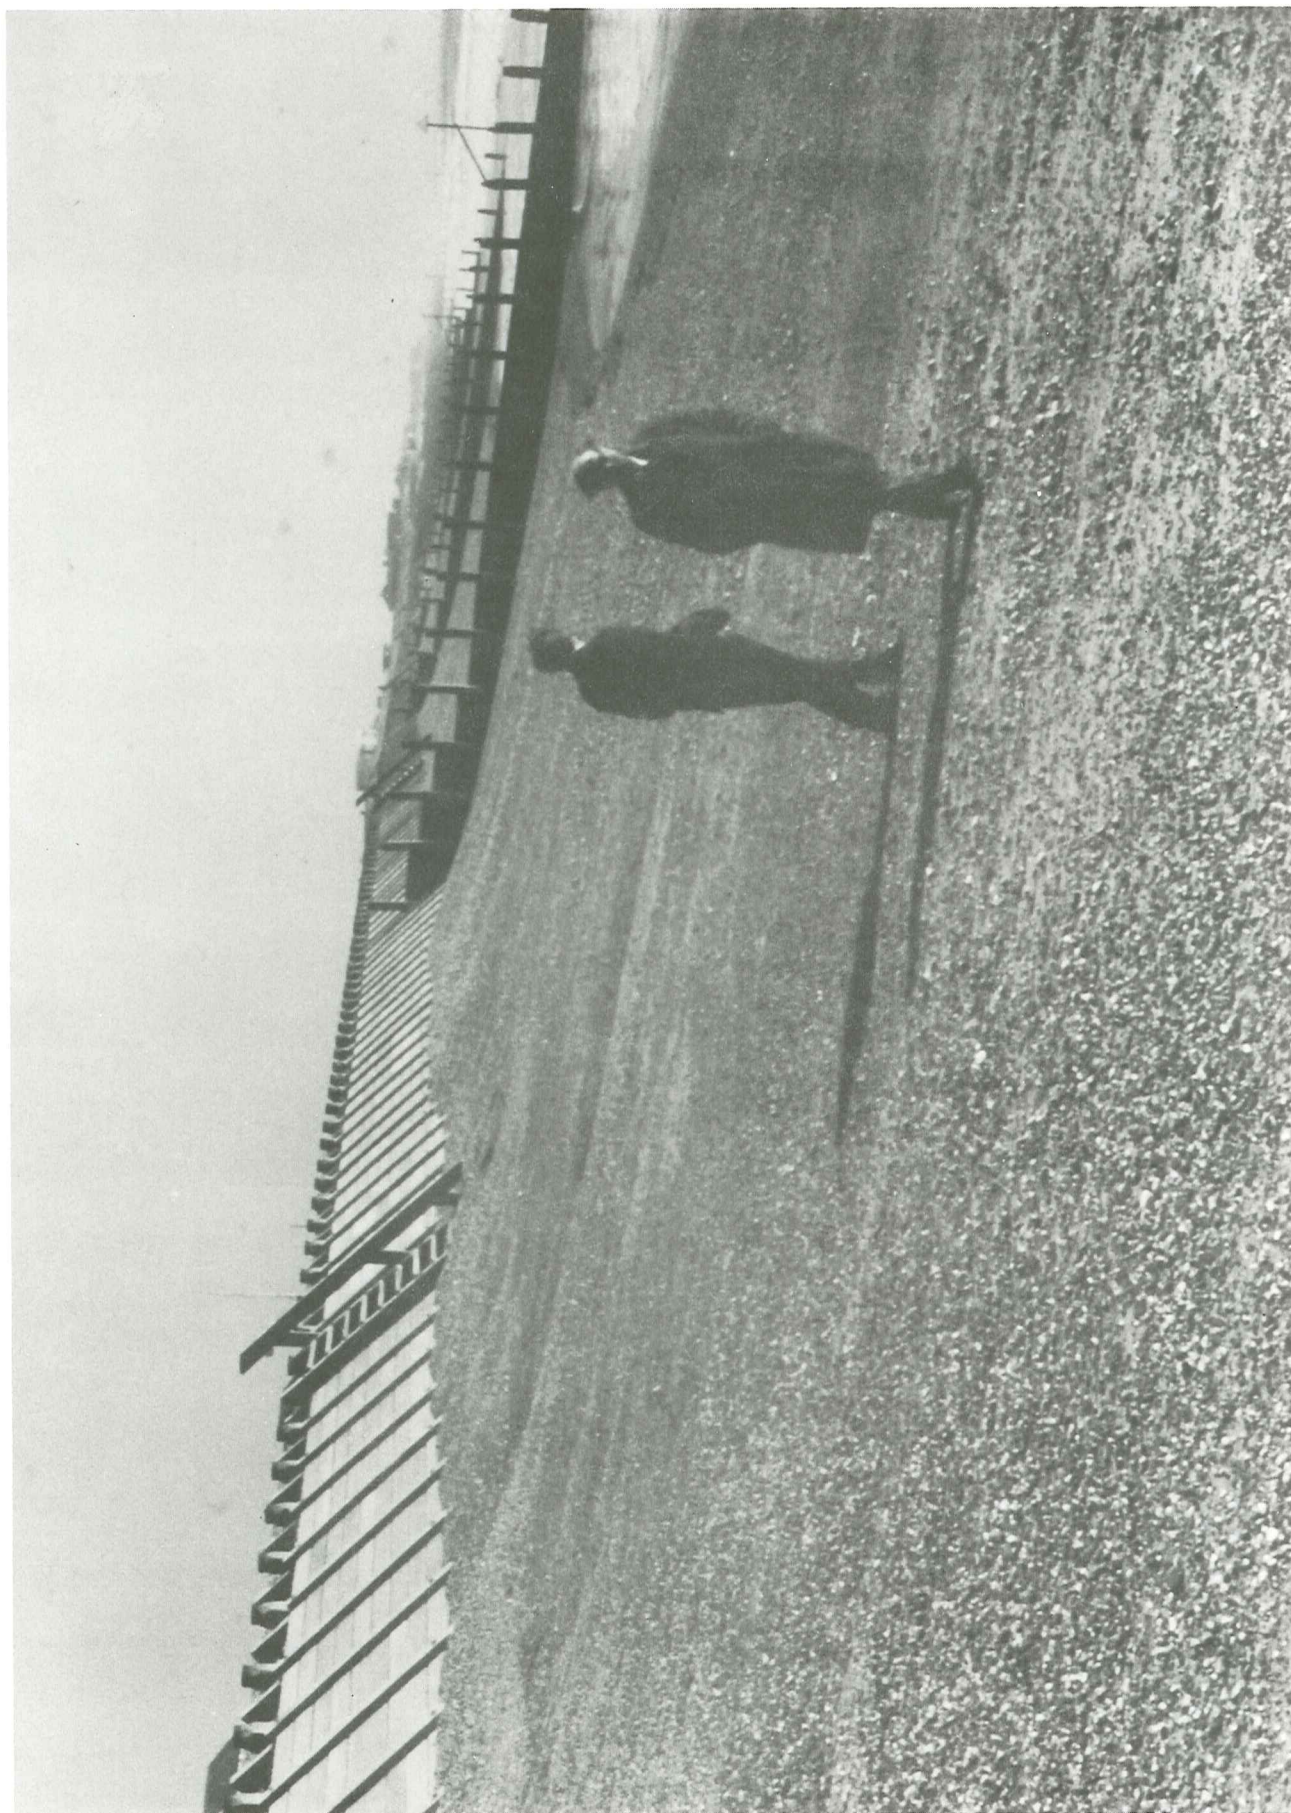
16. Revetment - timber - Hayling Island, Hants

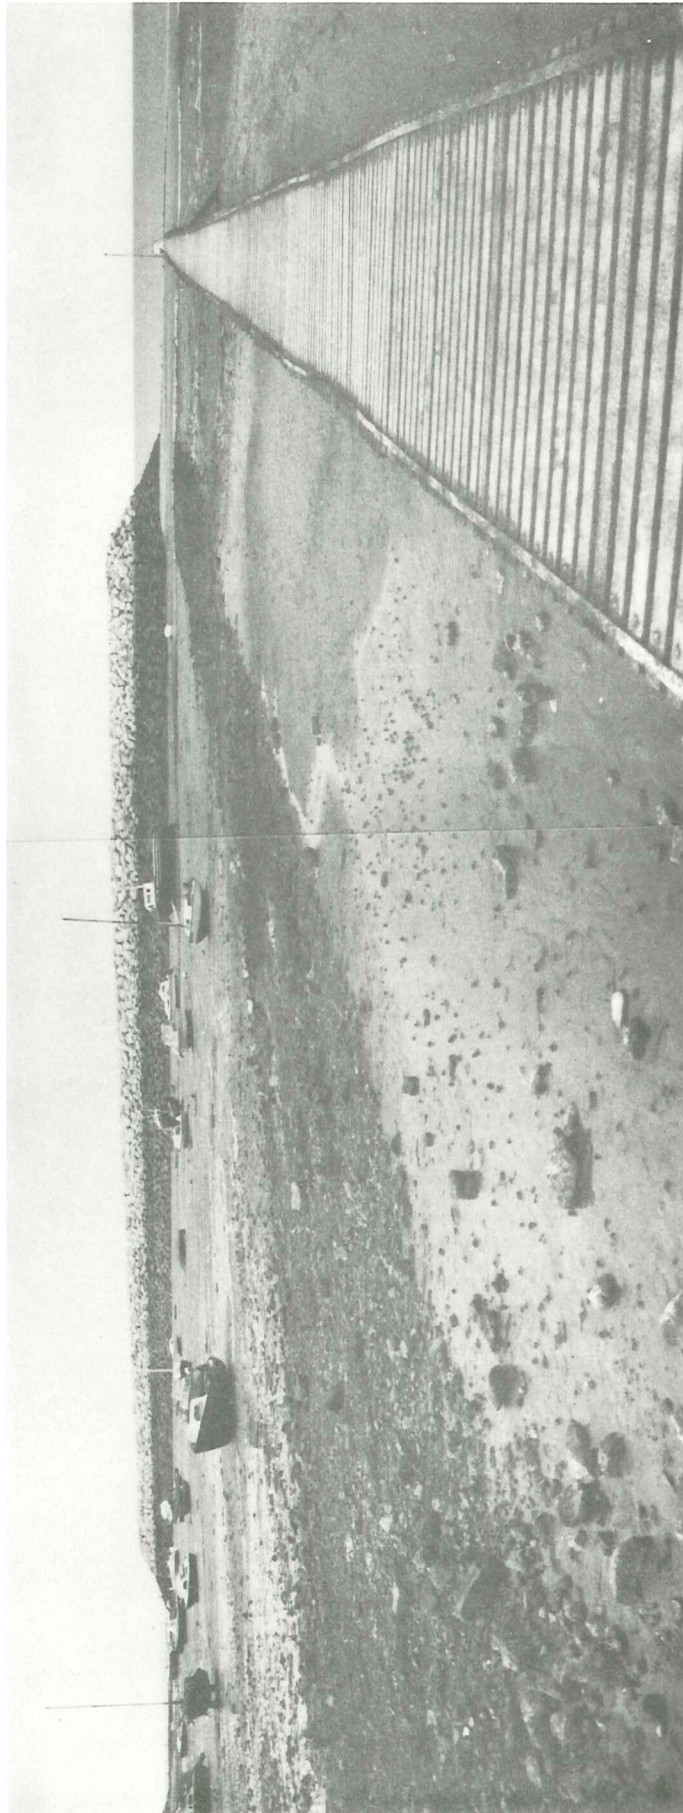
18. Offshore breakwater - rock - Rhos-on-Sea

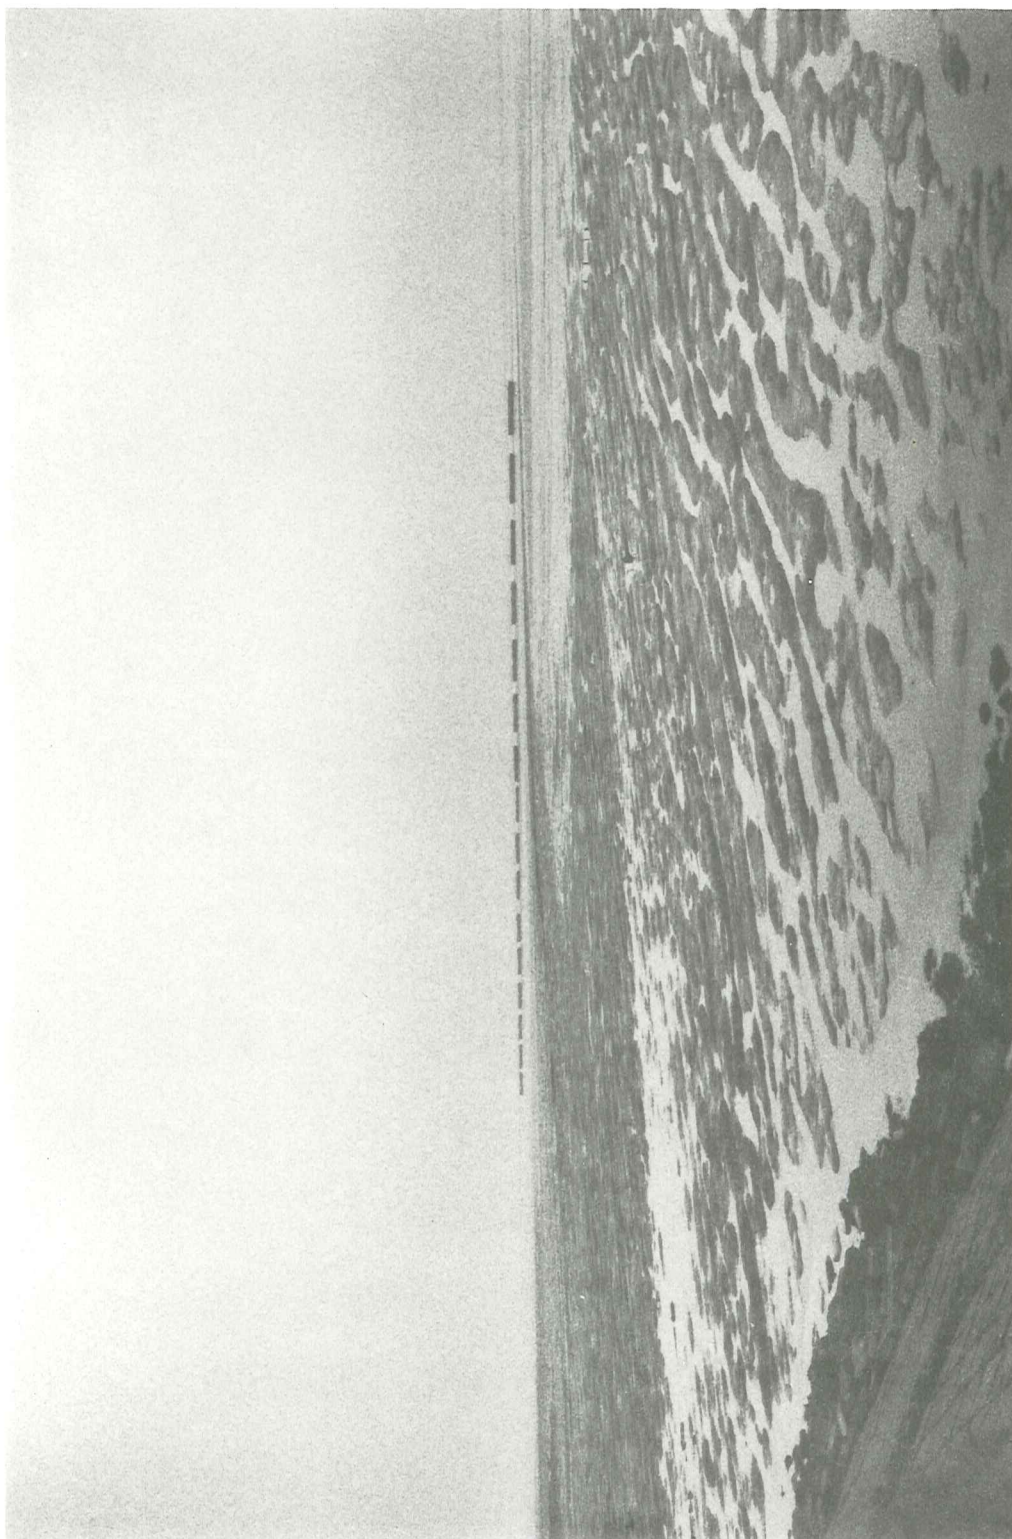
19. Offshore breakwater - Lighters - Dengie, Essex

A number of unusual breakwaters have been tested off the Dengie Peninsula, Essex. This area is one of salt marshland subject to low wave conditions and a moderate tidal range. A series of barges have been placed in a line on the lower foreshore and infilled. The breakwater system is designed to halt the erosion of the edges of the salt marsh. The design is certainly in the low cost category and initial results are favourable. The adjacent coastline is being monitored regularly to see how effective the systems are in damping wave attack. It will also be necessary to determine whether scour becomes a serious problem around the vertical sides of the barges. While such designs are not suitable for open coast conditions, they have considerable potential for semi-sheltered conditions.
