Hydraulic study on scouring downstream of Funagira Dam spillway apron (Japan)

ABSTRACT: Funagira Dam is a concrete gravity dam having a height of 24.50 m and a dam crest length of 220.00 m, and is located approximately 30 km upstream from the mouth of the Tenryu River. The Funagira Dam is owned by the Ministry of Agriculture, Forestry and Fisheries, Shizuoka Prefecture, and Electric Power Development Co., Ltd. (J-POWER), and its objectives include power generation and supply of agricultural water, public water, and industrial water. For energy dissipation, the downstream area of the dam was designed as a hydraulic jump-type dissipater using bed protection blocks. The dam has experienced several large storm events in the 40 years after its completion. The protection blocks were damaged and the scouring downstream of the dam began soon after completion. About 6,300 tetrapods were added stage by stage to the bottom. In recent times (2011), however, flood events have been more intense and of longer duration, with maximum spillway releases of up to approximately 6,396 m³/s. This resulted in increased scouring at the foot of the dam. Emergency measures were taken just downstream of the

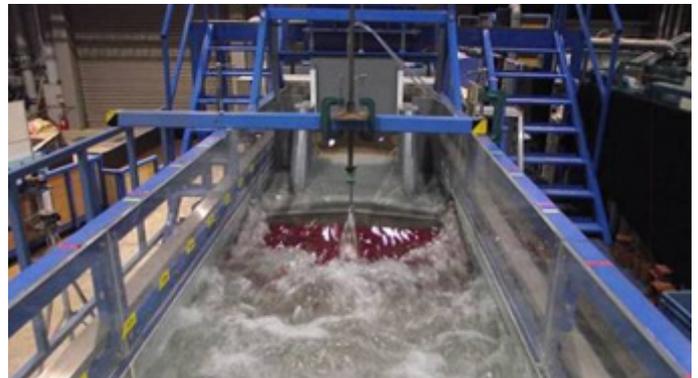
Figure 6. Vertical 2-dimensional partial model

The experiments using the vertical 2-dimensional hydraulic scale model, where a boundary was reproduced between the bedrock and gravel, showed that, even though the bed-protection blocks were stable when they were entirely evenly placed, a large morphological change was observed and the damage to the blocks was expanded in front of Gate 7 (Figure 9).
