Investigation into the multiple recent sinkholes in Pokhara, Nepal

R. Kuwano, T. Kiyota, R. M. Pokhrel & T. Katagiri
Institute of Industrial Science, The University of Tokyo, Japan

ABSTRACT: Since November 2013, numerous sinkholes have been forming in the Armala area of Pokhara Valley, Central Nepal, posing serious threat to local residents. In order to provide countermeasures for reducing sinkhole risk, detailed investigations into the cause and the formation mechanism of the sinkholes are crucial. Preliminary surveys were conducted in June 2014 and November 2014. Comparison of photos, taken in the two surveys, clearly indicates not only the formation of new sinkholes, but also the re-activation of filled sinkholes. By means of dynamic cone penetration tests and surface wave investigations, qualitative characterization of the soil profile was attained, and shallow weak soil layers which are believed to be the location for future sinkholes could be identified. On the basis of the preliminary field investigation, possible sinkhole formation mechanisms are considered. A risk of sinkhole does not seem to disappear as white turbid water continuously springs. It indicates that the int

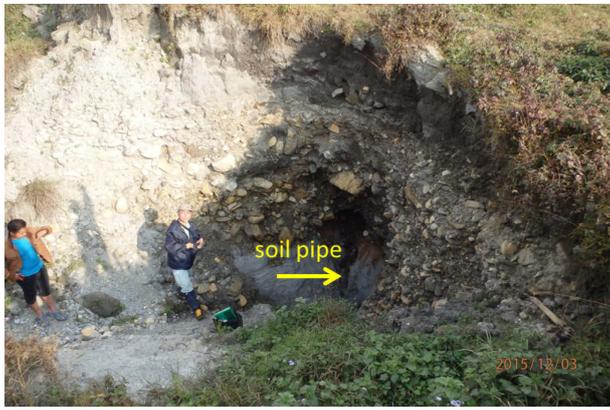
The sign of subsurface water pathway was found in the bottom of one of sinkholes, as shown in Figure 8. The soil pipe developed in a white silty clay layer at GL-6.0m. White turbid water stayed around the pipe. A lot of reactivated sinkholes existed at the location of soil pipe as shown in Figure 5.

Figure 8. Soil pipe found at one of sinkholes
