Riprap design for wind-wave attack

Retrospective model tests of the measured damage to
riprap panels on the offshore bank in the Wash

Report No. IT 213
December 1981
Crown Copyright

Hydraulics Research Station
Wallingford
Oxon OX10 8BA
Telephone 0491 35381

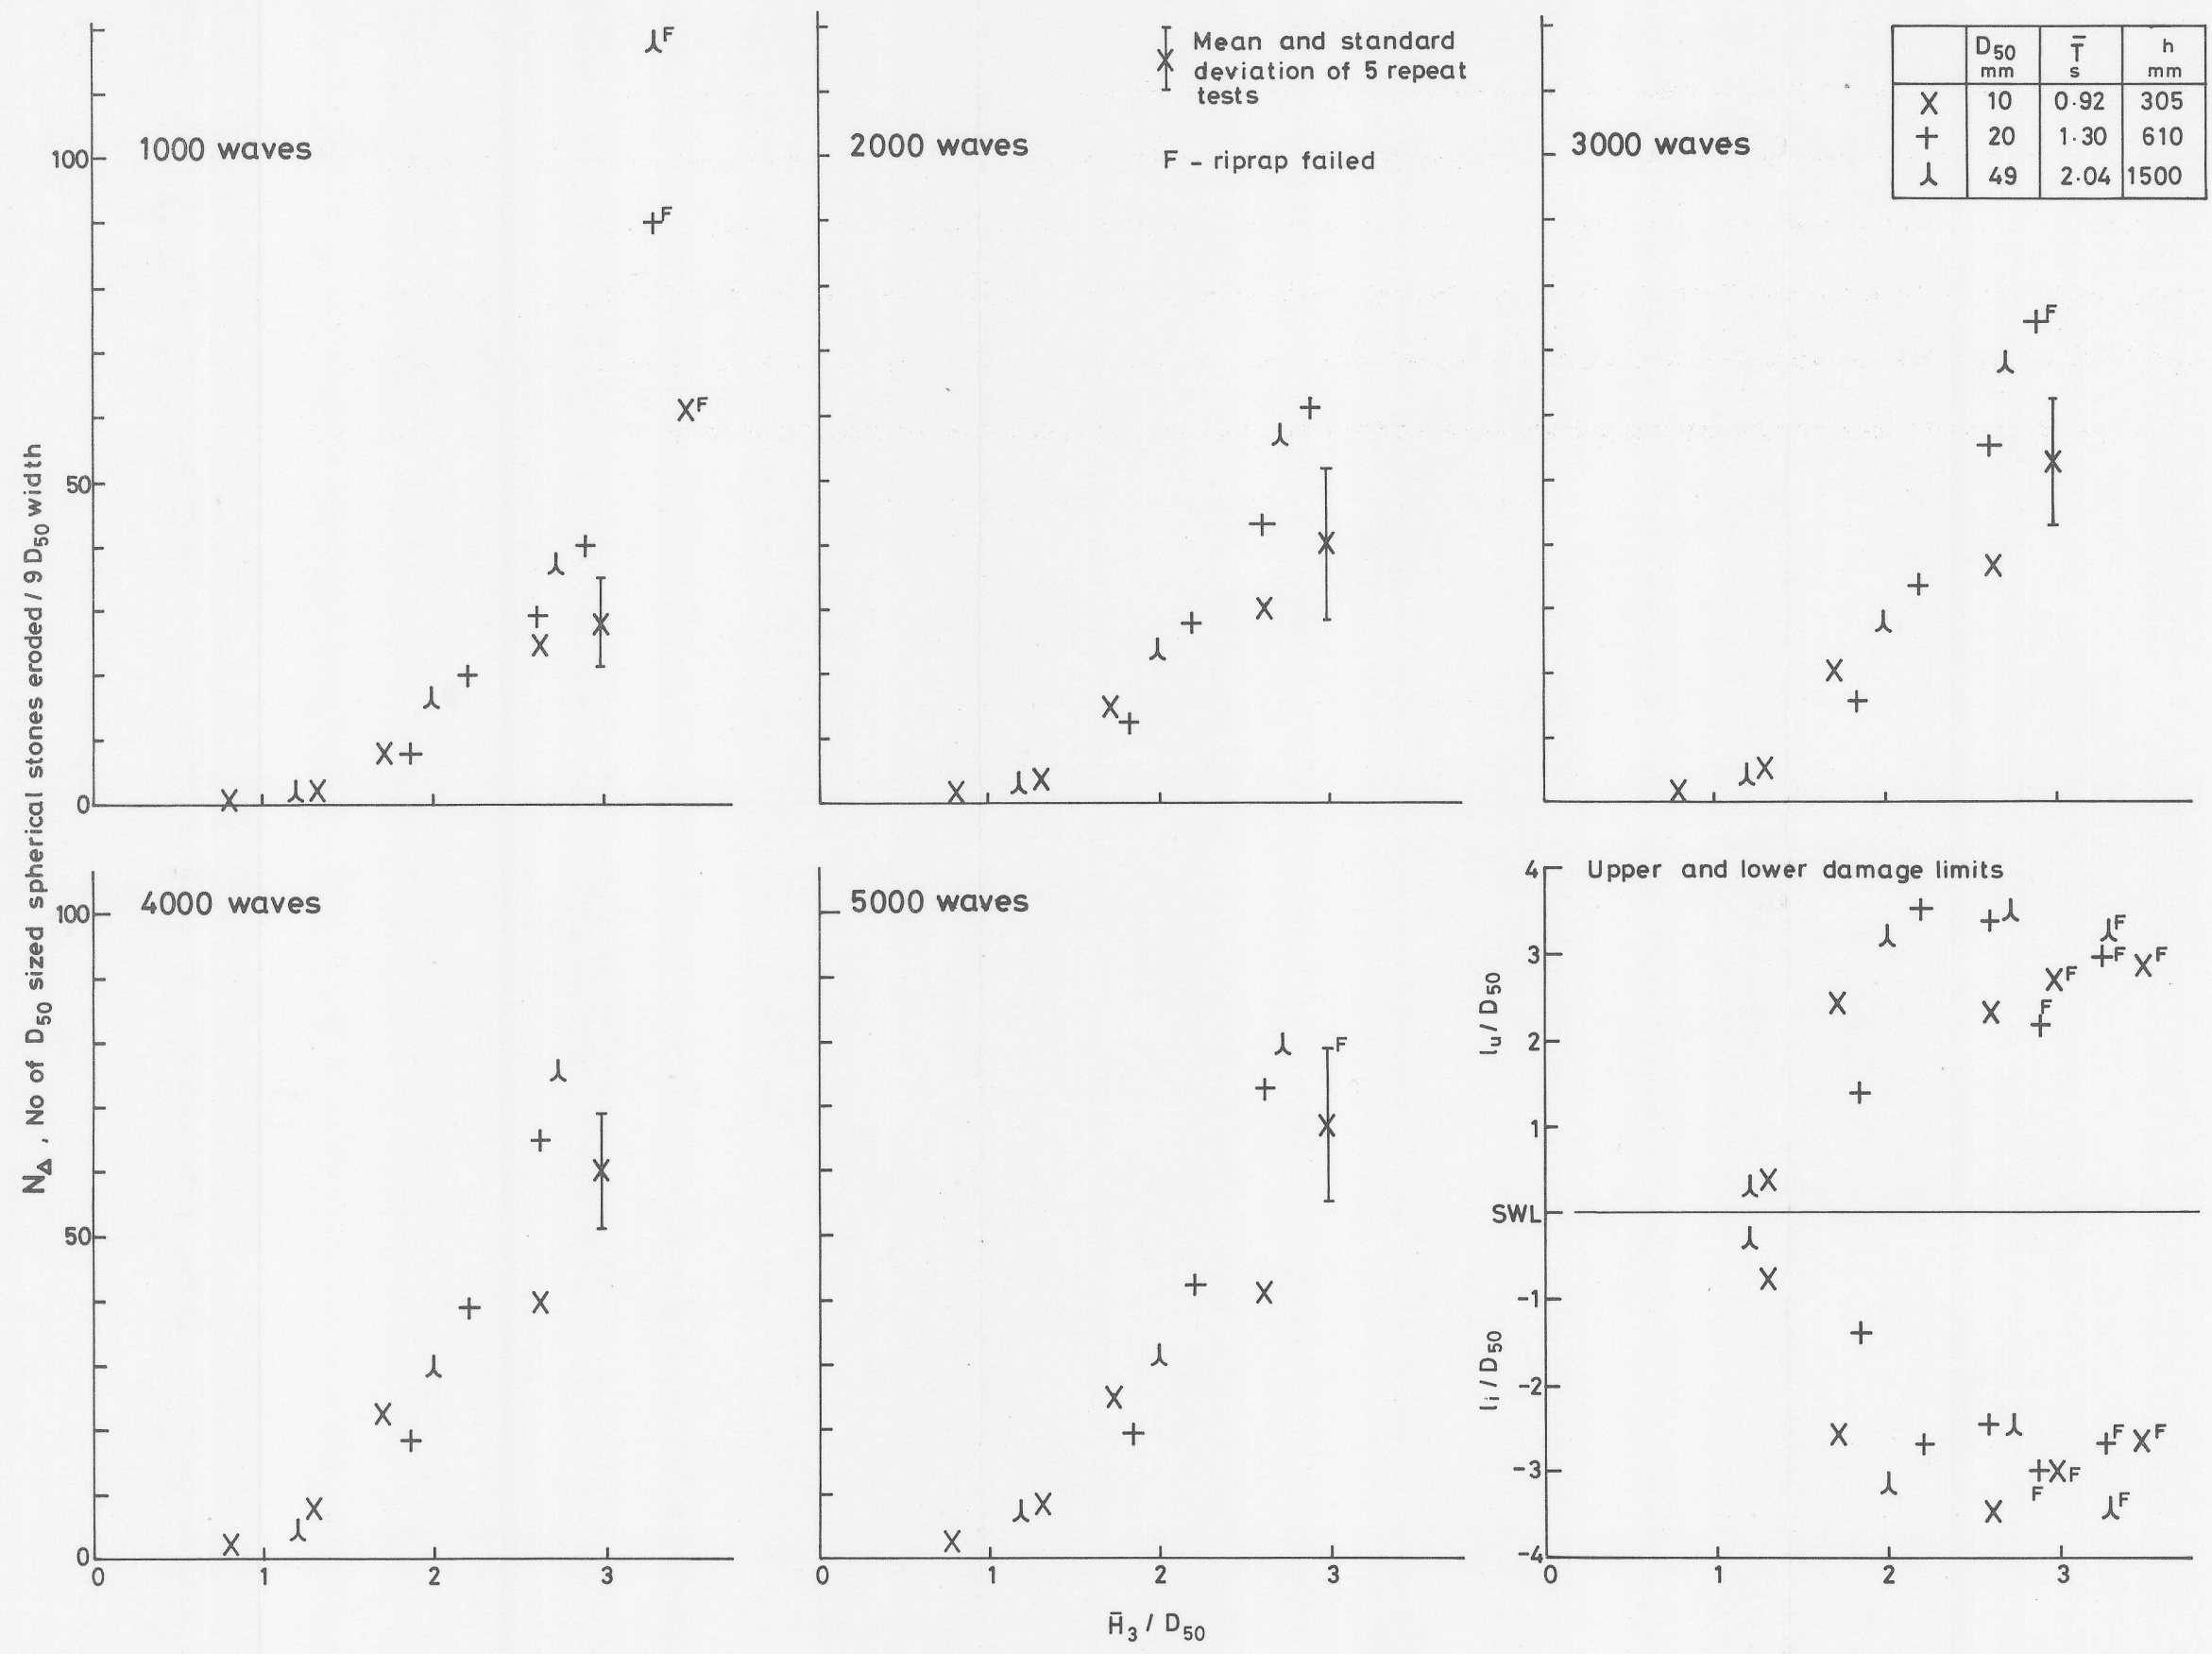
Results of extended CIRIA 61 tests

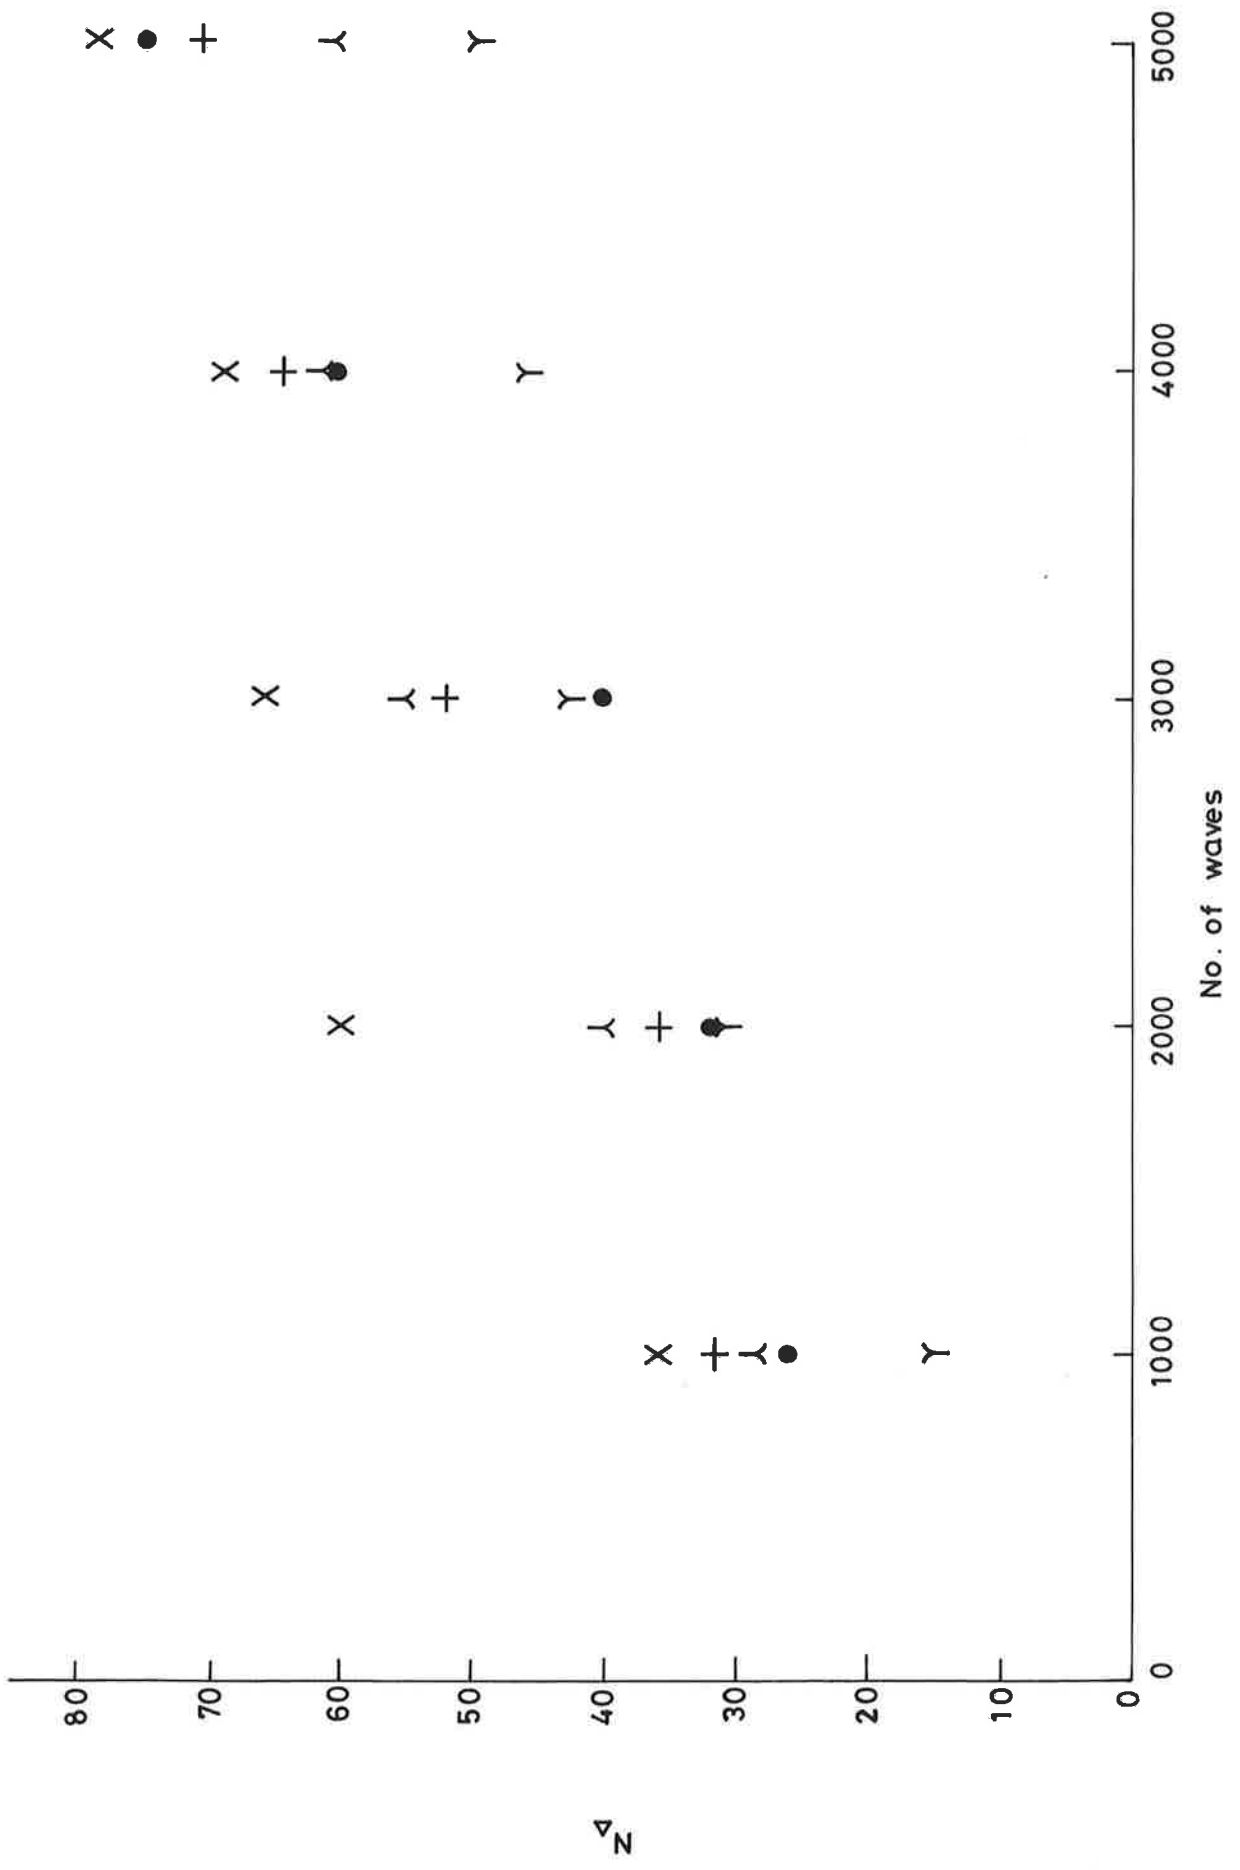
Fig 13

The results, plotted on figure 13, show a significant difference between the test. The overall variation of \bar{H}_3 and \bar{T} between the tests was less than 2% and 1% respectively and does not explain this difference. It is thought that the difference is related to the relative disposition of the larger stones in the grading, particularly in the erosion zone. These tend to shelter and support stone in their immediate vicinity particularly upslope. Two or more large stones close together can produce an arching effect in the intervening riprap which hinders erosion. Conversely, the removal of a large stone is often accompanied by a general local erosion of smaller stone.

Repeat tests

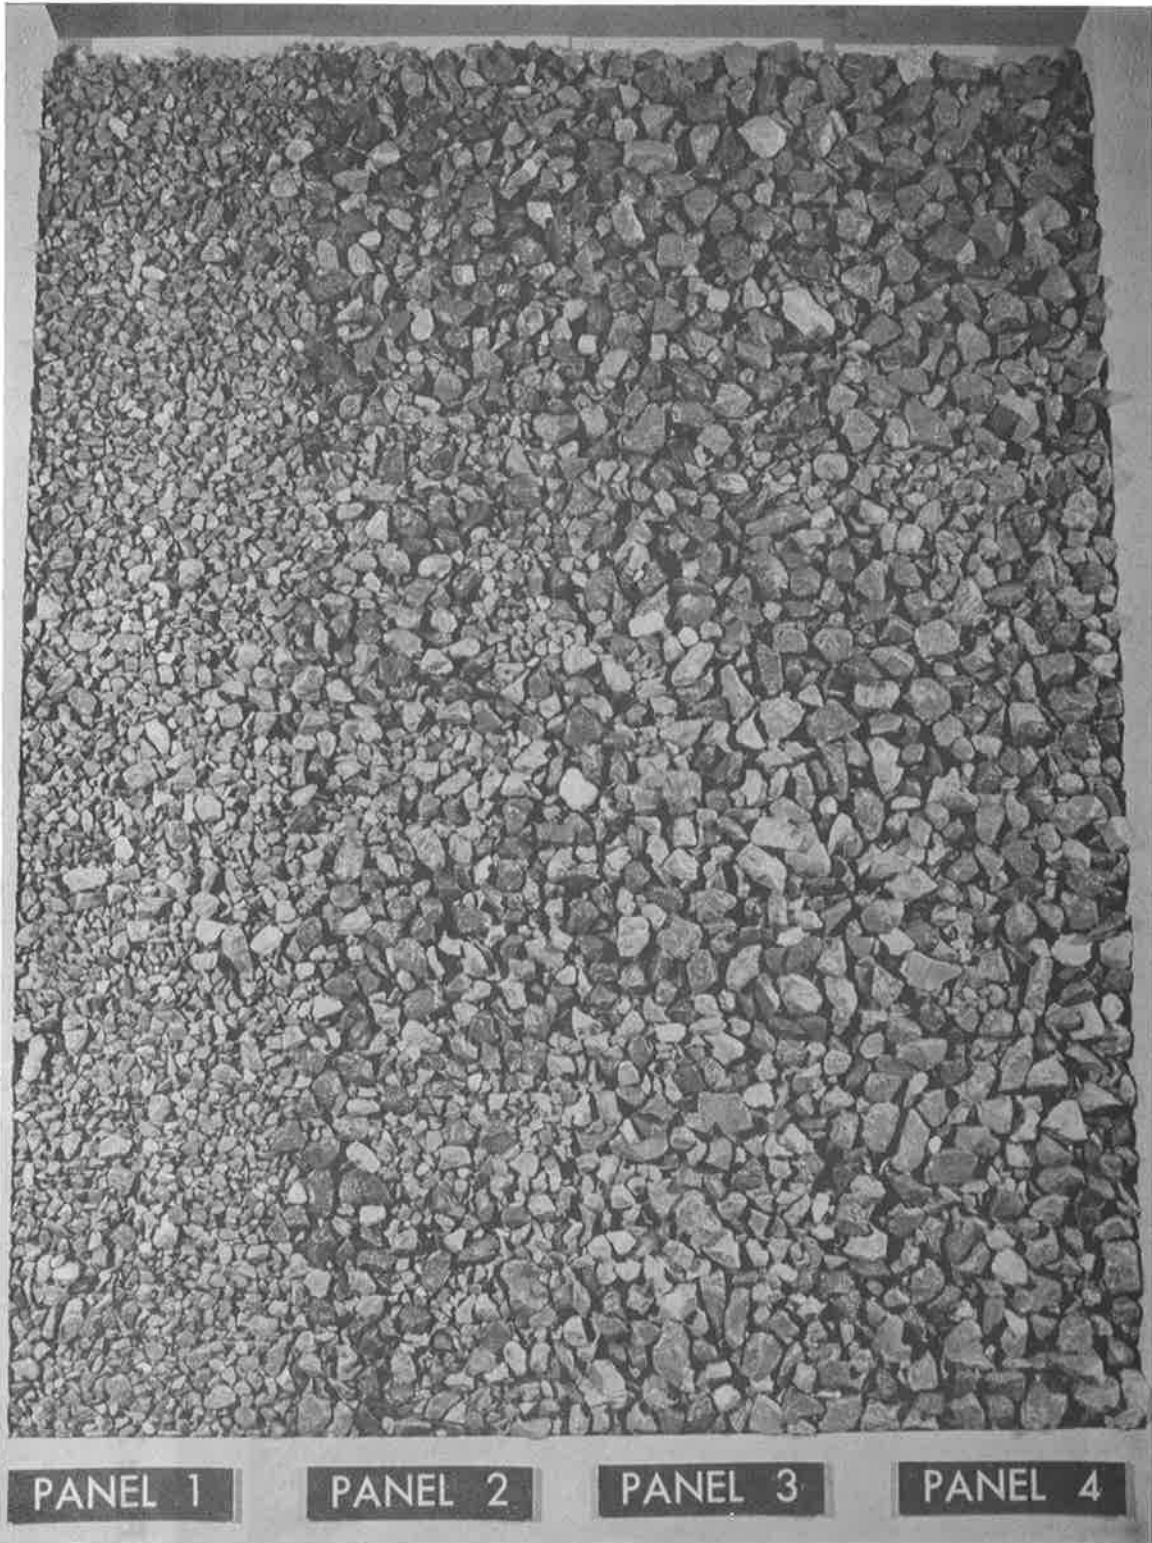
Panels 1-4 were positioned in the main flume, figure 6, and tested using the four wave/tide events simulating the two major storms. Table 2 shows the measured wave parameters for each tidal step. After each wave/tide event a full survey of all the riprap panels was made. The eroded volumes are given in table 3. The panel 1 riprap was sufficiently eroded by storm 1 to allow exposure of a small area of the filter. The damage, however, was less than occurred on the field riprap for the same storm. After storm 2 the model panels 1-3 were eroded away to the support frame level over the upper part of the slope. Panel 4 would also have suffered more damage but for the large step in the support frame floor between panels 3 and 4 which allowed stone to become wedged in position and thus resist the eroding forces. Plates 4-6 show overhead views of the panels as constructed and after each major storm.

Plate 4 Riprap prior to test run 1

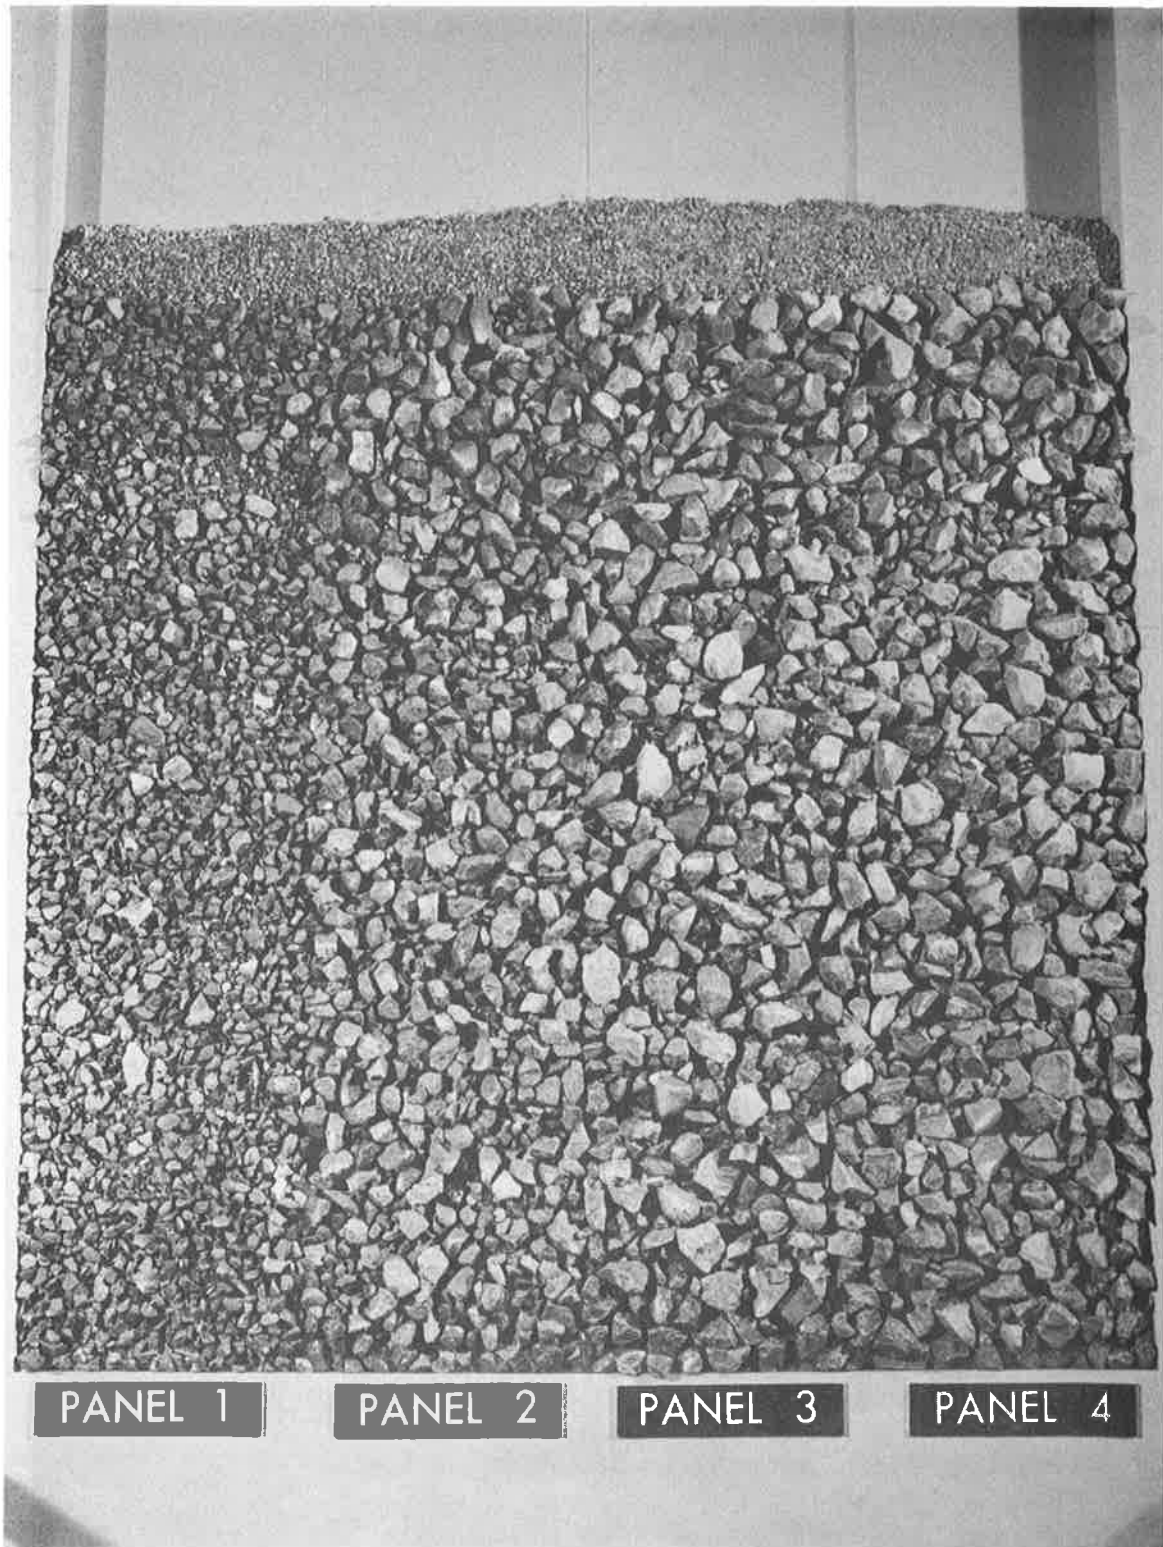
Plate 7 Riprap prior to test run 2
