A Review of Novel Shore Protection Methods

Vol 3 - Gabions

Report No SR 5  
November 1984

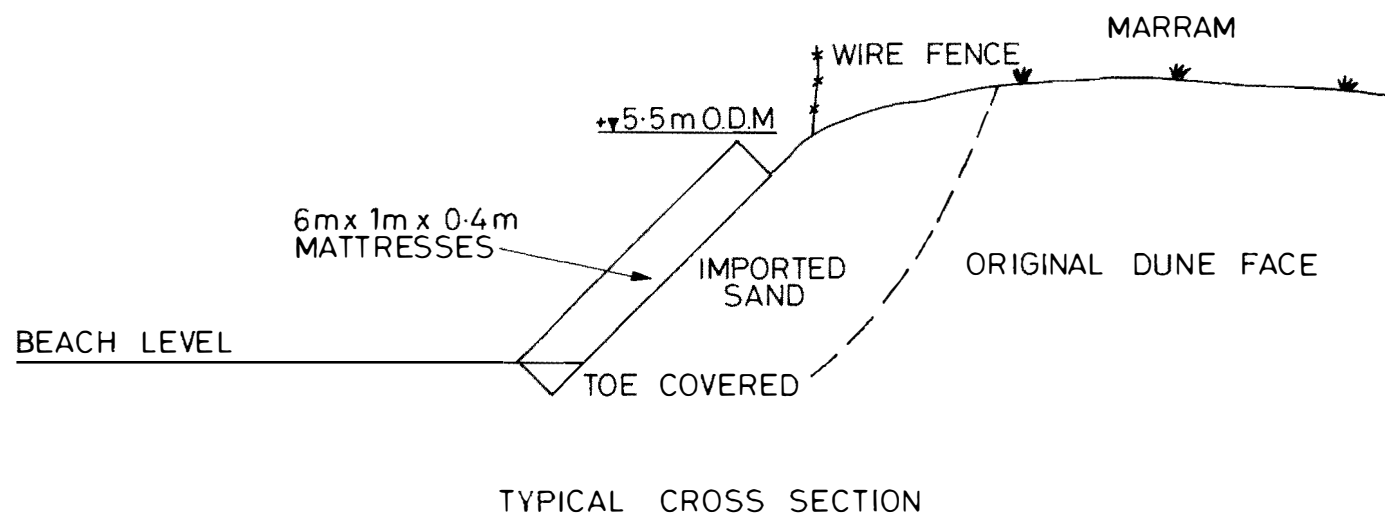
FIG. 3 SKETCH OF STRUCTURE AT BRANCASTER, NORFOLK

At Brancaster on the Norfolk coast, a sloping revetment consisting of a "Netlon" mattress and incorporating "Tensar" short stub groynes (Tensar is another type of plastic mesh manufactured by "Netlon"), was built in 1981 to protect the seaward face of eroding sand dunes (see Plate 6 and Fig 3). As the attached summary indicates, this was an experiment to determine their usefulness compared with the "Maccaferri" type gabion. One problem encountered when the baskets were being filled from the top by machine, was that the fabric stretched and holes were punched through the cages. They thus had to be hand filled to ensure that the baskets kept their shapes. It would appear that this revetment, although cheaper, requires more attention than plastic coated metal gabions.

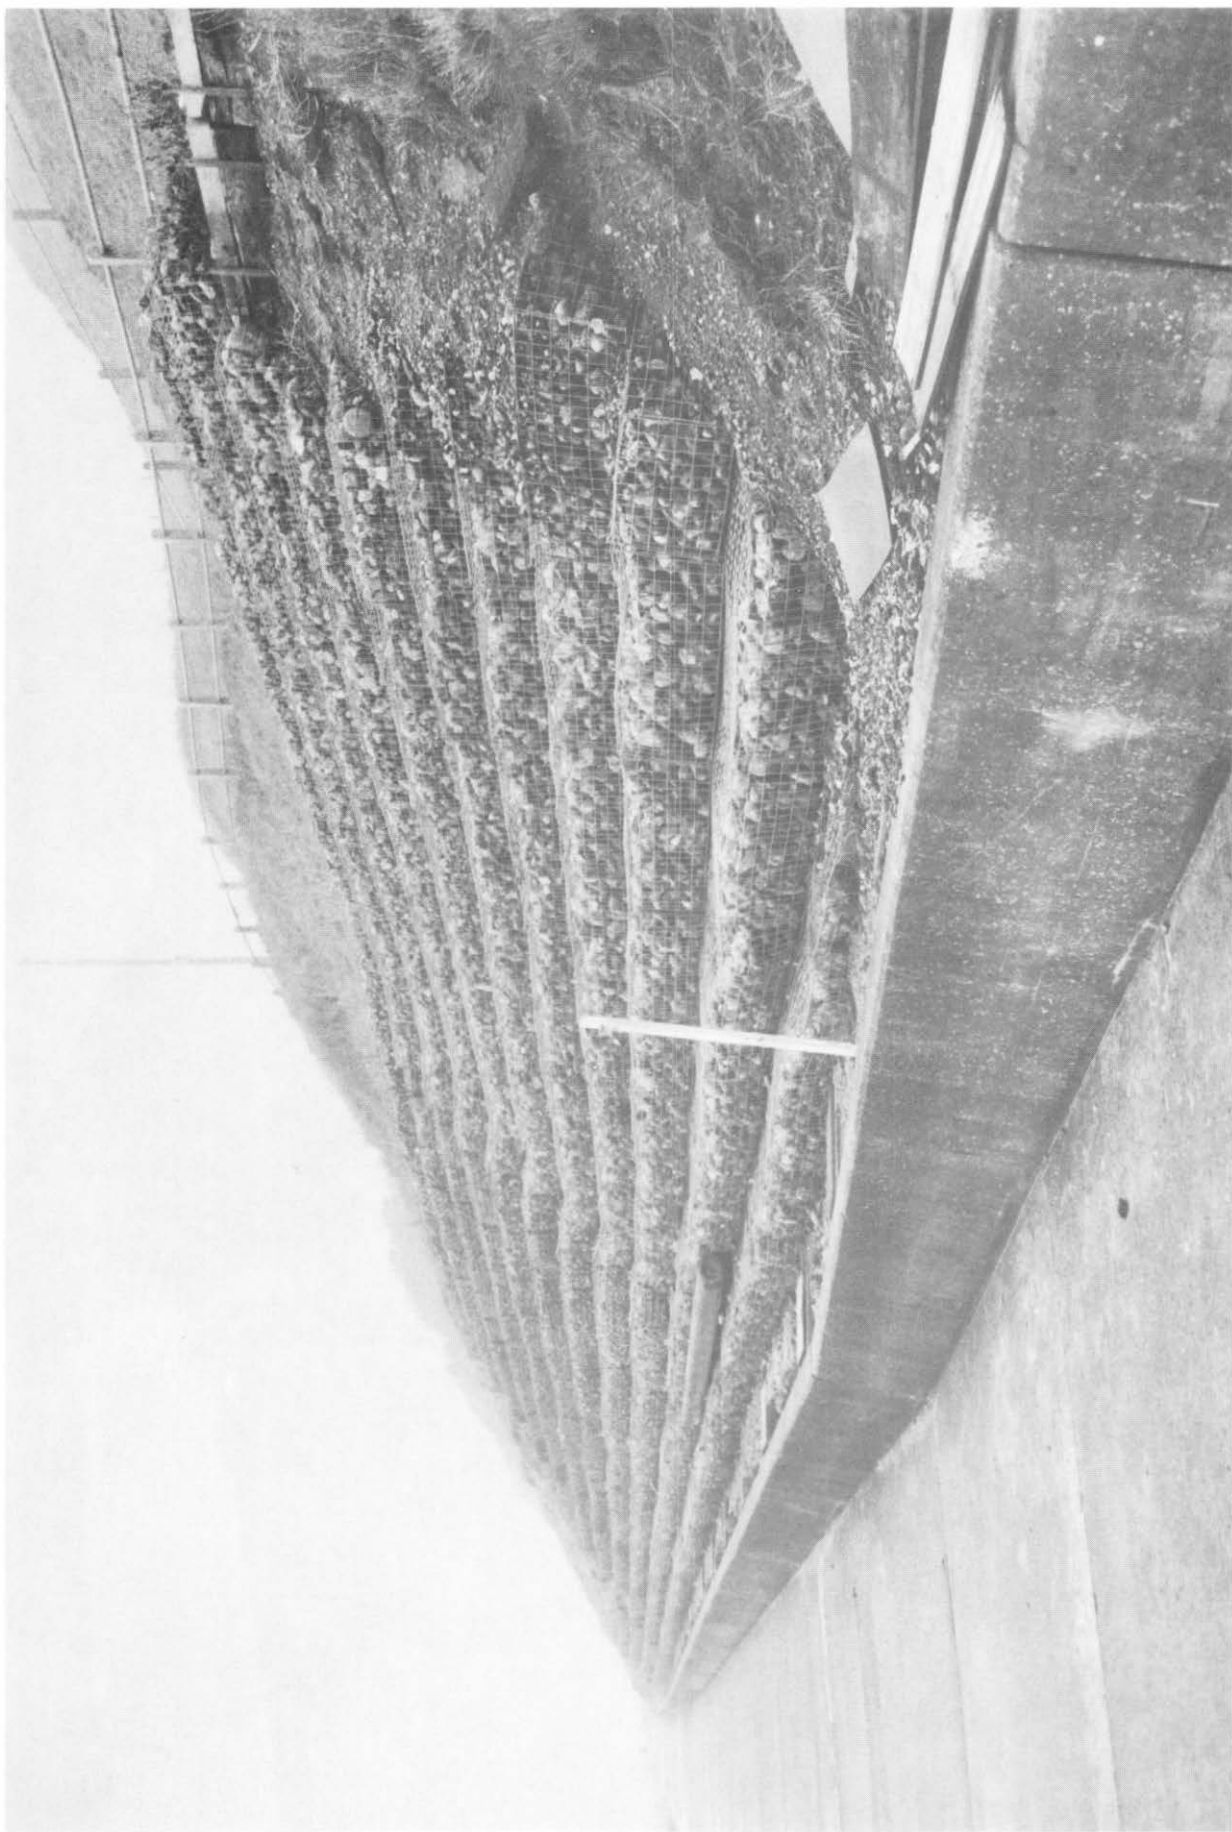
**Plate 1** "Maccaferri" type gabion sea wall on shingle beach at St Bees Bay

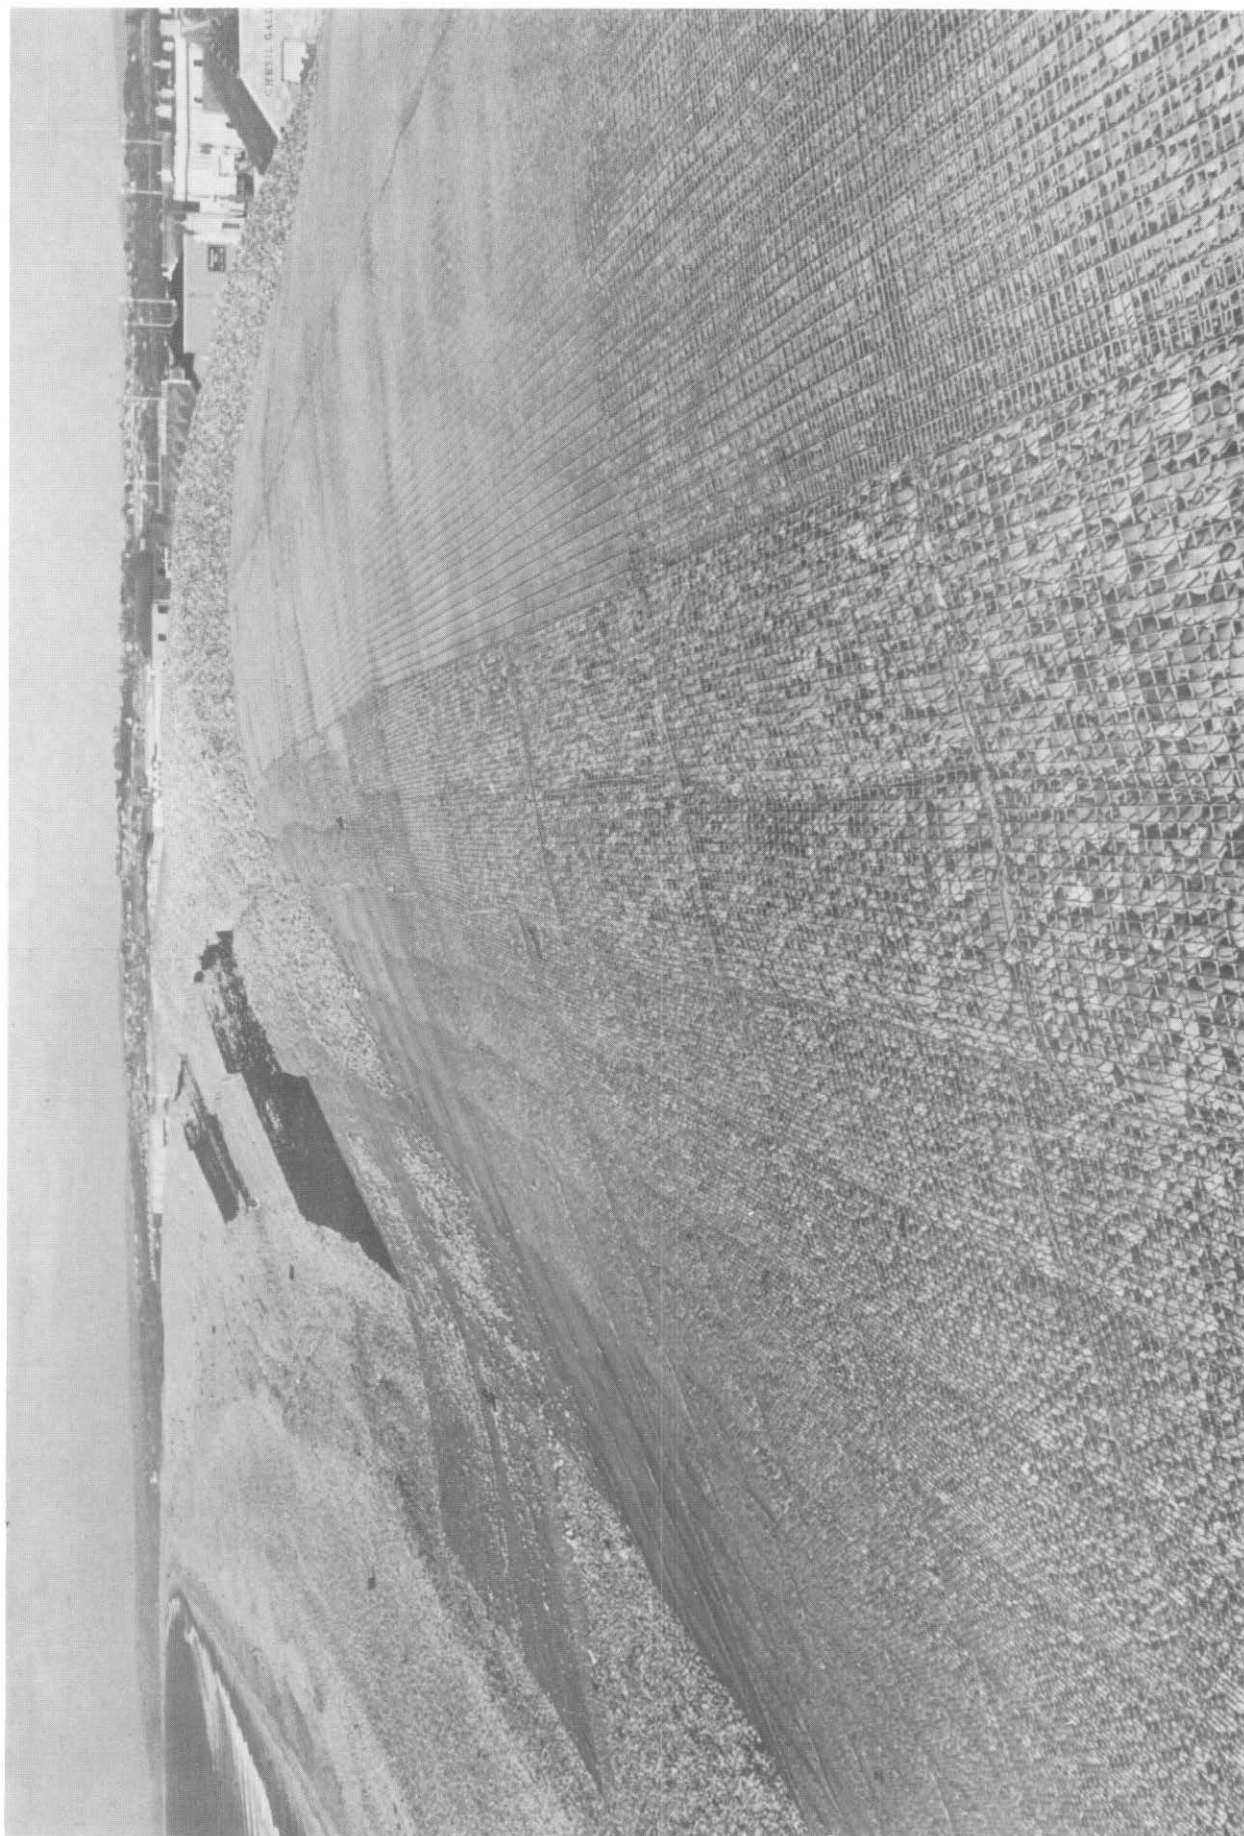
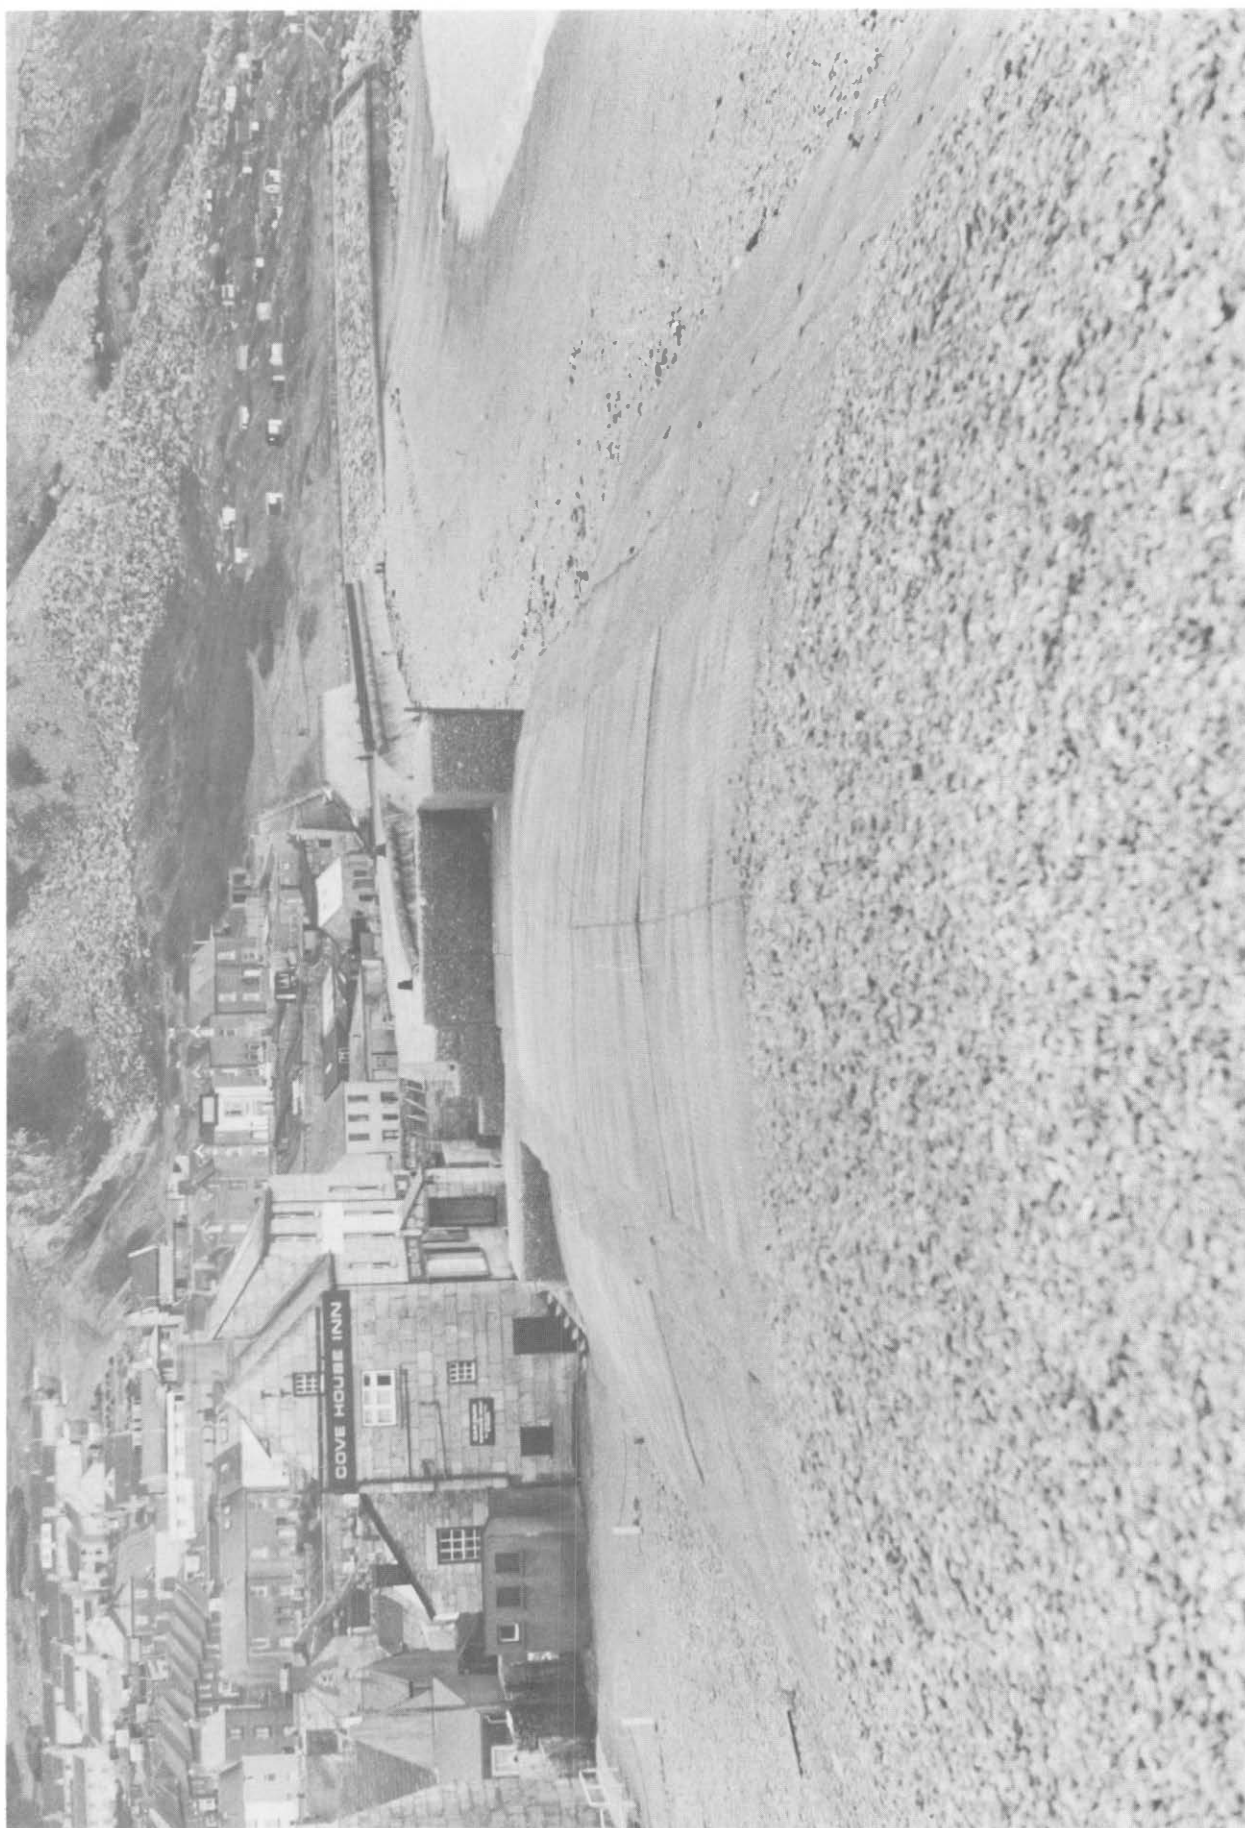
At the Chiswell end of Chesil Beach, Portland, a system of gabion mattresses, both Maccaferri and Weldmesh, straddle the beach crest in three layers. Installed in 1981 (see Plates 3, 4 and 5) they are anchored to gabion boxes set into the landward slope of the beach. As the attached summary indicates, both local beach pebbles and Portland capstone were used as fill material and some of the Maccaferri gabions had a lining of Netlon to prevent undersized fill from being drawn out by wave action. The mattresses are situated on the beach crest above normal wave activity and are subject to only occasional overtopping. Generally, the exposed baskets are in good condition although we believe that some damage has occurred to the Netlon lining.

**Plate 3**     Installing "Weldmesh" and "Maccaferri" gabions on Chesil Beach

**Plate 4** Gabions in position on shingle ridge at Chesil Beach (looking west)

**Plate 5** Gabions in position on shingle ridge at Chesil Beach (looking east)

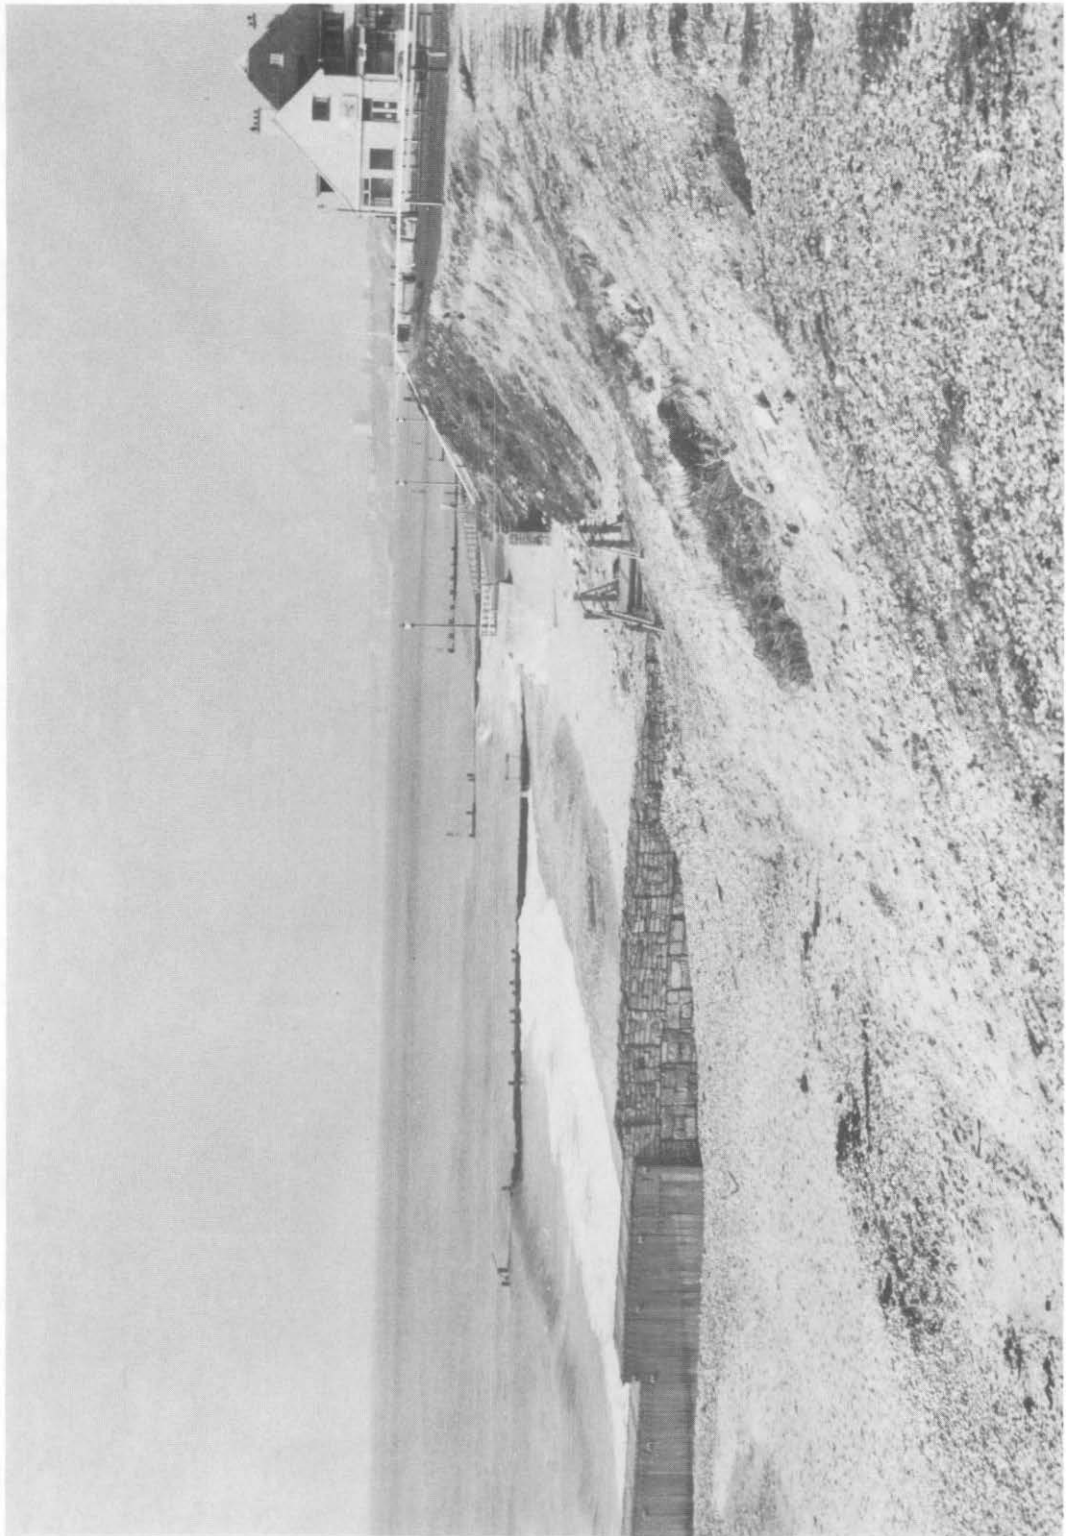
**Plate 10** "Maccaferri" type groyne showing foundation pad and scour hole,  
Old Hunstanton

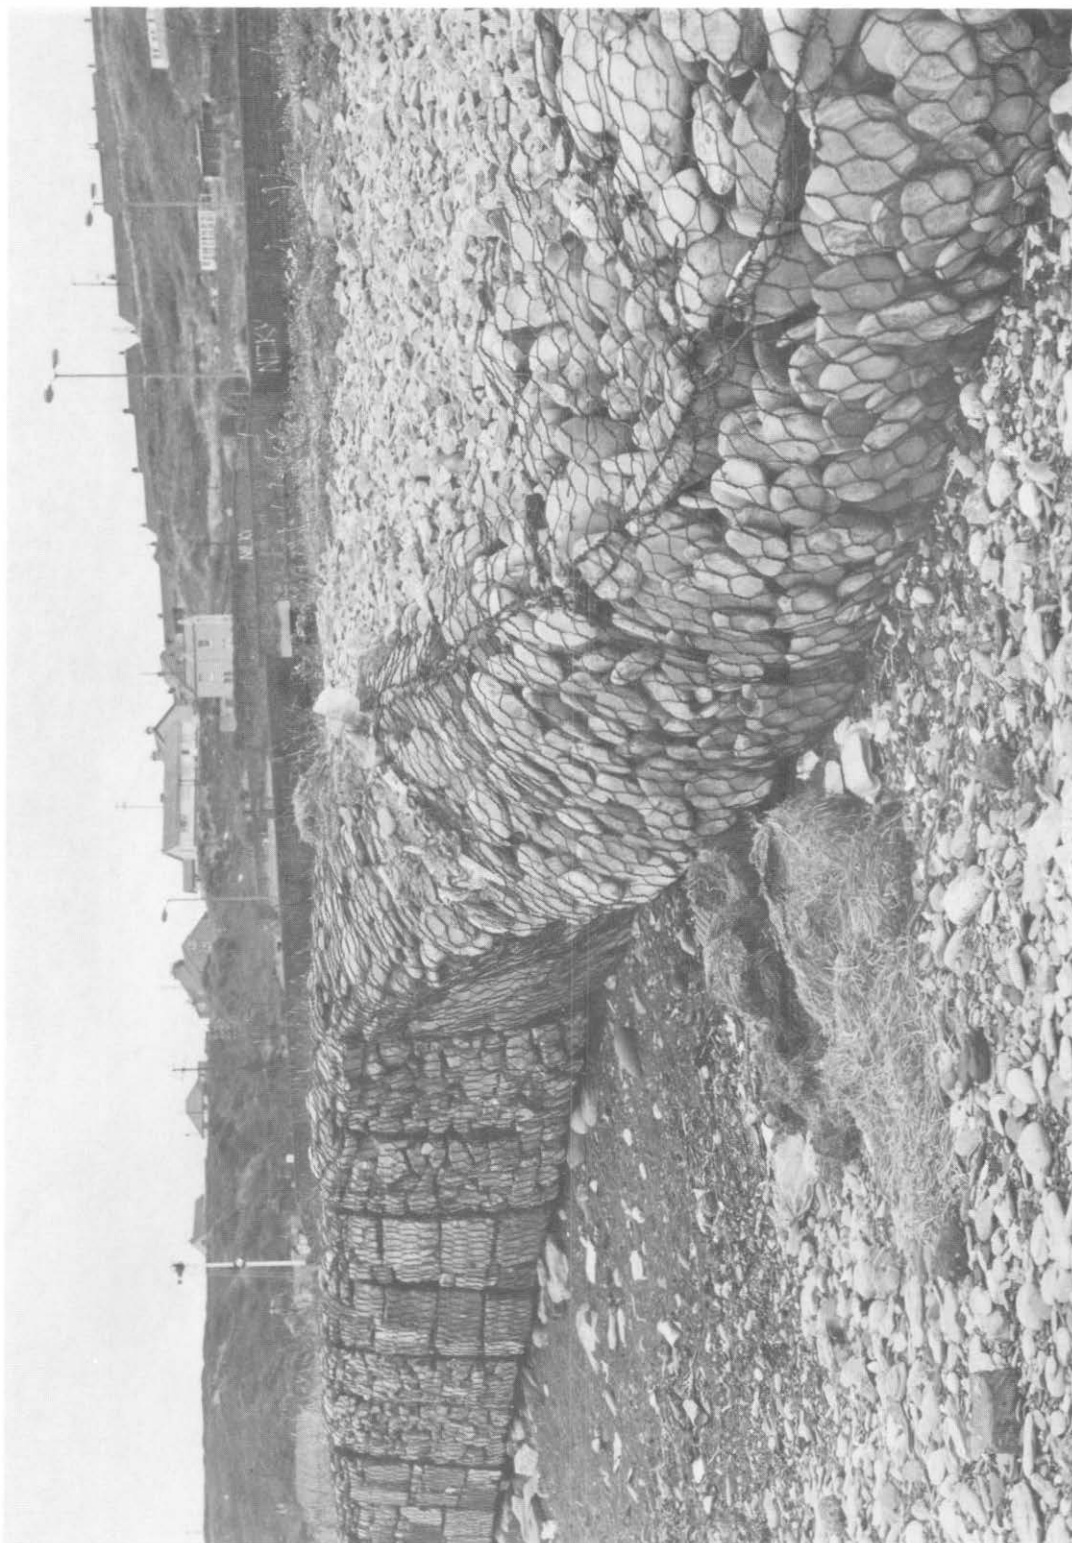
**Plate 11** Hybrid groyne at Southbourne, Dorset

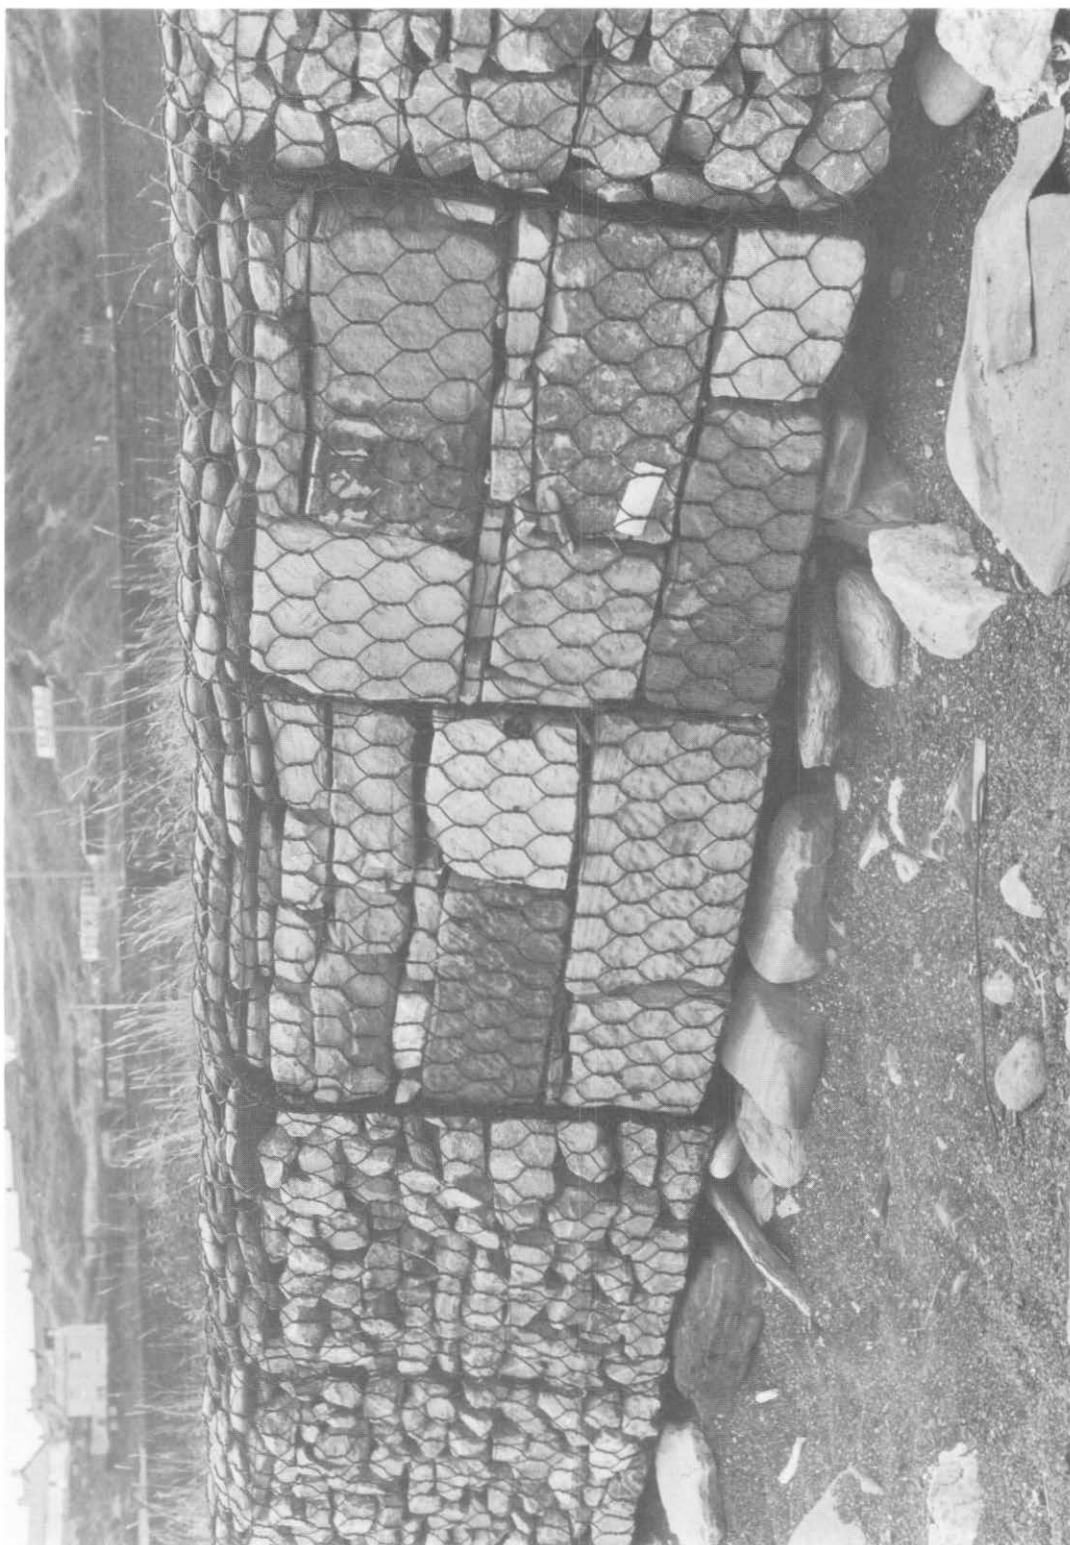
Plate 15 Example of damaged gabion revetment

3. Regular monitoring and repair is essential, especially in the more popular holiday areas and in places where gabions are subjected to beach movement and wave activity is high. It is usually possible to repair the mesh type gabion quickly by rewiring if the damage is localised. Unless baskets are repaired quickly, broken wires can become a hazard to holidaymakers (see Plate 15).
