**Highways Agency
Contract No: 3/323 F**

**Resilience of the HA
Network:**

**Review of flooding incidents in
Autumn 2000**

**Report SR 584
March 2001**

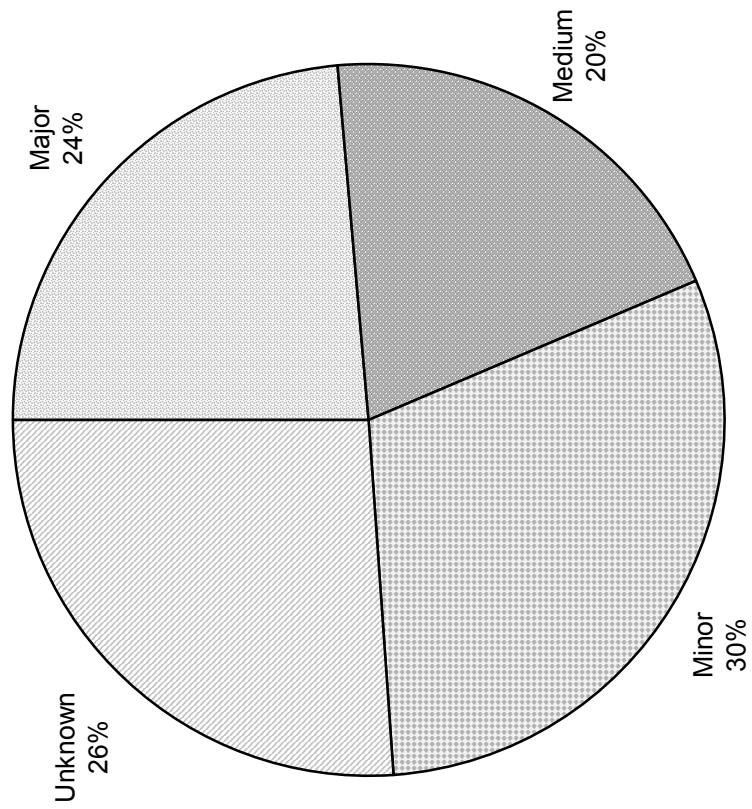
Figure 5 Severity of incidents on HA Network

Figure 5 presents the data in terms of the severity of the incident. The distribution between major, medium and minor incidents is fairly equal. The severity of 26% of the incidents cannot be determined from the information available; however, assuming these to be divided fairly equally between the three categories, it would appear that about 33% of all the incidents (ie, about 65 in number) would be rated as major.

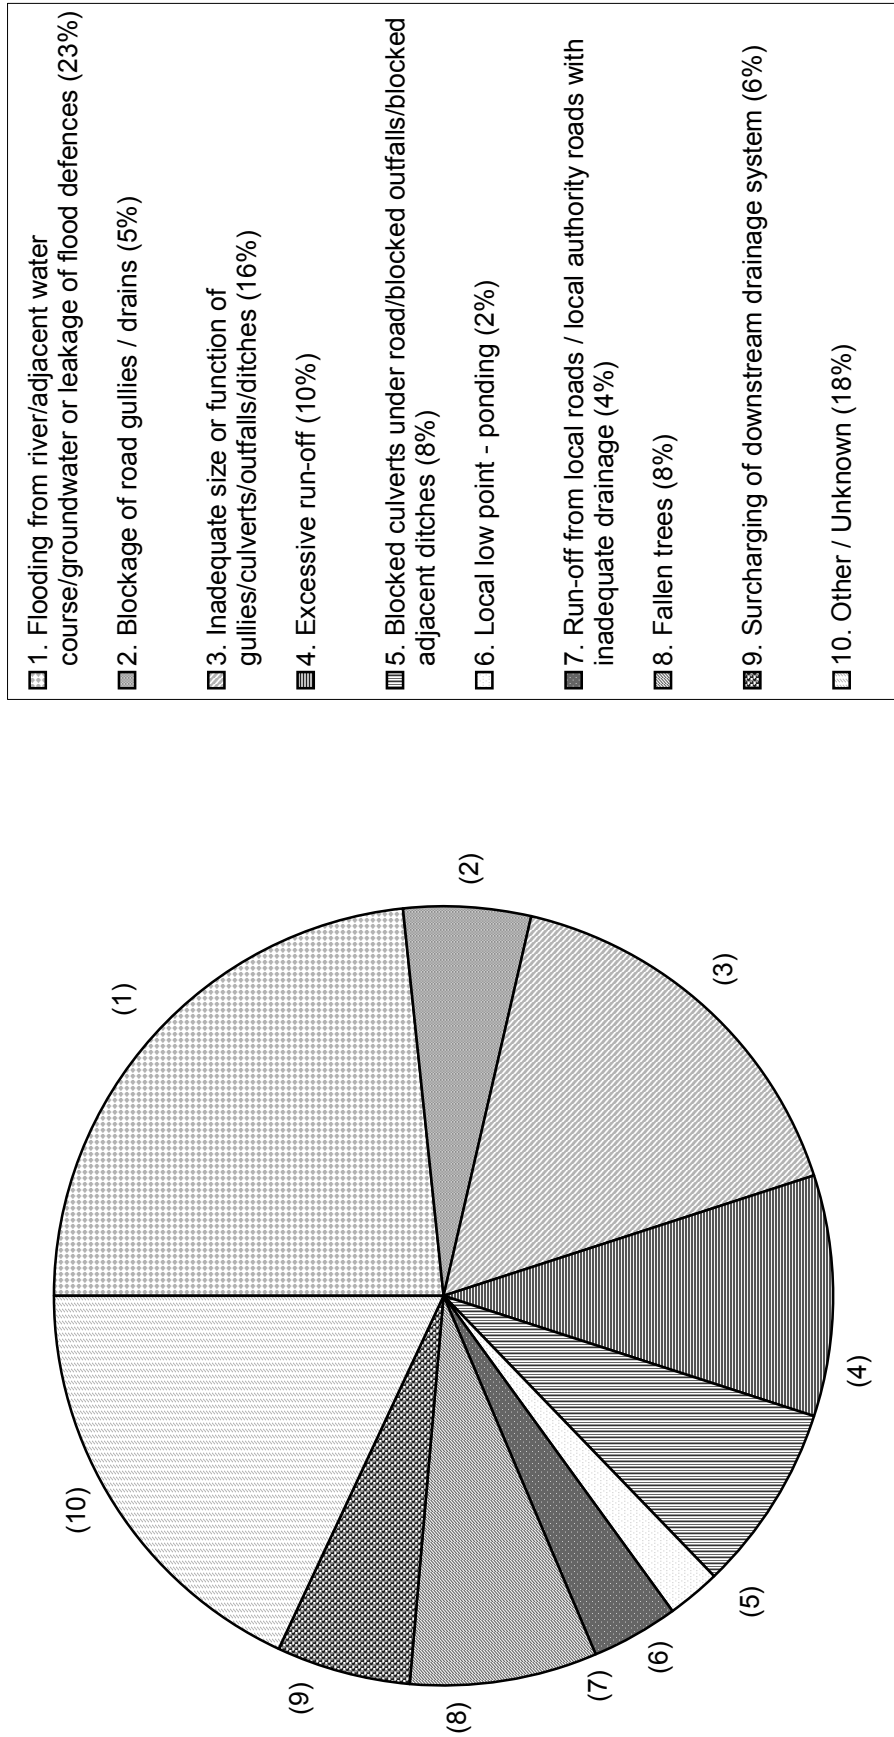
Figure 6 Distribution of incidents according to cause

The distribution of incidents according to their cause is shown by Figure 6. The results show that about 84% of the total incidents were caused by flooding, with the other 16% being due to fallen trees, high winds, accidents and other unspecified factors. Within the cases of flooding, about 29% of the total incidents occurred as the result of high water levels in rivers or streams inundating sections of road or submerging drainage outfalls. This suggests that about 55% of the total incidents (ie, about 107 in number) were due to inability of the highway drainage systems to cope with the flows received.
