A REVIEW OF NOVEL SHORE PROTECTION METHODS

Inspection of sea defences in Holland
and Belgium
17 to 21 September 1984

Report No SR 6
December 1984

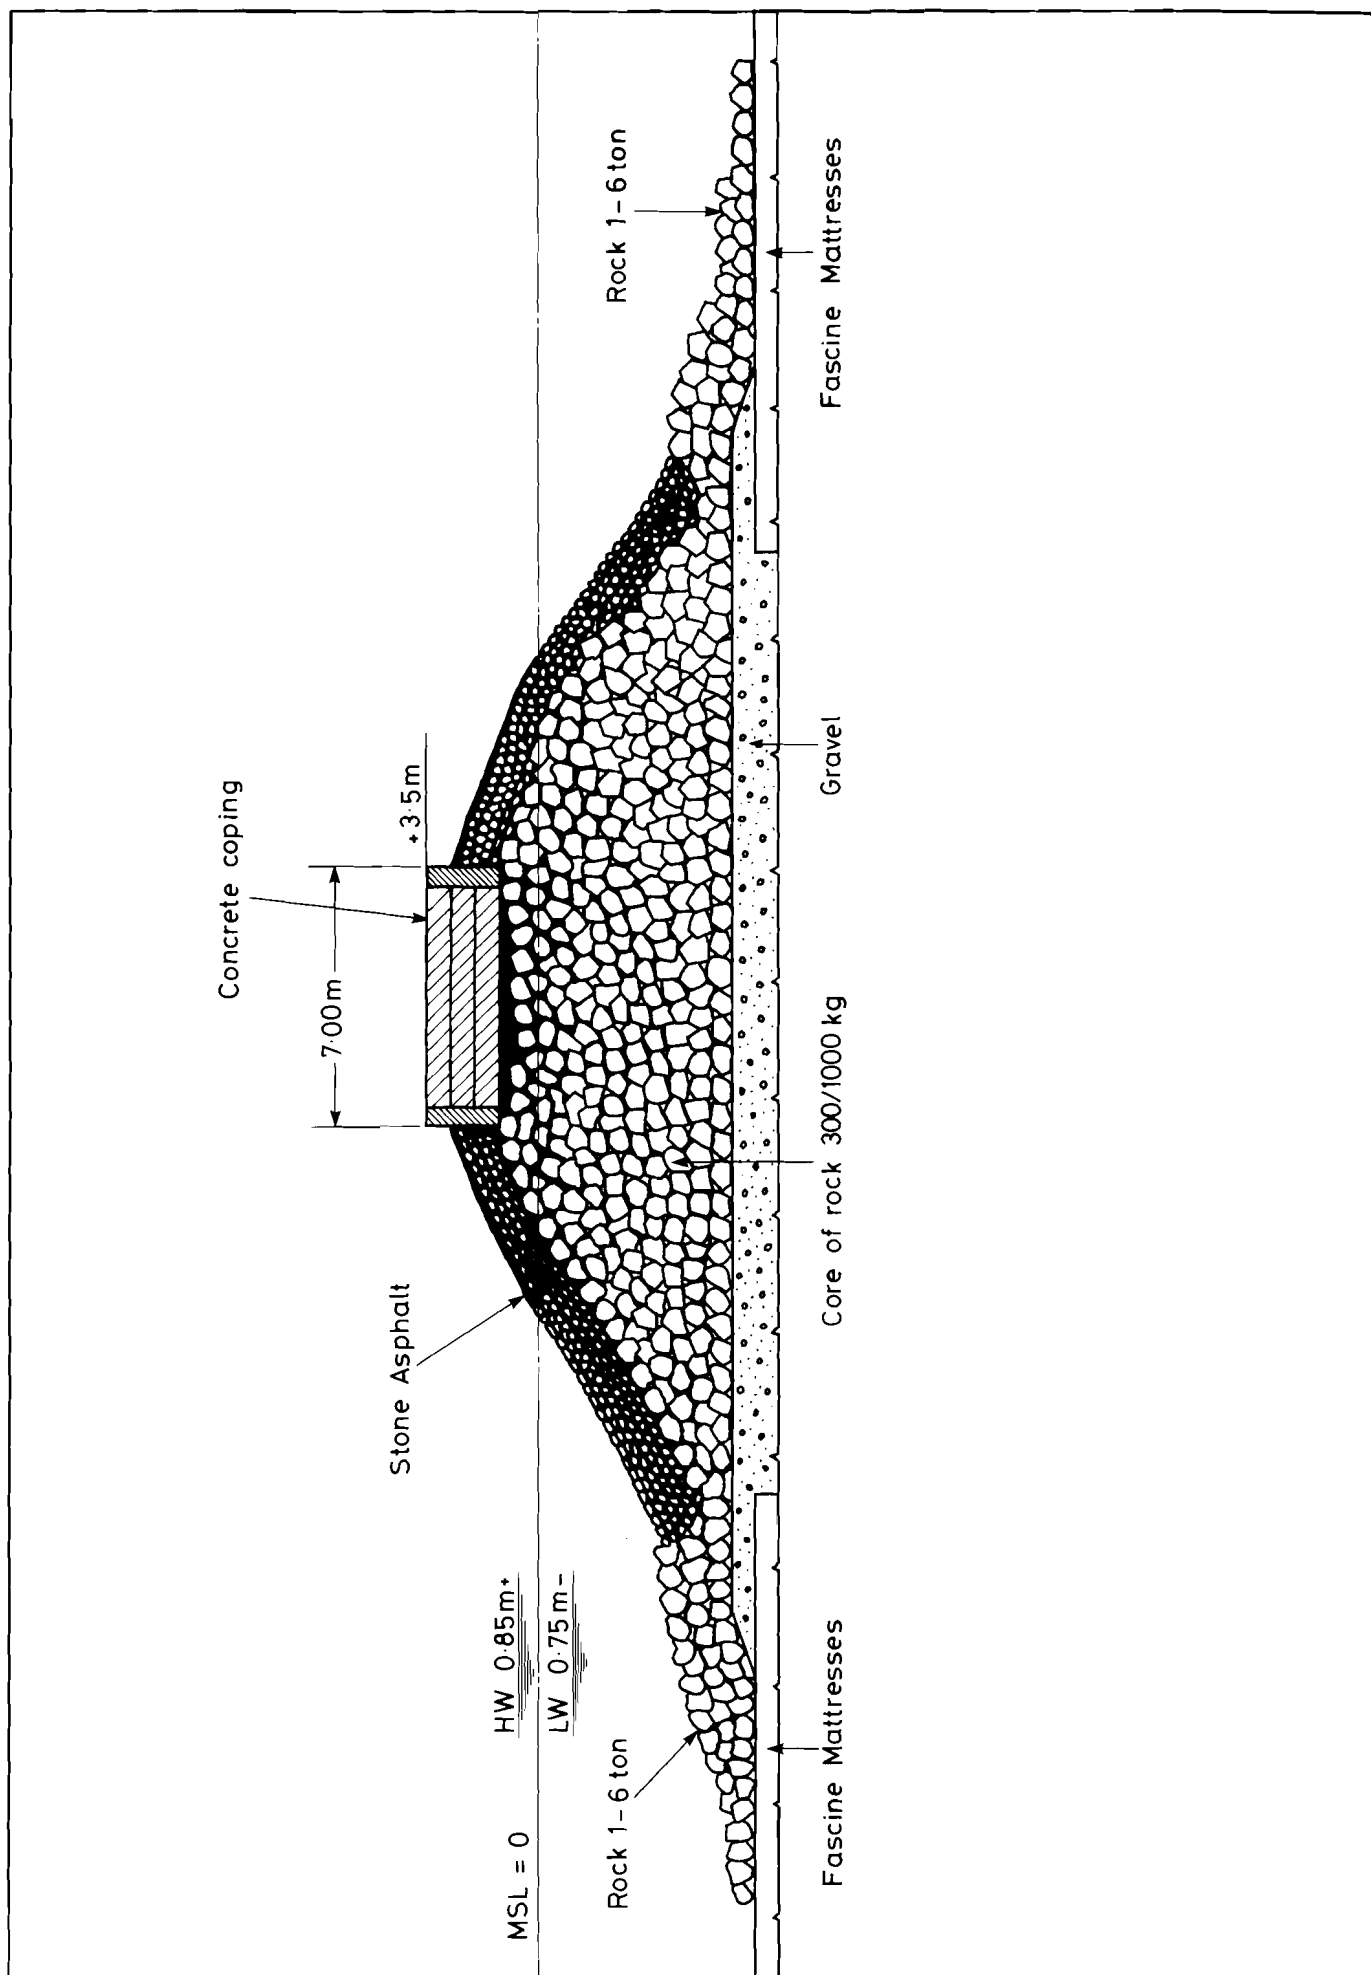
We were shown around the south breakwater by Mr Woestenenk, Managing Director of Bitumarin BV. Both the north and the south breakwaters have a core of rock, covered with a 2.5 metre layer of heavy stone asphalt, see Fig 7. The placing of the asphalt was a major achievement by Bitumarin in that the mix included stones up to 34 kg in weight and that about 700,000 tonnes of this were used to provide armouring for some 3200 metres length of breakwater. A large proportion of this mix was laid underwater. Since that time the breakwaters have been extended seawards and upgraded, and the primary protection on the seaward face now consists of 20 - 50 (?) tonne concrete cubes. (The cube size used depends on the

Fig 7 Ijmuiden Breakwater, Holland, built 1962-67

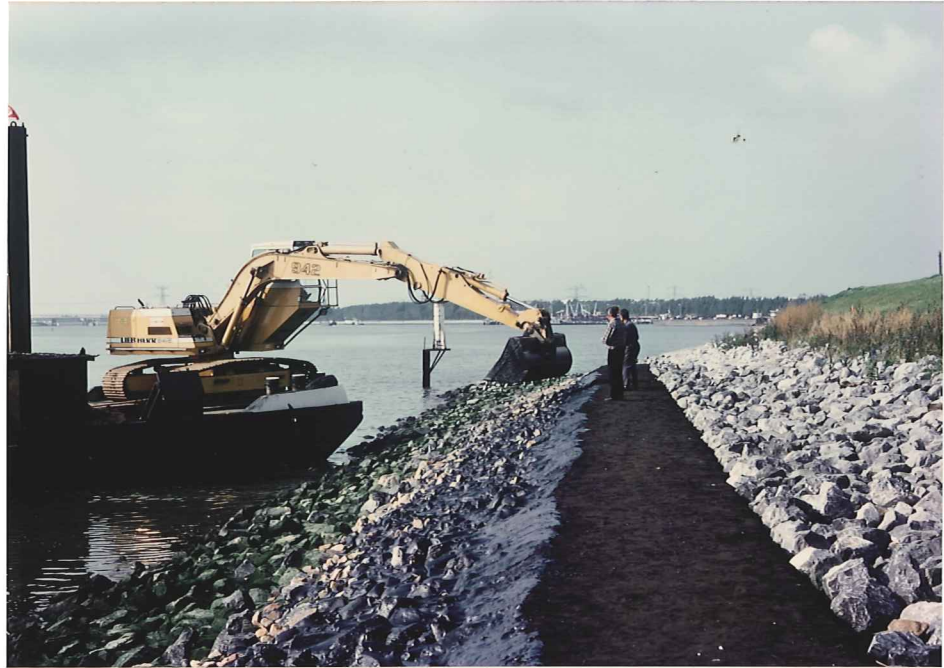
Plate 9 Rotterdam Waterway. Small scale bank improvements using asphalt grout and sand asphalt.

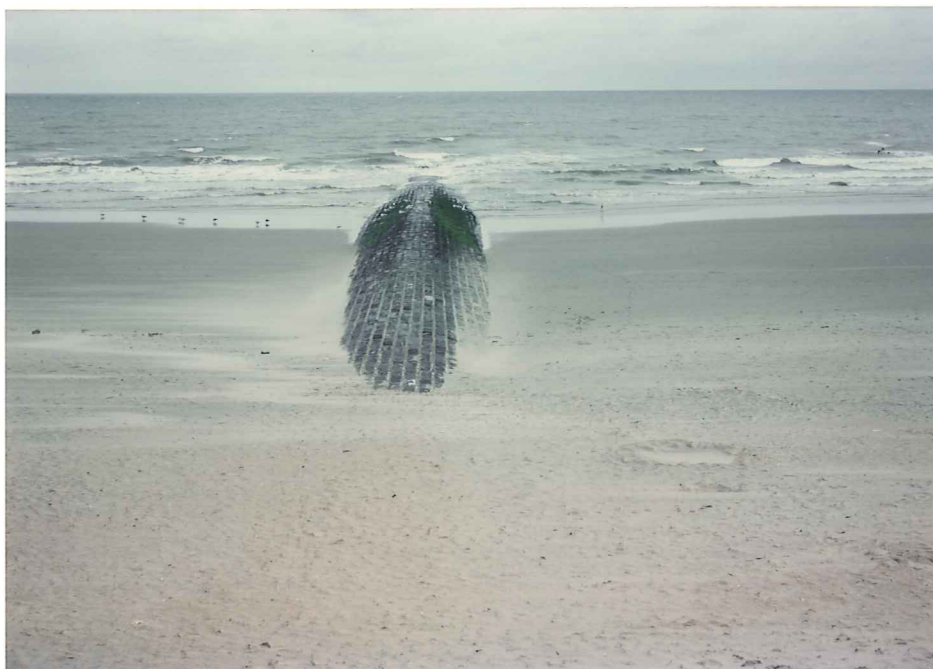
Scheveningen is a tourist resort north of Hoek van Holland which lies at the southern end of a wide belt of sand dunes which extend northwards almost to Den Helder. This area is probably the most widely used stretch of coast in Holland so far as bathing and other water-based recreational activities are concerned. It has a number of towns including Scheveningen, which resemble British resorts, that is to say the wide sand beaches are groyned and are backed by concrete sea walls. At Scheveningen, the sea wall is situated well up the beach and the groynes (Plate 11) are of the low profile type. The impact on adjacent beaches (downdrift erosion, updrift accretion, scour in front of sea walls) is much less marked than at many United Kingdom resorts. The lower part of the beach is quite flat and the wave breaker zone very wide. Strong offshore currents evidently develop and bathers are warned not to swim in the vicinity of the groynes. The groynes consist essentially of basalt blocks grouted with asphalt.

Plate 11 Scheveningen. Low profile basalt groyne.

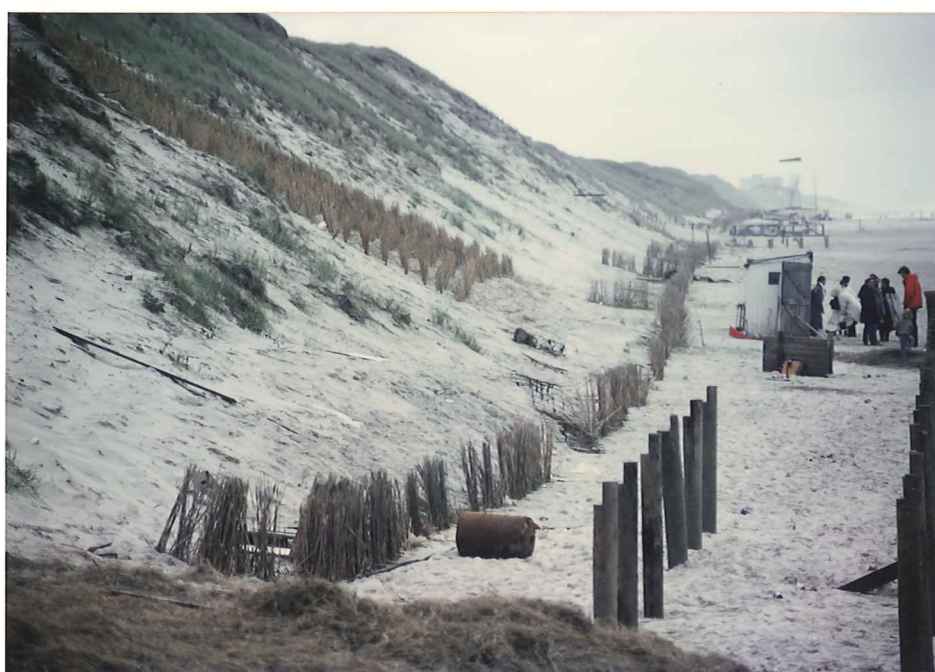
Bergen is to the north of Scheveningen, near the northern end of the wide belt of sand dunes mentioned above. Although it appears to be a small holiday resort it is obviously heavily used in the summer. During our inspection the havoc wreaked by pedestrians was being made good (see Plate 12). The toe of the sand dunes was being protected by a form of fagotting not seen in this country. It consisted of clumps of rushes or dried grasses placed in rows, presumably with the intention of trapping sand. This area is exposed to winds blowing from the north-west over the North Sea. Judging by the steep seaward face of the dune line it would appear that set up of the water level brings wave action up to the toe of these dunes. The protection measures appeared to be somewhat half hearted by comparison with the scale of the erosion problem.

Plate 12 Bergen aan Zee. Dune stabilisation.

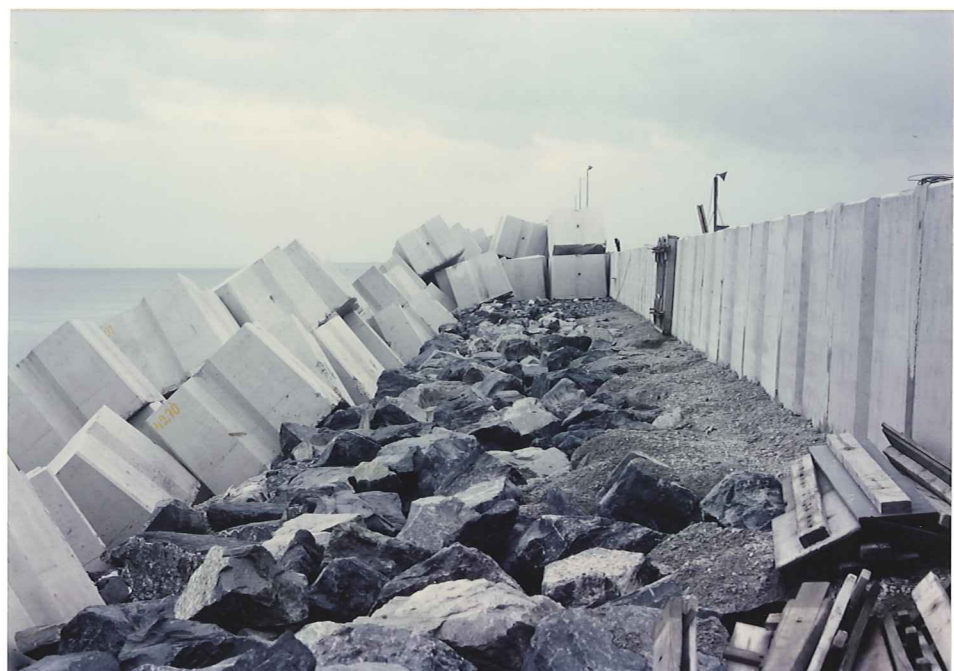
Plate 14 Zeebrugge. Concrete armour units protecting the new south breakwater.
