2nd Generation Asset Inspection Techniques

FRMRC / PAMS Projects Developments

Michael Wallis – HR Wallingford

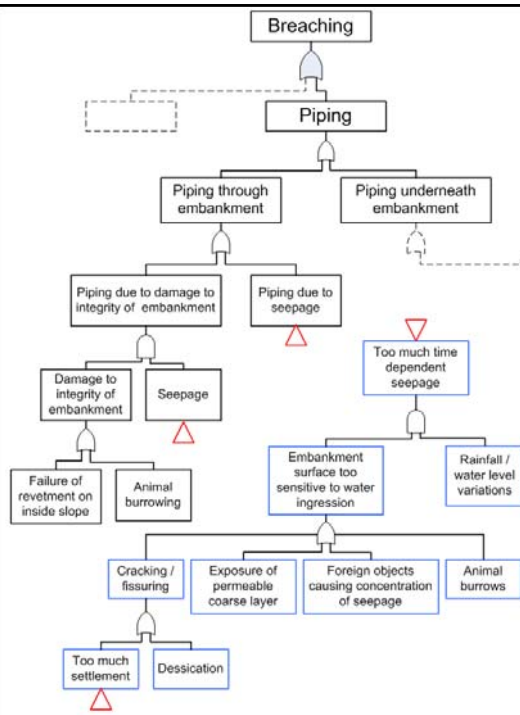
PF grading

Table 4.2 Performance feature assessment for asset component 3b (embankment)

Performance Features	Condition	Confidence	Condition Max	Condition Min
1. Animal burrowing/vermin infestation	1	0	1	1
2. Foreign objects in the crest or rear slope concentrating the erosion process	1	0	1	1
3. Cracking and /or fissuring	4	+1	5	4
4. Third party damage (cattle, vehicles etc)	1	0	1	1
5. Direct evidence of seepage or piping	1	0	1	1
6. Visible deformation of cross-section caused by slope instability	4	+1	5	4
7. Erosion of cross section	1	0	1	1
8. Vegetation condition (outer slope)	1	+1	2	1

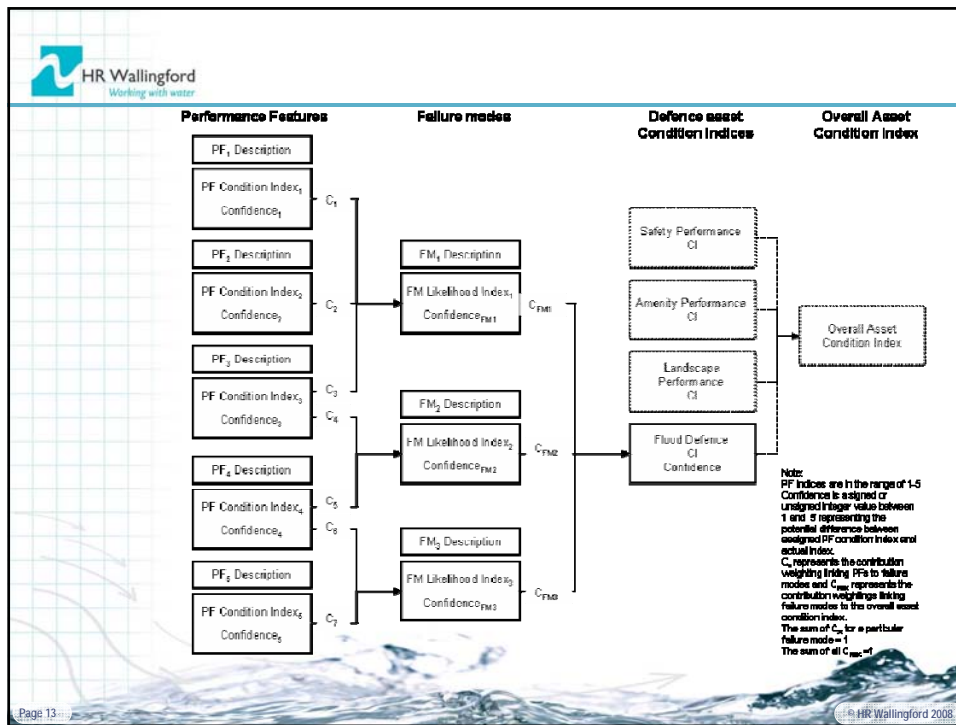
PF Contributions

Earth Embankments Performance features	Slope Instability	Revetment failure	Piping	Fill washout	Overtopping breach
1. Visible deformation of cross-section (e.g. slumping heave, local translation)	❖		❖		
2. Animal burrowing / infestation	❖	❖	❖	❖	
3. Foreign objects in the crest or rear slope	❖	❖	❖	❖	❖
4. Cracking &/or fissuring	❖		❖	❖	
5. Third party damage (cattle, vehicles etc)		❖			❖
6. Direct evidence of seepage or piping			❖	❖	
7. Revetment condition	❖	❖		❖	
8. Vegetation condition					❖
9. Erosion of cross-section					❖

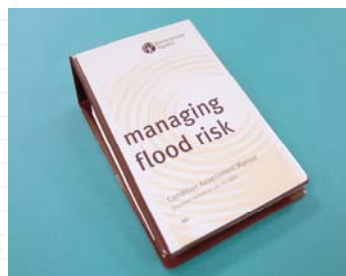
Channels: vegetation Condition 3: Fair
General: Defects that could reduce performance of the asset

Specific description: Vegetation present but stiff or dense vegetation is limited in extent.

- Update of the CAM – images and modification of the guidance language to align with performance-based assessment.
- Introduced inspection of channels for Conveyance & Blockage into the CAM
