# Prototype measuring of erosion and currents under the keel of a sailing ship in a canal

**ABSTRACT:** A full scale experiment with a deep loaded push-tow barge combination was carried out in the Juliana Canal to determine the stability of a canal bed against future ship-induced loads. The resulting under keel currents and the subsequent bed erosion were monitored and analyzed. Clearly, the results showed that in the future the canal bed will be unstable. The observed bed lowering could be estimated with a time/dependent scour prediction formula. The results of the observed flow velocities under the ship's keel were comparable with measured flow velocities in small-scale experiments.

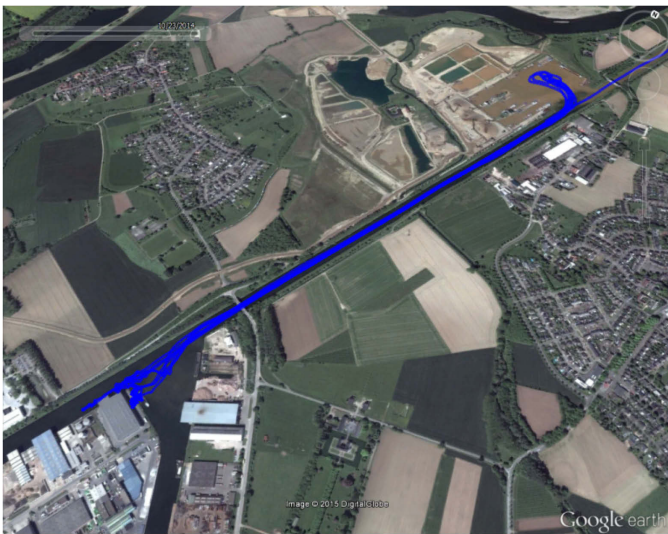
Figure 4. Measurement location with shiptracks of the barge (from AIS = Automatic Identification System) and the two turning points in the harbours. Source: Google earth.

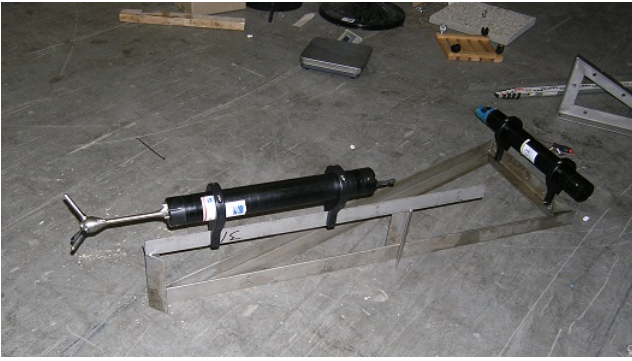
Figure 6. Bracket with Vector (looking sideways) and EasyQ (looking upward).

Current velocities were measured using a Nortek Vector point current meter and a Nortek EasyQ profiler, both acoustics Doppler instruments. The instruments were mounted on a bracket. The point current meter was measuring with 2 Hz at a height of 0.26 m above the bed in a volume of 2x2x2 cm. With the EasyQ it was possible to determine a current profile from 0.38 m above the bed of the canal up to the water surface or the ship's keel. The profile was segmented in 0.2 m cells. Due to the beams being positioned in one plane the measurements were only taken in a direction parallel to the channel axis.

The bracket was an open frame which was dugged into the gravel bed in the middle of the canal by a dive team. This ensured both minimum influence of the bracket on the currents and maximum stability of the set-up. Signal and power cables were run to shore. The instruments were connected and operated from a single laptop situated on the dike next to the canal. The instruments were left on the bottom of the canal over a period of 10 days.
