# Seabed scour assessment for offshore windfarm

RJS Whitehouse<sup>1</sup>, J Sutherland<sup>1</sup> and D. O'Brien<sup>2</sup>

Published in the Proceedings of the 3<sup>rd</sup> International Conference on Scour and Erosion. CURNET, Gouda, The Netherlands

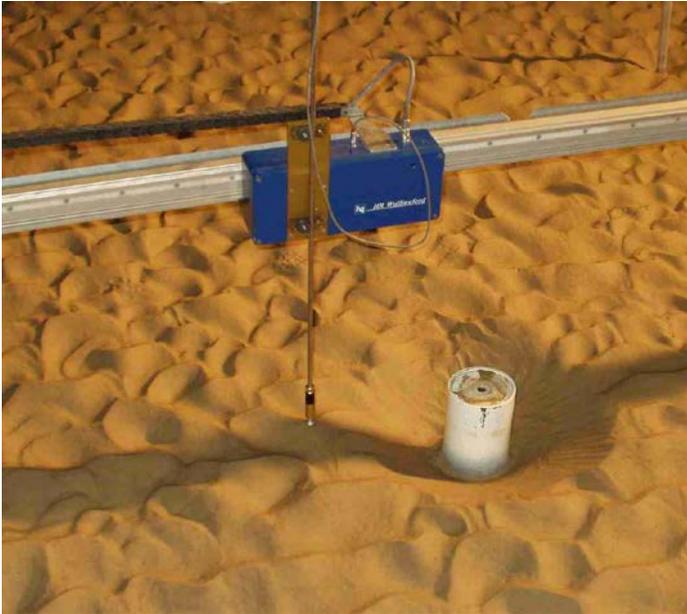
Figure 1: Bed profiler measuring scour hole

Bed profiles were measured along 8 radial lines from the monopile using a touch-sensitive bed profiler. The top section of the monopile was removed and the profiler head (shown in Fig. 1) was positioned on the edge of the monopile to provide a known starting locations. Measurements were made every 15mm from there.

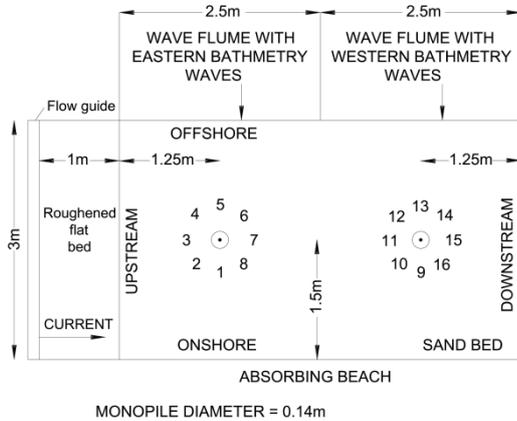
Figure 2: Sketch of test section showing current and wave flumes, sand bed, monopile positions and profiling line numbers

The layout of the test section is shown in Fig. 2, which also shows the numbering scheme adopted for the profiling lines. Dimensions in Fig. 2 are given in model scale. Results given in the paper are presented at full or prototype scale.

Damage statistics from the Scour Protection Tests with larger armour stones are given in Table V, which shows that most damage occurred in the two offshore quadrants between profile lines 11 and 15 (Fig. 2). Designs A, B and C all showed damage of over 10% in one of the offshore quadrants, although SP Tests 5 and 9 were unusually long (at 30 hours each). Therefore the structure as a whole may be said to be on the onset of failure. However, two factors should be borne in mind:

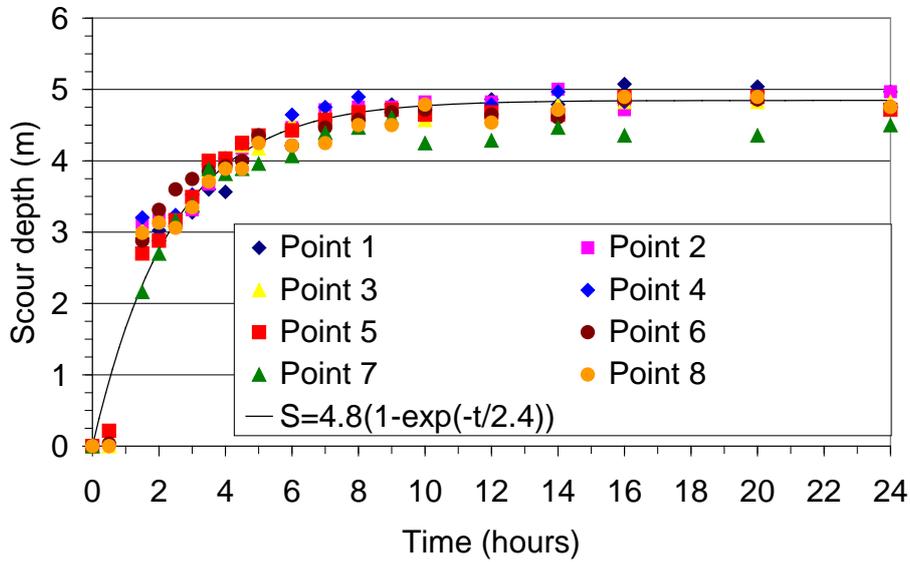
Figure 3: Time development of scour from current-only test

$$S(t) = S_{eq} \left( 1 - e^{-t/Te} \right) \quad (3)$$

where  $S(t)$  is the scour depth at time  $t$ ,  $S_{eq}$  is the equilibrium scour depth and  $Te$  is the timescale of the scour. The average value of  $S_{eq} = 4.8m$  and the average value of  $Te = 2.4$  hours. The maximum scour depth for any of the points was close to one monopile diameter.

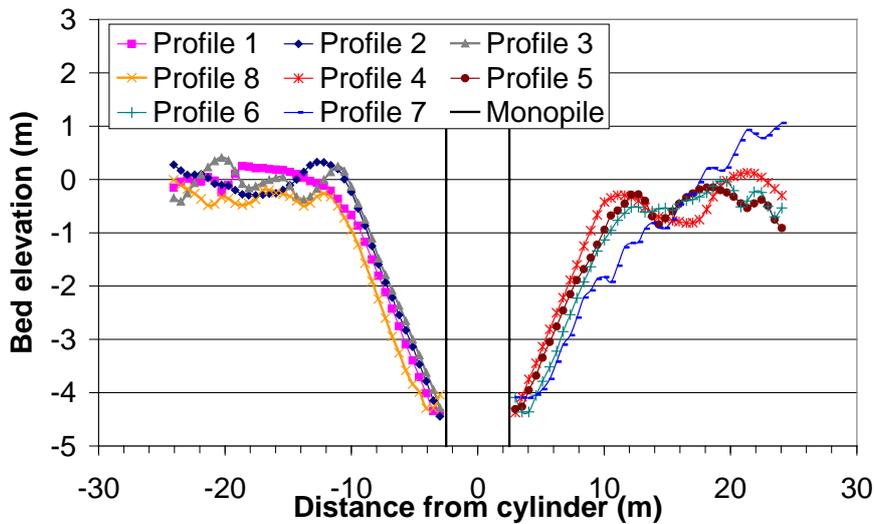
Figure 4: Radial bed profiles after sand bed Test 1

The 8 radial bed profiles measured at the end of Sand Bed Test 1 are shown in Fig. 4, with zero in the vertical being the original bed level. Measurements made before the test showed that the original bed was typically within 0.04m (prototype) of zero. Fig. 4 shows that the sides of the scour pit generally had a fairly constant bed slope of around 30° to 32°.

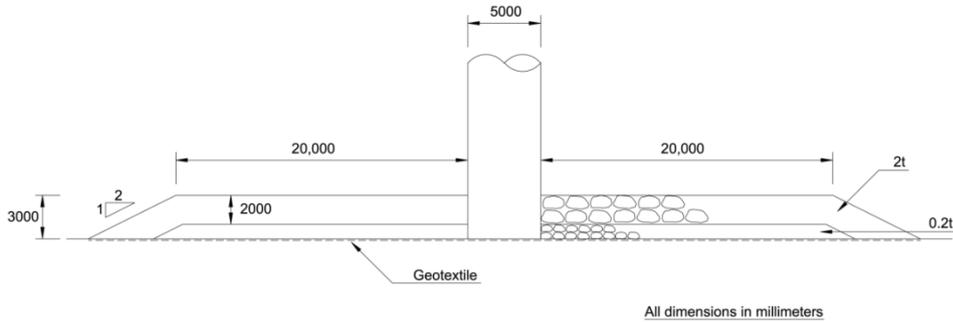
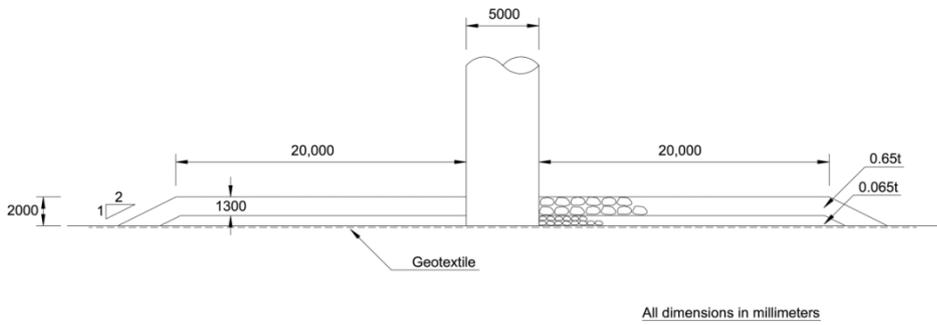
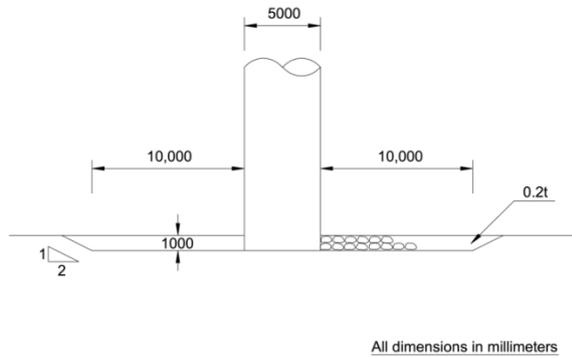
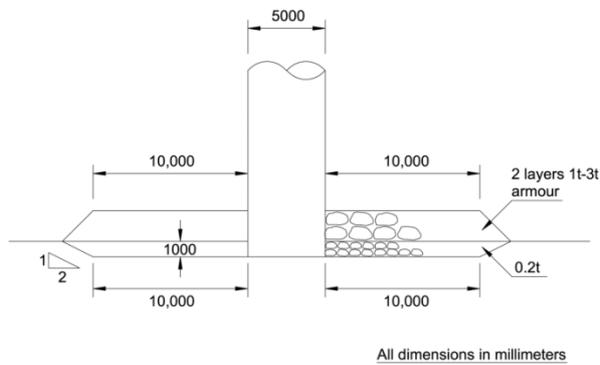
Figure 5: Prototype cross-sections for scour protection designs A, B, C and D (from top to bottom)

The ten scour protection model tests were carried out using different combinations of four scour protection schemes and three environmental conditions. The four scour protection designs are described below and their cross-sections are provided in Fig. 5.

The flow acceleration around scour protection designs 'A' and 'B' (Fig. 5) which stood 3m and 2m above the bed caused substantial lowering of the sand bed around them. This trend was particularly pronounced at low water condition, when the initial water depth was only 4m and bed lowering of up to 3m was observed. Although there is some evidence of armour stone movement on the flat tops of these models (particularly close to the monopile where there would have been higher than ambient shear stresses due to local flow accelerations) the majority of the damage occurred at the edge of the model, where the bed had lowered.

The results for scour protection design 'D' (Fig. 5) were of a similar form to the results from design 'A' and 'B'. The lower structure caused less flow acceleration and bed lowering around it. Damage levels were correspondingly lower as well (compare the results from Test 8 with those from Tests 3 and 6 which used the same environmental conditions with designs A and B).

The two tests with design 'C' (Fig. 5) showed little apparent damage, although only filter material was used. This design had its top surface flush with the bed, so it did not disrupt the flow.

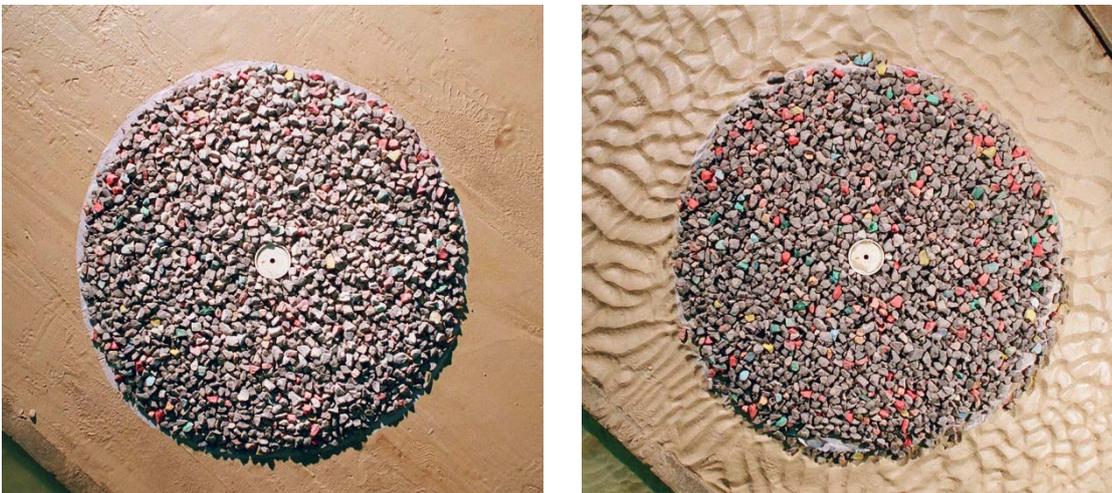
Figure 6: Before (left) and after (right) Scour Protection Test 1

The damage caused during Scour Protection Test One can be seen by comparing the two photographs in Fig. 6. Fig. 6 shows that the sand bed is rippled throughout (so sediment transport is occurring throughout) with the ripple crest direction predominately perpendicular to the current direction on the upstream and onshore sides of the model (implying development is current dominated). The ripple patterns are more three-dimensional on the offshore side, showing the influence of waves. There is a small area downstream of the model where the ripple crests are parallel to the incident wave crests showing that their growth is wave dominated.

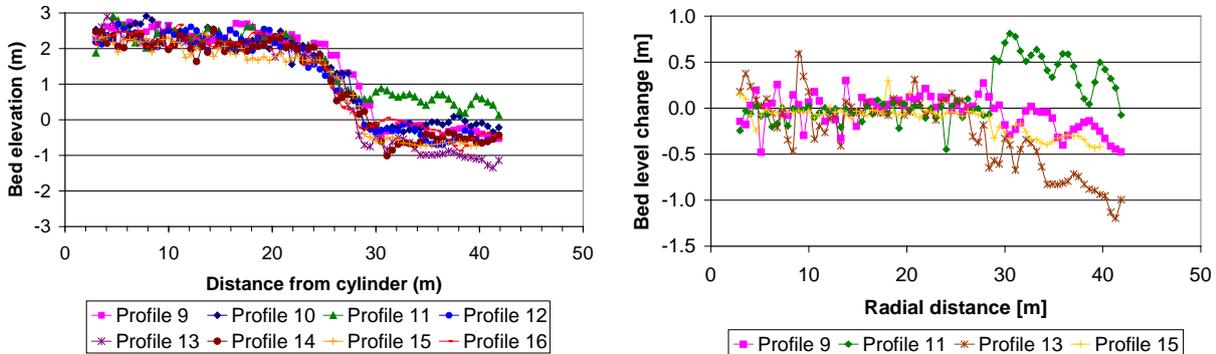
Figure 7: Bed levels at the end of Scour Protection Test 1 (left) and bed level changes during the test (right)

Bed profiles at the end of the test are shown in Fig. 7 (top). The scour (negative values) and deposition (positive values) were calculated by subtracting initial profiles from final profiles and are shown in Fig. 7 (below) for Scour Protection Test 1. Fig. 7 shows that there were some changes in elevation between the edge of the monopile and displacement of stones (at 2.5m radial distance) and about 15m radial distance. This may have been due to flow acceleration around the monopile. Note however, that changes in elevation between 'before' and 'after' may occur due to slightly different displacement of the probe in the two deployments or to minor rotations or displacements of armour stones. Consistent changes over two or three points are a more reliable indication of movement than differences at a single point.

The profile showing the greatest changes in elevation close to the monopile is profile 13, which points directly offshore (into the waves). It is therefore likely that the environmental conditions could cause some stone movement on the flat top of the model, close to the monopile. Little movement can be detected from the changes in bed elevation at the edge of the protection, shown in Fig. 7. However, the photographs (Fig. 6) reveal that some stones have moved out from the edge of the model, off the geotextile.

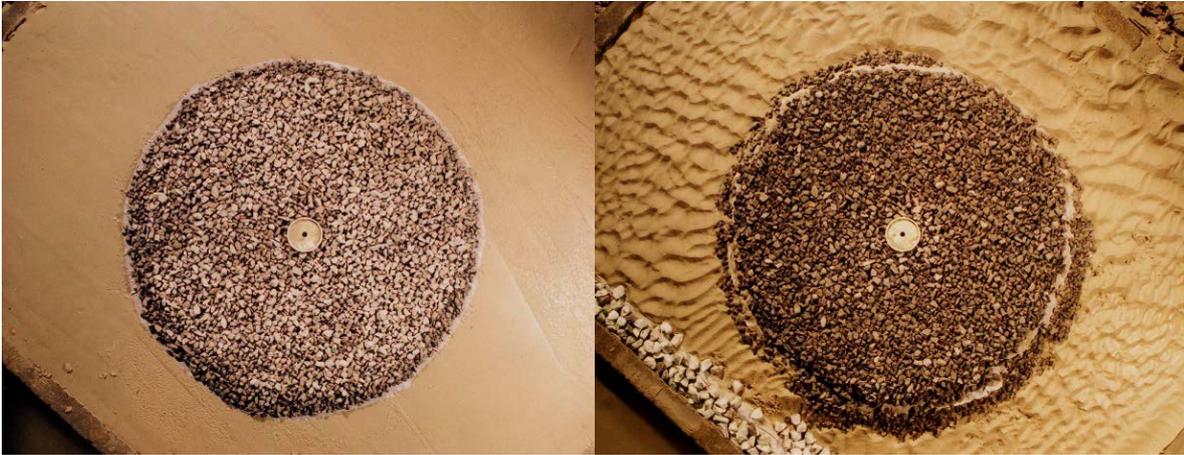
Figure 8: Scour protection Design B before SP Test 4 (top) and after SP Test 5 (below)

Scour Protection Test 1 was presented in some detail to show the type of data collected for all the scour protection tests. Examples are given below from the other scour protection tests. Fig. 8 (top) shows scour protection design B before SP Test 4, while Fig. 8 (below) shows the same design at the end of SP Test 5, after 36 hours of environmental condition 'i'.

The photographs in Fig. 8 reveal that some stones have moved out from the edge of the model, off the geotextile. Where this has occurred, there is often a strip of geotextile visible between the remaining stones in the model and those that have slipped down and out from the edge of the model. This movement is associated with bed lowering and shows that the model is unraveling by movement away from the model. The radial profiles showed that steep slopes typically occur between 23m and 25m radial distance, with a flatter area where the displaced stones have settled between 25m and 27m radial distance.

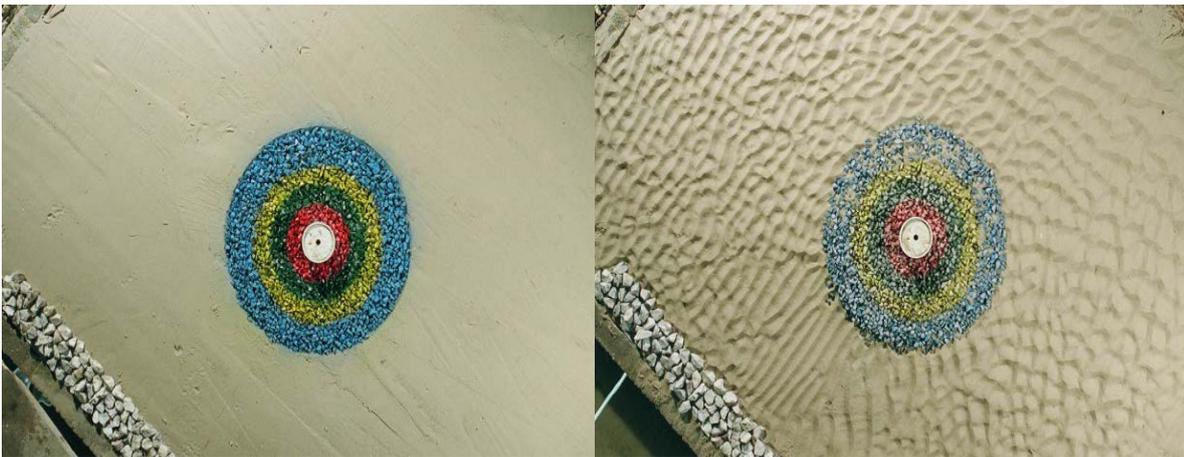
Figure 9: Scour Protection Design C before (top) and after (below) SP Test 10

Equivalent sets of photographs for SP Design C are shown in Fig. 9, before and after SP Test 10. Here the upper surface was spray-painted in concentric rings so that movement could be assessed at different distances from the monopile. Fig. 9 shows that there was relatively little movement of scour protection material during the test, although some occurred along profile 11 close to the monopile and some occurred at the edge of the protection, where the seabed lowered. Fig. 10 shows an overhead photograph of Design D after SP Test 9.

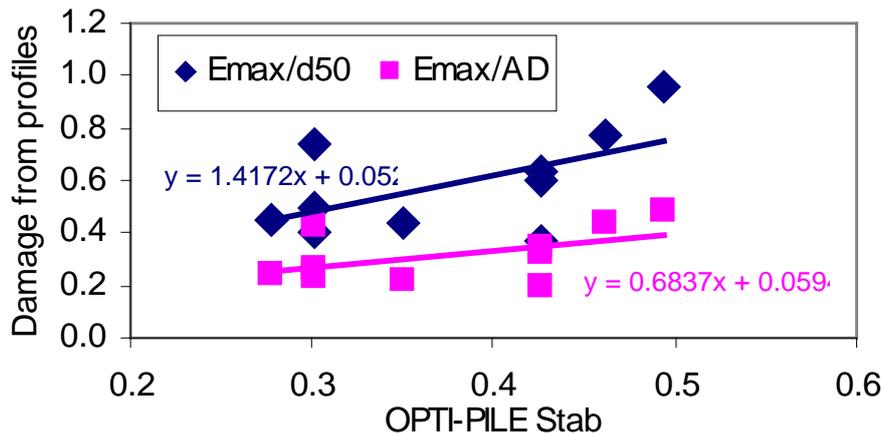
Figure 13: Measured damage against predicted damage

Table VI shows that the stability parameter,  $Stab$  is not closely related to the maximum damage. It is related to the damage statistics  $E_{max}/d_{50}$  and  $E_{max}/AD$ , as shown in Fig. 13, which also shows best-fit straight lines through the data. These lines were used to predict damage from  $Stab$  to obtain a relative mean absolute error of 0.19 in both measures of damage.

The OPTI-PILE design tool stability number increases with increasing measured damage: the correct behaviour for a stability predictor. However, the different measures of damage used in [3] and here have made the comparison more difficult. The Arklow experiments only measured changes in the armour level along 8 radial profiles and it would be possible for greater levels of damage to occur in between. The definition of failure for a static protection used in OPTI-PILE implied a maximum erosion,  $E_{max}/AD = 1$ , a condition that was not observed in the tests. The OPTI-PILE design tool would need to be recalibrated for design use in similar circumstances.
