## A Database of major breakwaters around the world

N.W.H. Allsop, R.S. Cork and ir. Henk Jan Verhagen

Coasts, Marine Structures and Breakwaters 2009 Conference  
EICC, Scotland

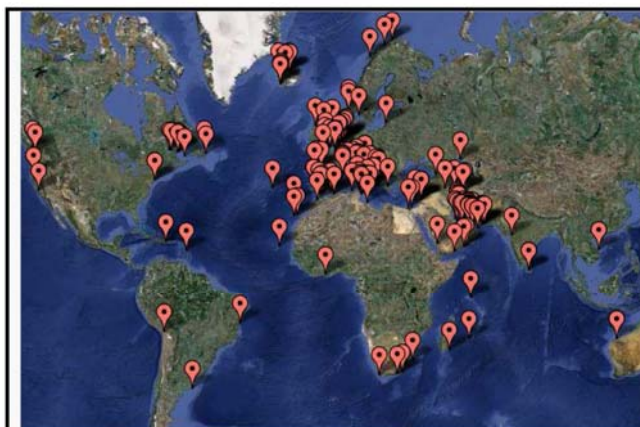
Figure 2 (left): locations of the breakwaters at present in the database

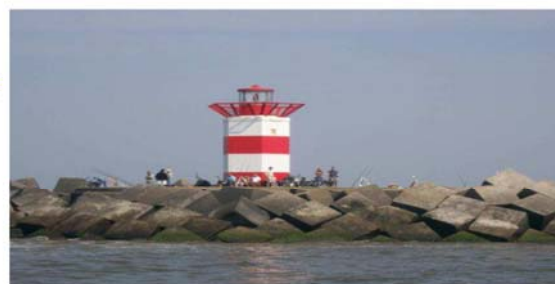
#### **Netherlands - Scheveningen** ([Lat: 52.102 Lon: 4.256 - click for map](#)) Zuiderdam

Rubble mound  
Breakwater extension

front slope 1:1.5	25	ton	<a href="#">Cubes</a>
rear slope 1:1.5	25	ton	Cubes
